PHASE I CULTURAL RESOURCES SURVEY OF 111 ACRES (44.9 HECTARES) NEAR BASTROP, MOREHOUSE PARISH, LOUISIANA

Draft Report

Due Diligence Assessment

April 2019

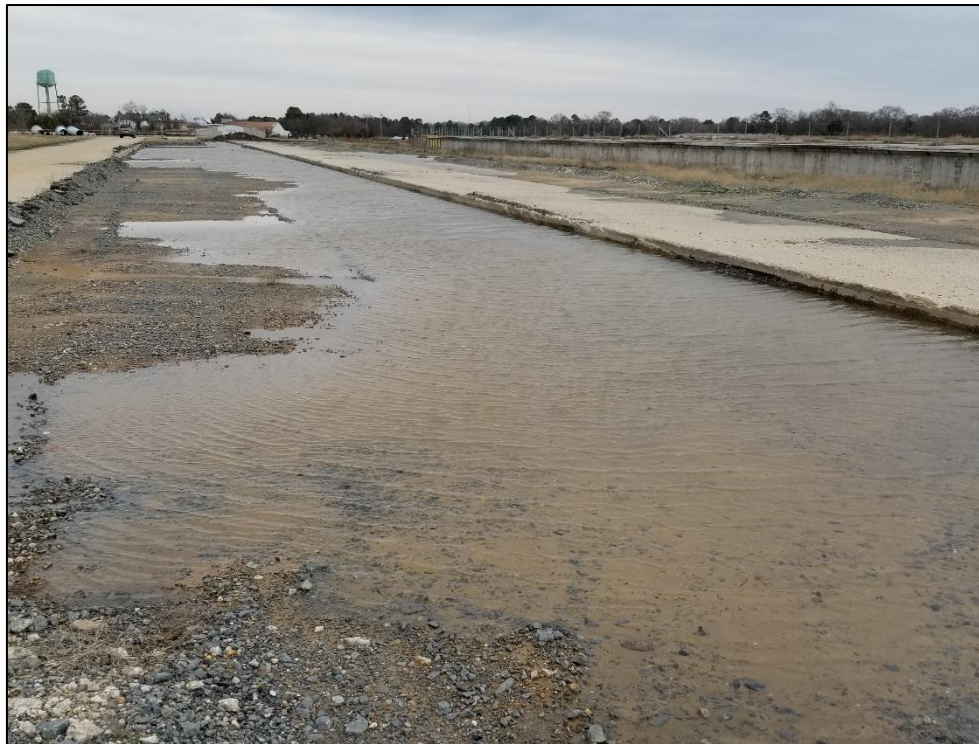
Figure 25. Inundation of gravel area north-south along western portion of PA (credit: Steve Treloar).

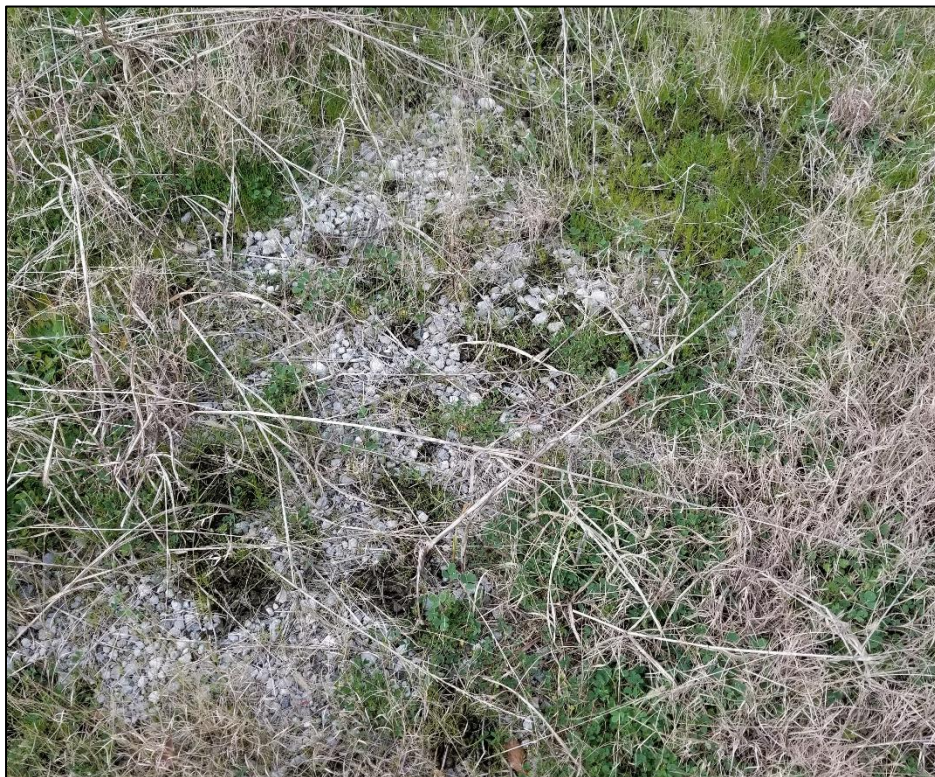
Figure 27. Exposed gravel from overgrown preexisting parking lots (credit: Steve Treloar).

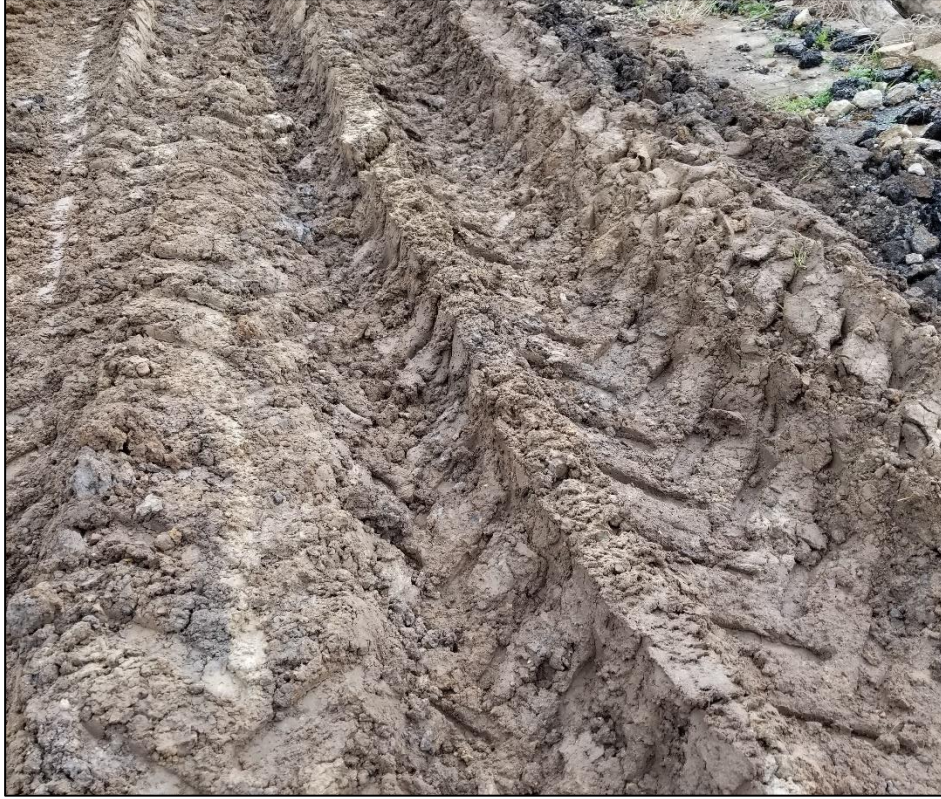
Figure 28. Bulldozed parking lot surface in southeast portion of the PA
(credit: Steve Treloar).

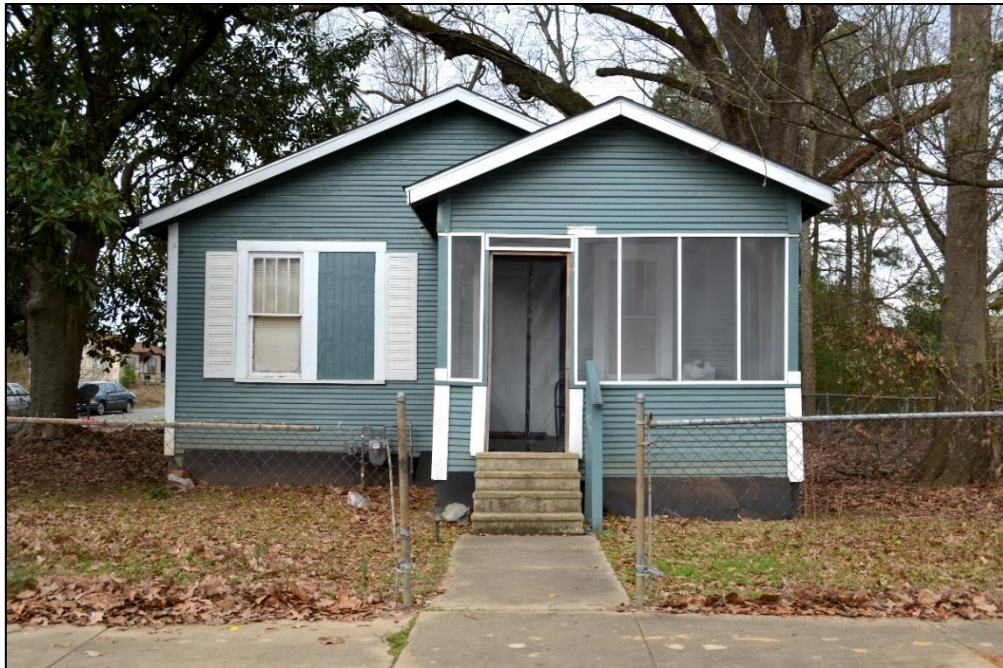
Structures 34-00174 - 34-00178 were all built between 1925 - 1927 in a row along N. Odom Street. Originally in a row of eight sister houses only five houses remain. Two of the five houses are in complete disrepair; Structure 34-00175 (Figure 32) with a completely caved in roof and Structure 34-00177 severely damaged by a fire. Structure 34-00174 (Figure 33), 603 N. Odom Street, is the most intact and presumably contains the most original features of the remaining houses on the west side of N. Odom Street. Structure 34-00174 still has the front porch while many of the others were closed in to become part of the living quarters. The house has four vertical panes over one pane double hung wood windows. The screened in porch is under its own gable that extends from the main roof, both shingled, and it protects the paneled front door and a window. There are concrete steps and a wooden railing leading into the porch.

Figure 32. Structure 34-00174 at 603 N. Odom Street (credit: Michelle Brenner).

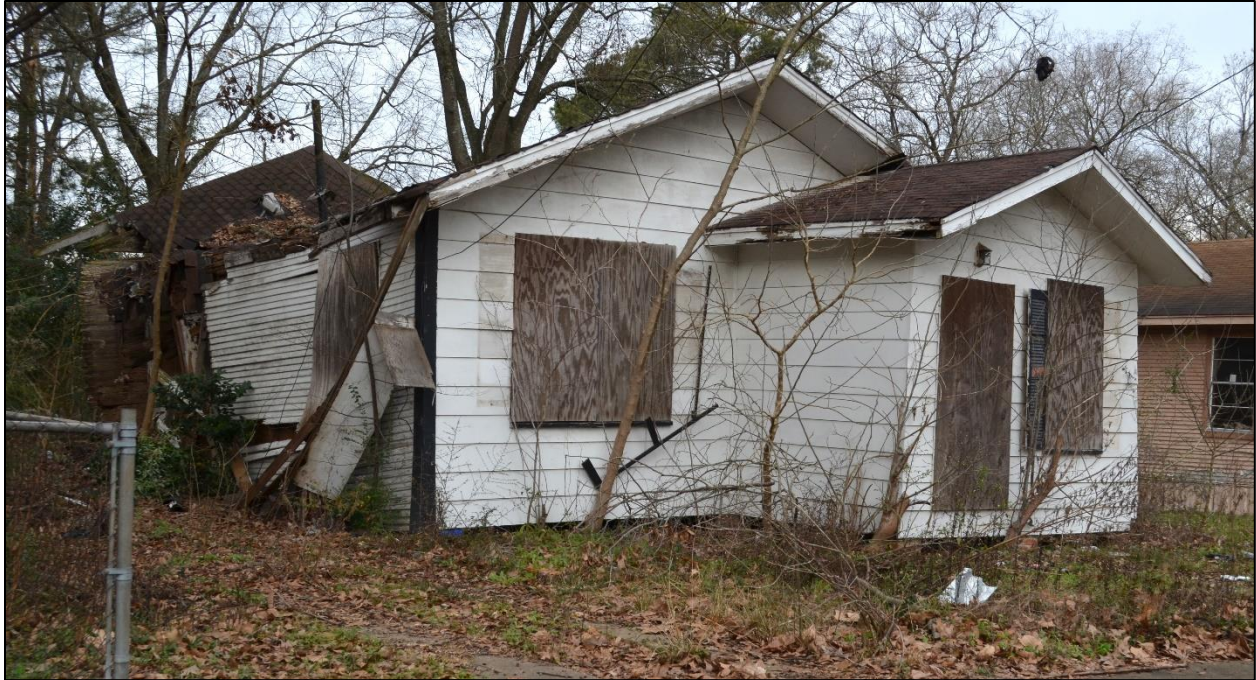
Figure 33. Structure 34-00175 at 607 N. Odom Street (credit: Michelle Brenner).

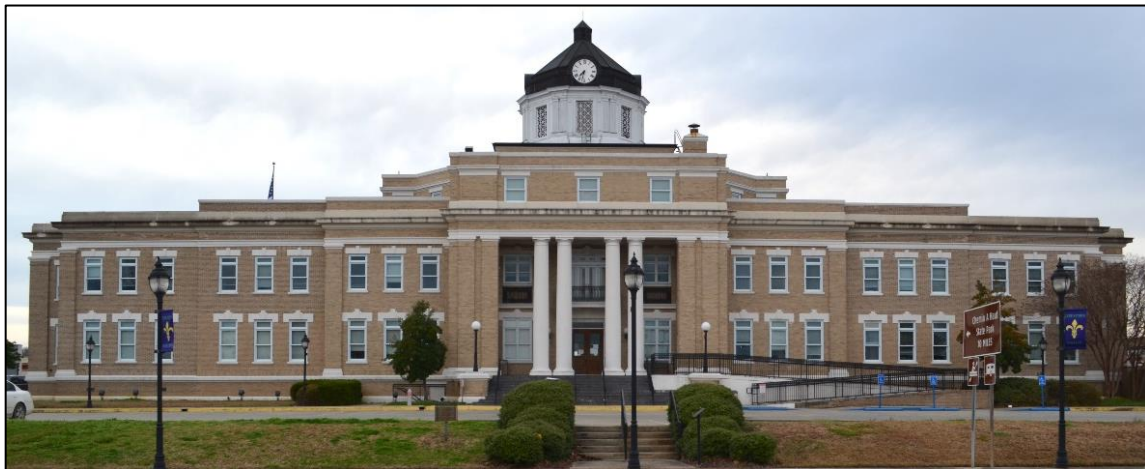
Figure 34. Morehouse Parish County Courthouse (credit: Michelle Brenner).

The Morehouse Parish County Courthouse, other than slight weathering, is in the same condition as when it was placed on the Register. There have been no obvious alterations to the exterior of the building. It is well maintained and still utilized as the courthouse.

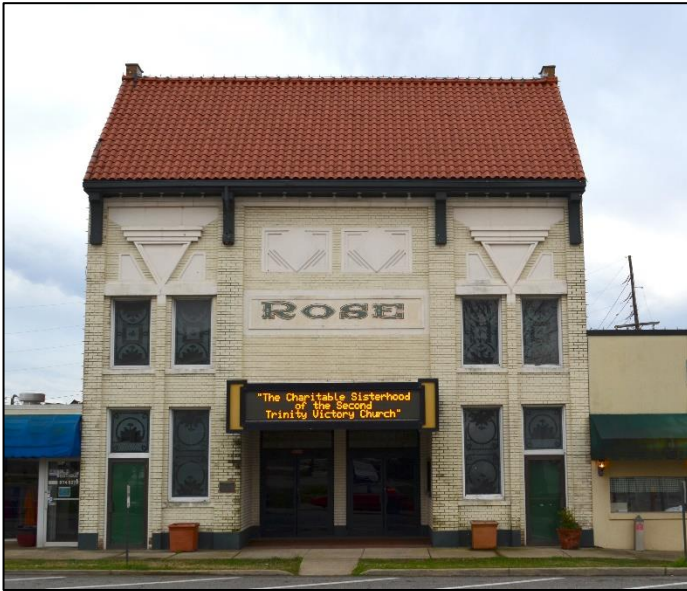
The Rose Theater (Figure 35) has not seen any development or changes since it was placed on the register in 1987. The digital marquee was lit up and active and, although the theater was closed, the marquee had upcoming show times listed for two months in advance. Nevertheless, its present condition causes worry. Many of the exterior window casings are showing small signs of rot and biological growth is starting to creep its way up the façade (Figure 36). These observations imply that the theater may not be receiving the maintenance that the historic structure requires.

Figure 35. Rose Theater facade (credit: Michelle Brenner).

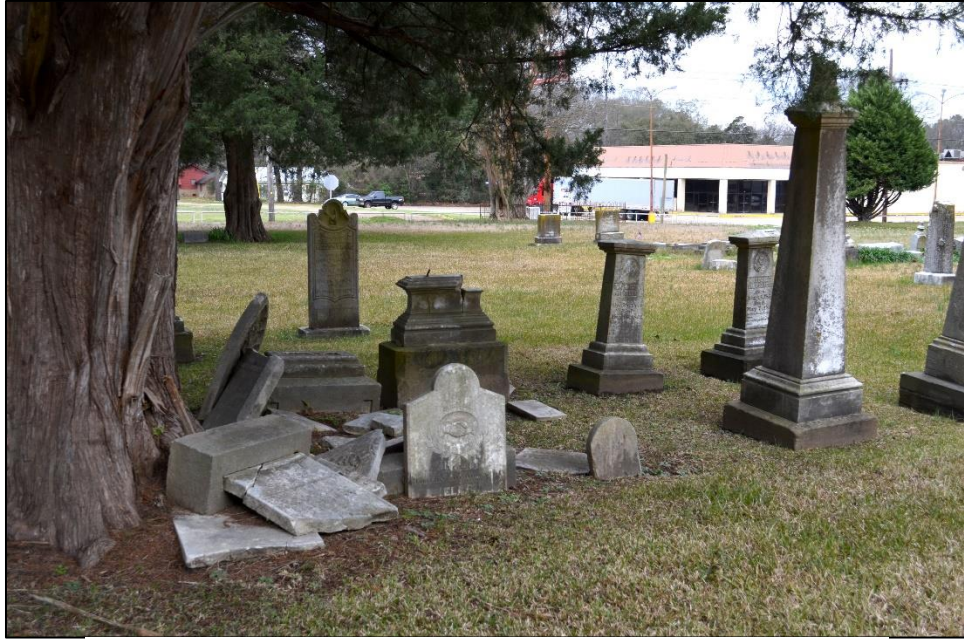
In comparing the two cemeteries, the Bastrop city cemetery consists of older graves, many encompassed by iron gates that range in condition from being intact to only having one remaining post (Figure 37). The gravestones are concrete, marble, or sandstone and many are weathered and illegible. While it appears maintained, the city cemetery has multiple broken and misplaced headstones and markers (Figures 38-40). The cemetery contains gravestones of civil war veterans.

Figure 39. Broken and misplaced headstones and markers in Bastrop City Cemetery (credit: Michelle Brenner).

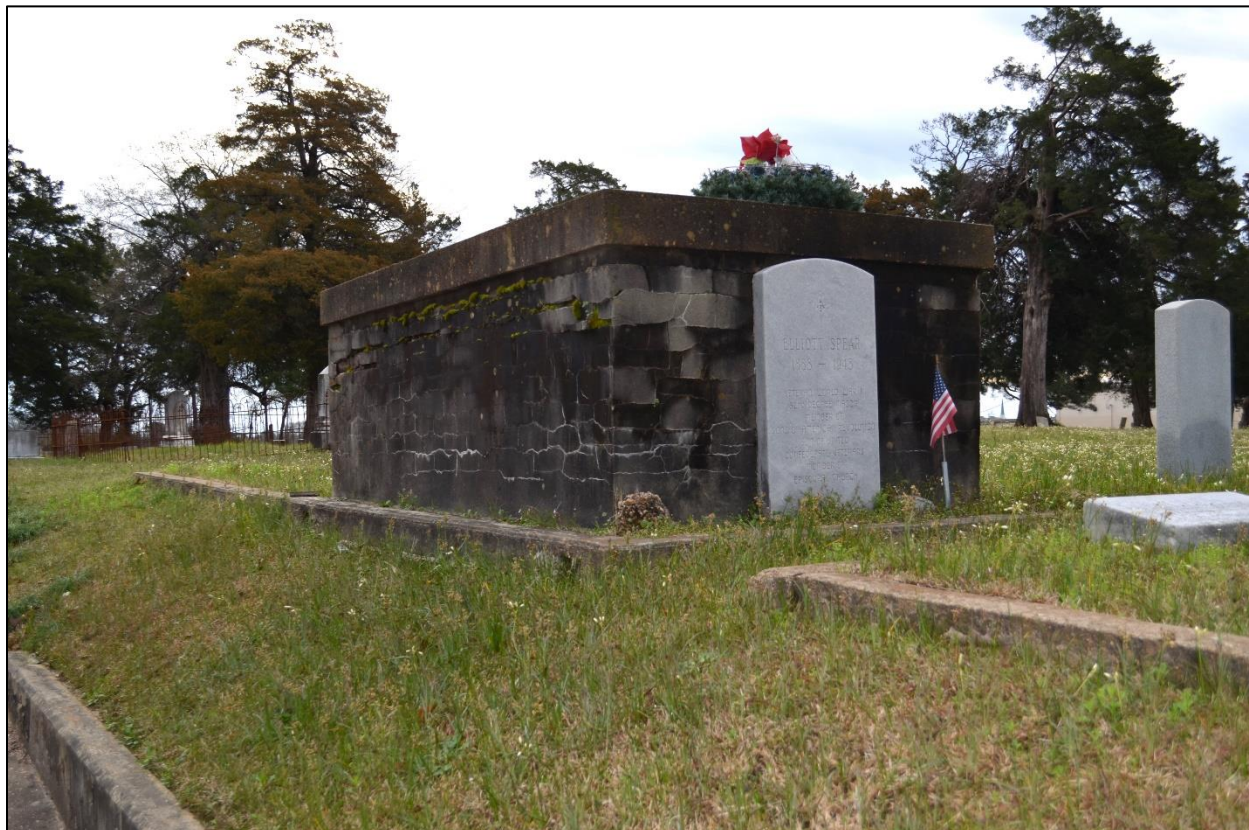
The Catholic cemetery, named St. Joseph Catholic Cemetery, houses seemingly newer graves many with elaborate tombstones adorned with fake flowers and American flags positioned by the graves. There are multiple above ground tombs (Figure 41). The cemetery is well maintained and active.

Figure 41. Above ground tomb in St. Joseph Catholic Cemetery of World War 1 veteran with American flag and wreath (credit: Michelle Brenner).
