## South Schaefer Site

### Wetlands Delineation Report

## **WETLAND DELINEATION FOR SOUTH SCHAFFER PROPERTY**

**+/-52.74-Acre Tract  
Section 23, Township-11-South, Range-5-East  
St. Martin Parish, Louisiana**

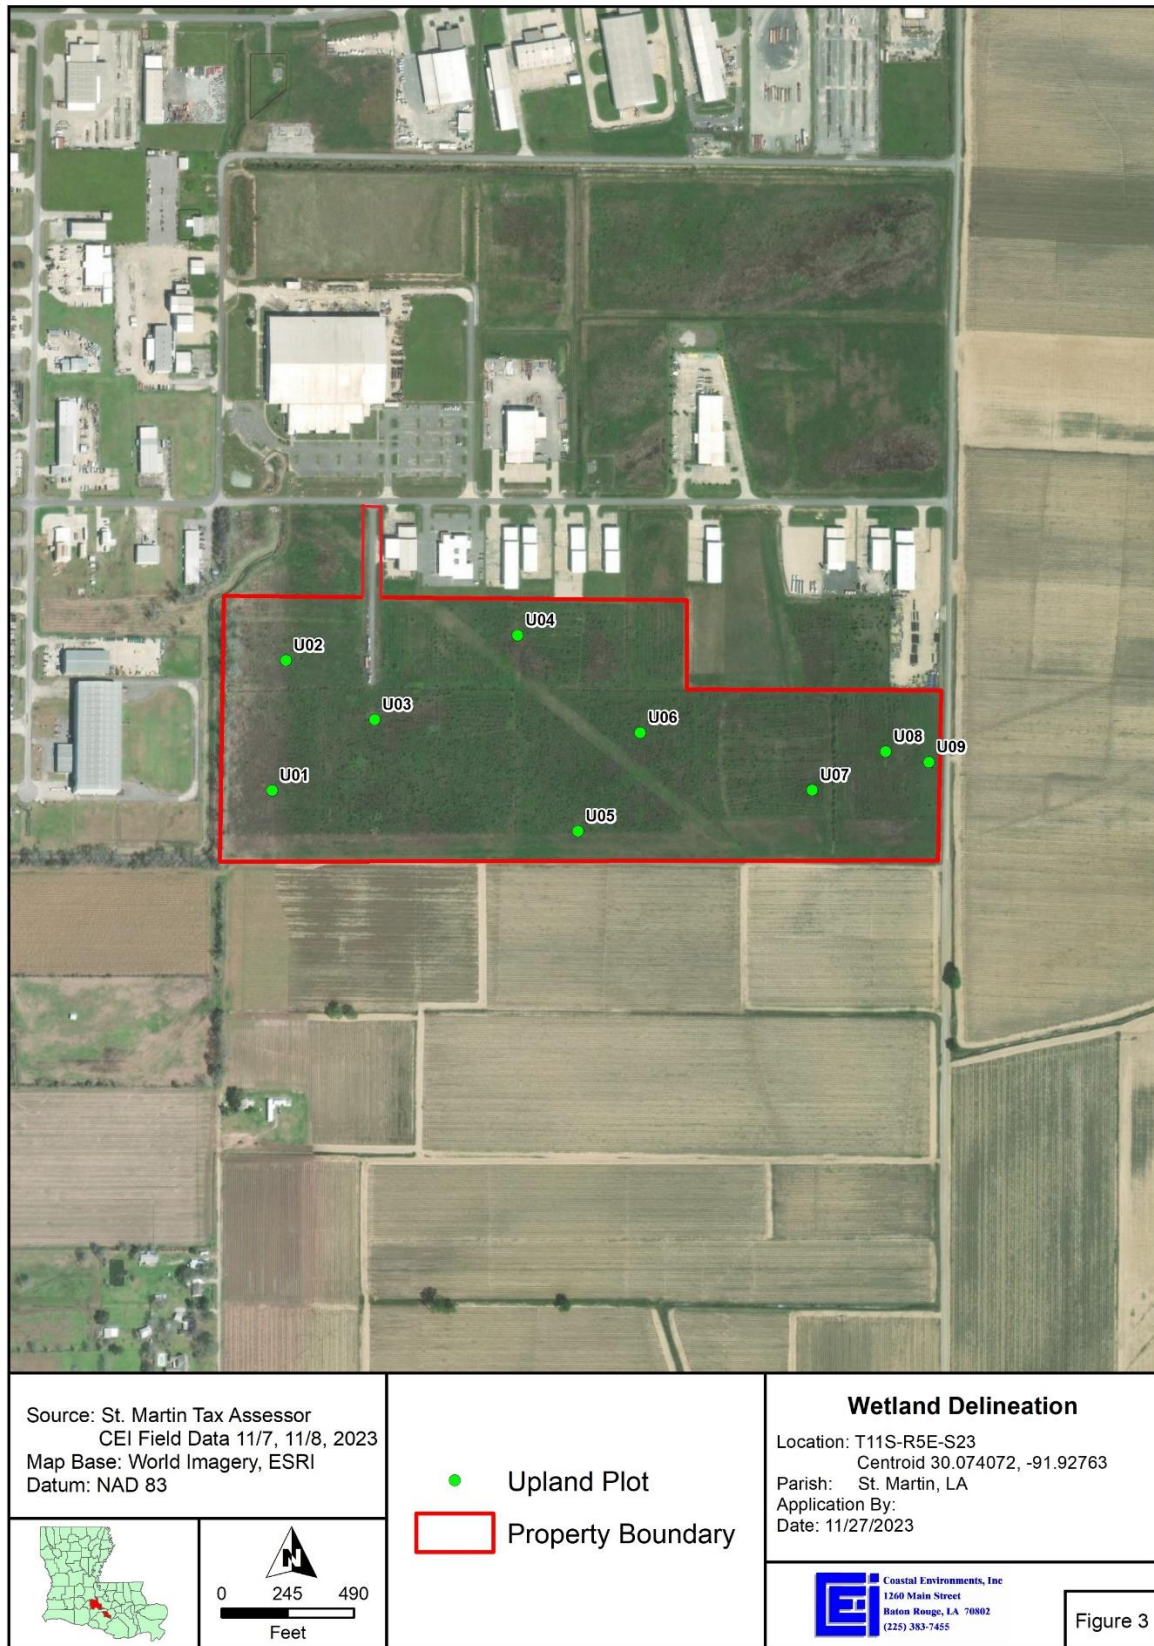
**Figure 3: Potential Non-Jurisdictional Wetland and Property Boundaries on 2023 Google Earth Image.**

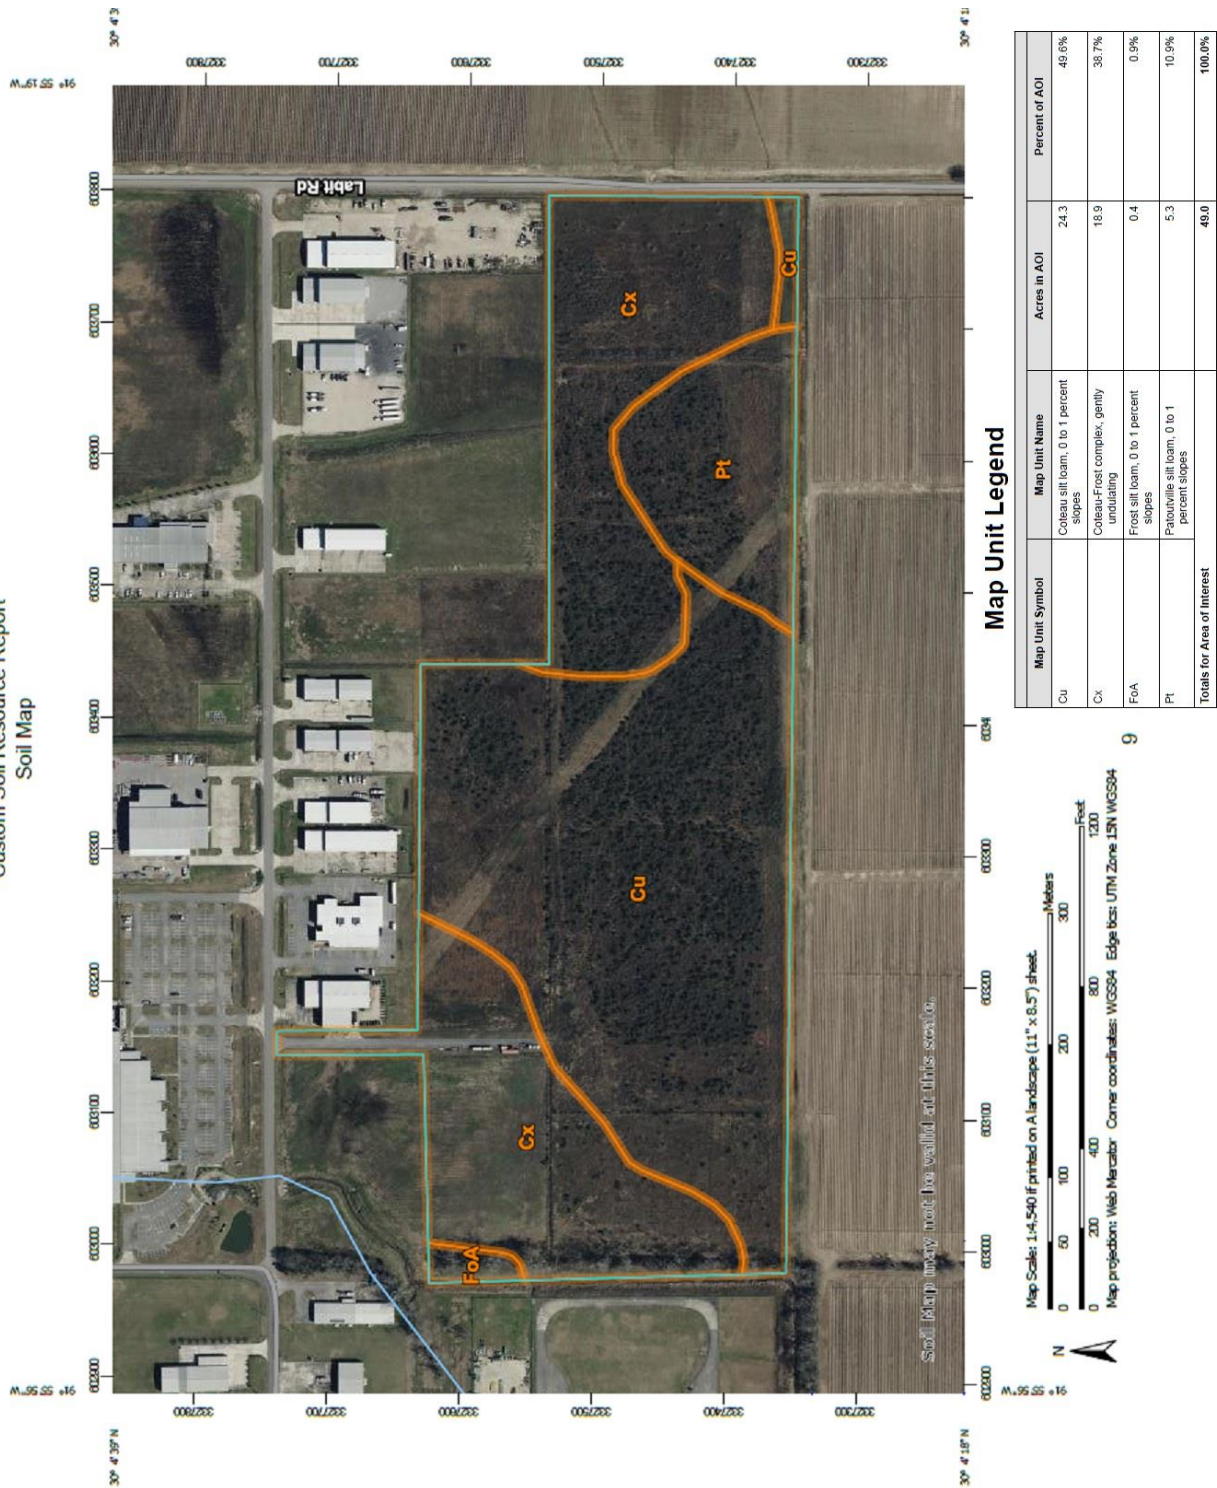
Figure 7: NRCS Web Soil Survey Report and Property Boundaries.

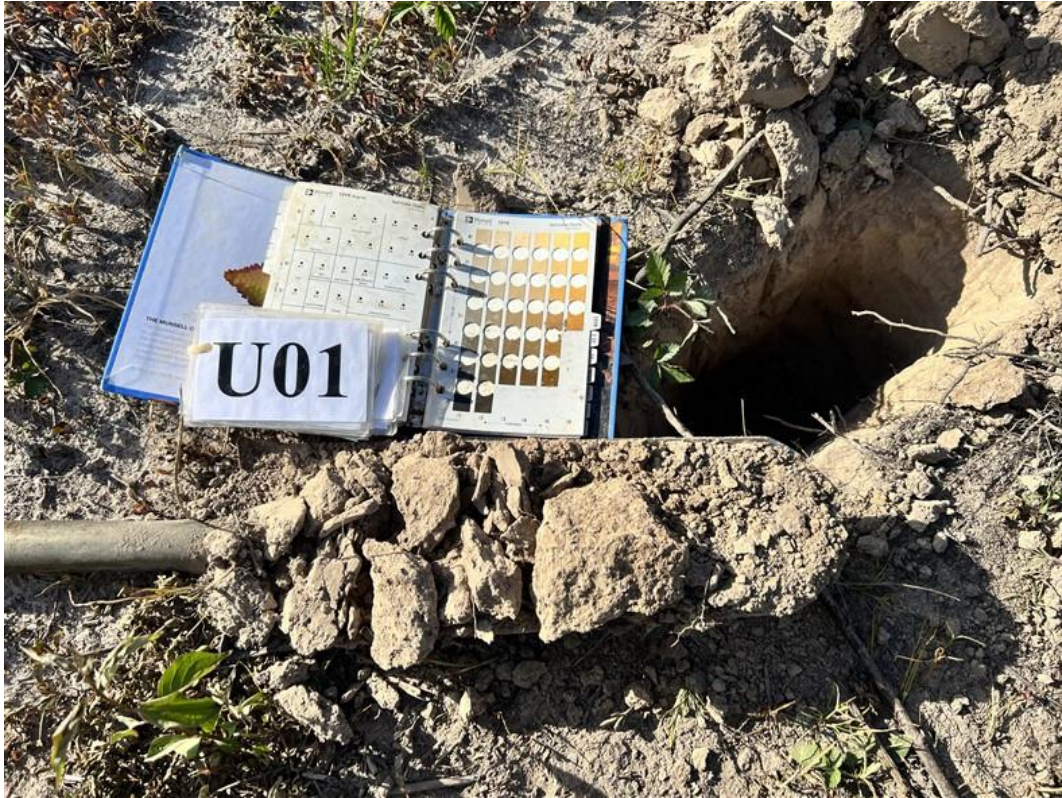
**Figure B.1** Photograph of soil sample from Sample Site U01- (CEI 11-07-23)- Upland areas on Southwest property corner.

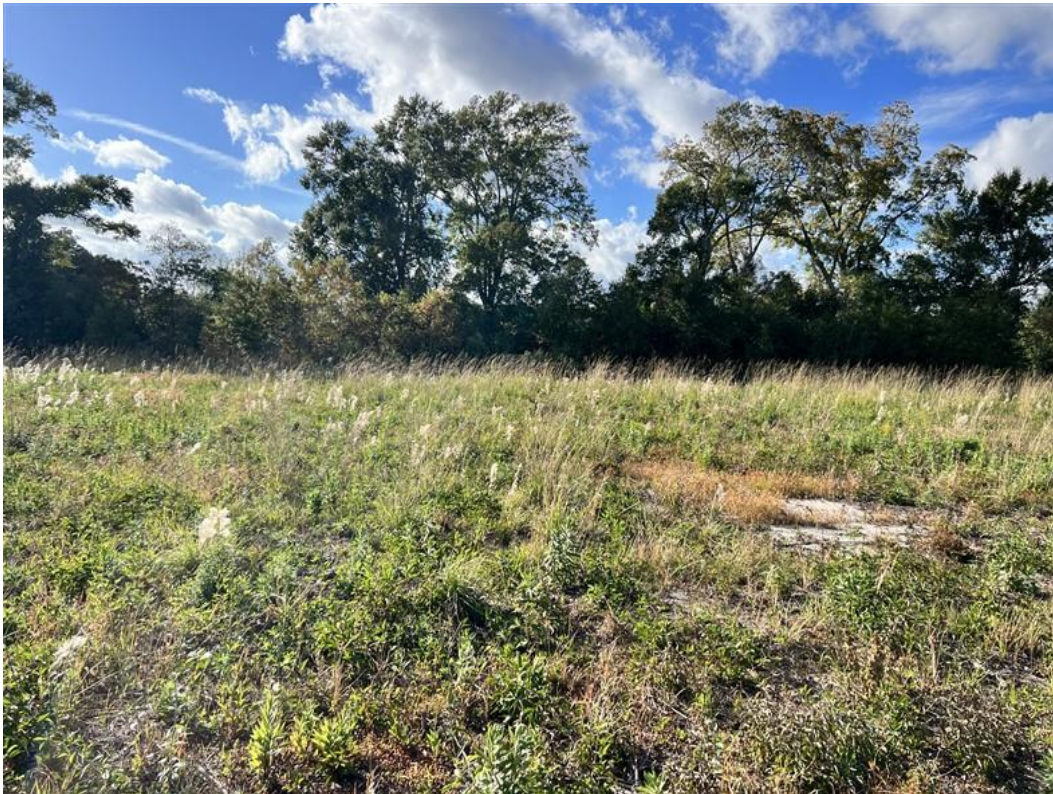
**Figure B.2** Photograph looking to the west of open field areas at Sample Site U01- (CEI 11-07-23)- Upland areas on Southwest property corner.

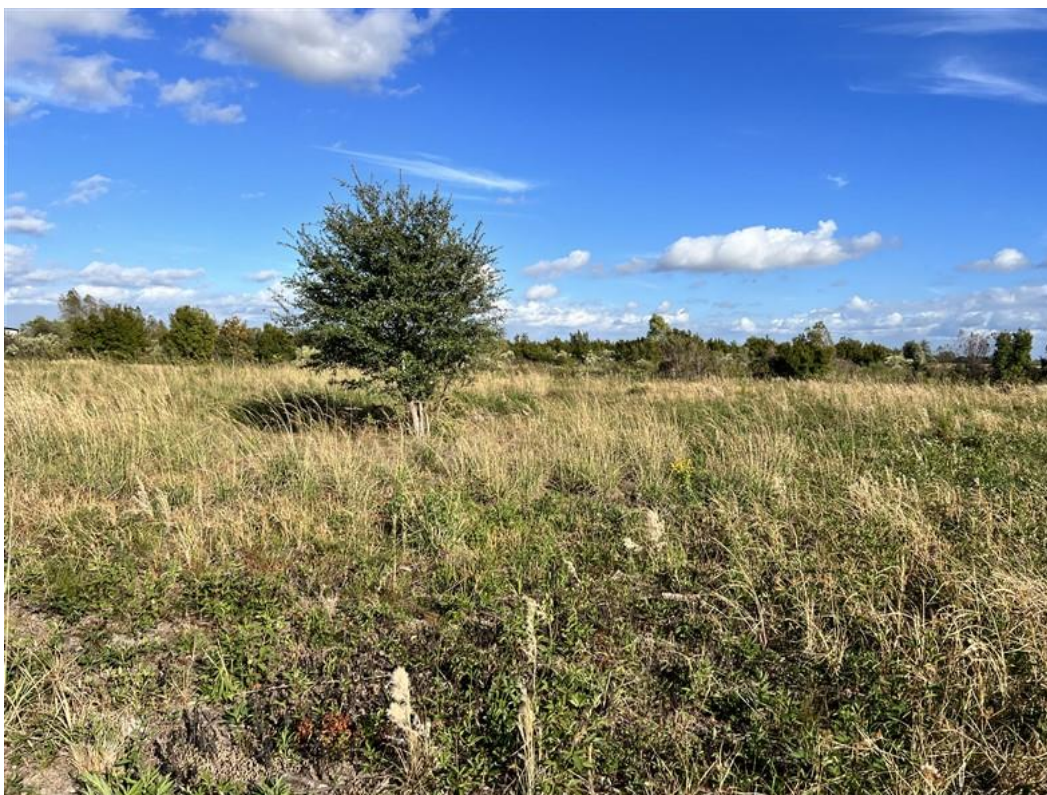
**Figure B.3** Photograph looking to the east of open field areas at Sample Site U01- (CEI 11-07-23)- Upland areas on Southwest property corner.

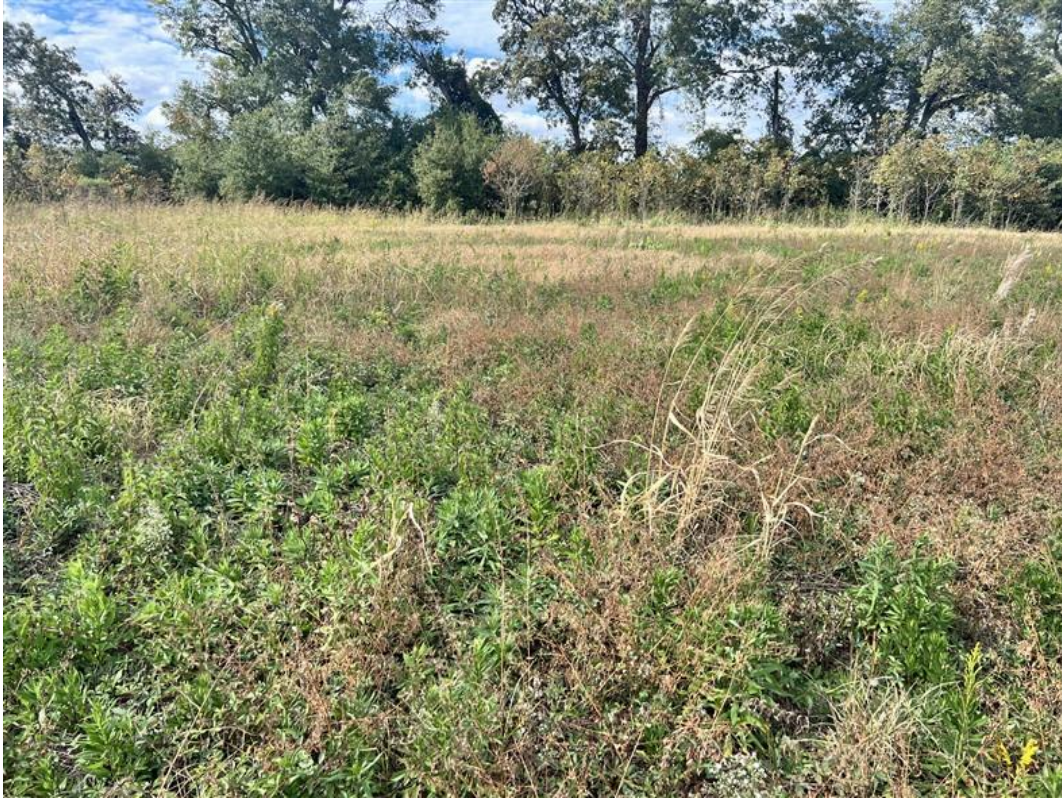
**Figure B.5** Photograph looking to the west of open field areas at Sample Site U02- (CEI 11-08-23)- Upland areas on southwest property corner.

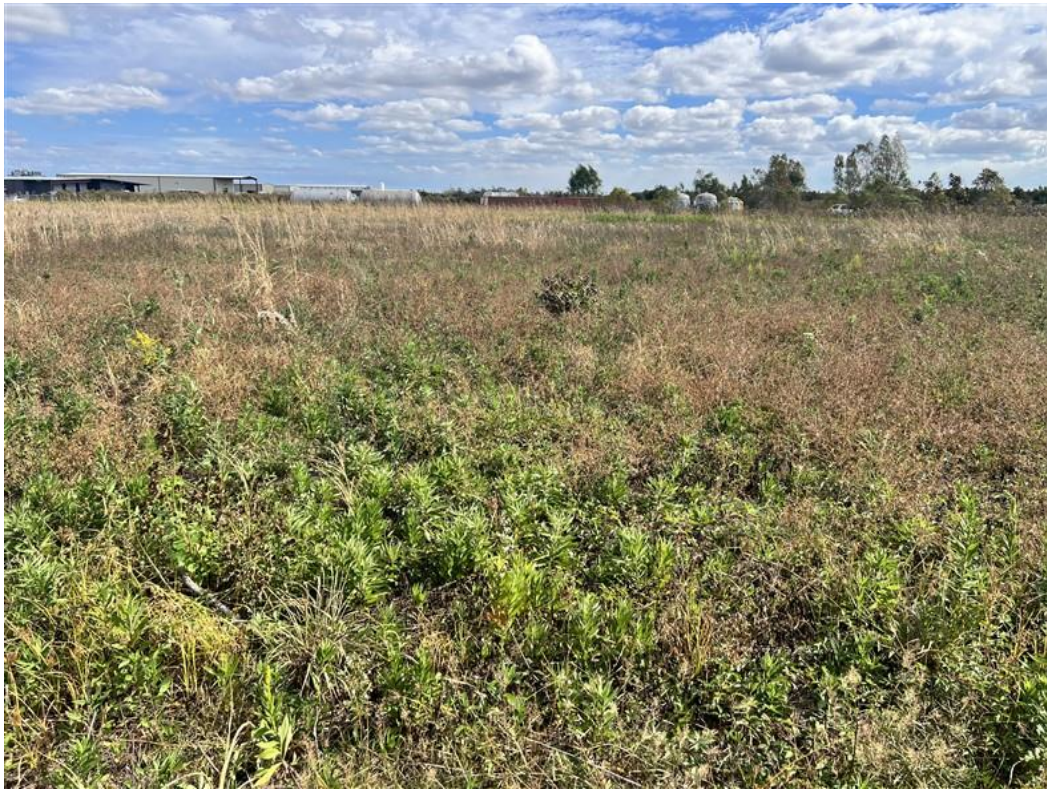
**Figure B.6** Photograph looking to the east of open field areas at Sample Site U02- (CEI 11-08-23)- Upland areas on southwest property corner.

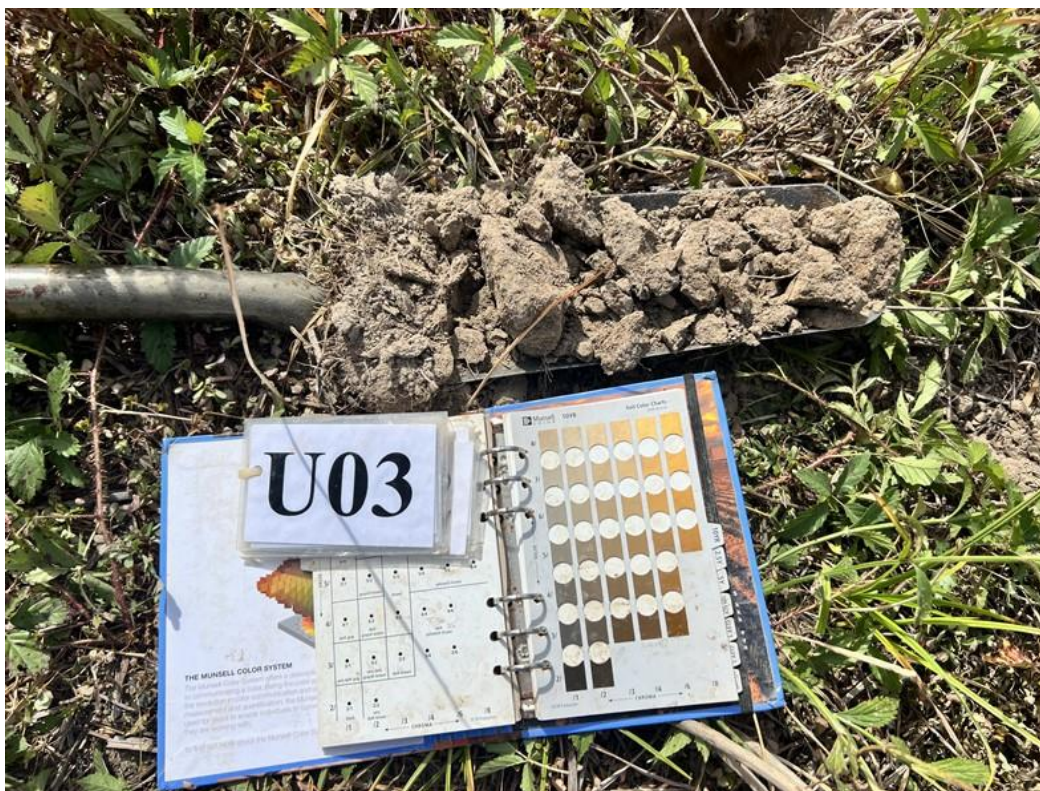
**Figure B.7** Photograph of soil sample from Sample Site U03- (CEI 11-08-23)- Upland areas on center-west property area.

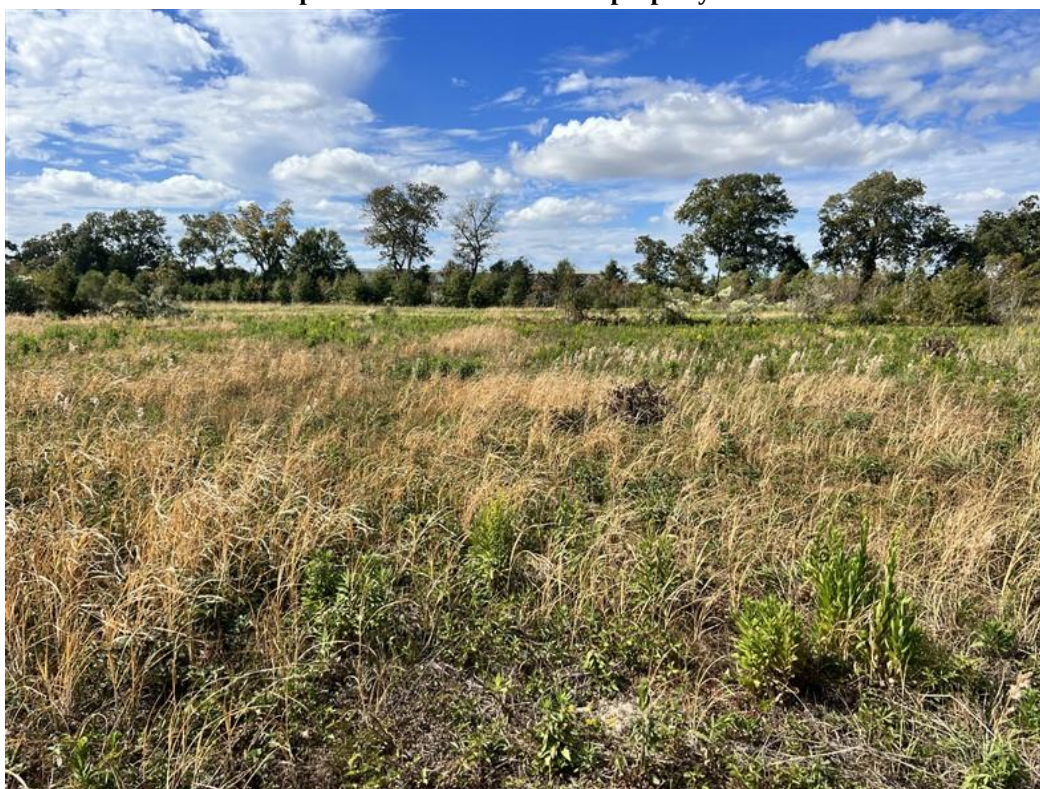
**Figure B.8** Photograph looking to the west of open field areas at Sample Site U03- (CEI 11-08-23)- Upland areas on center-west property area.

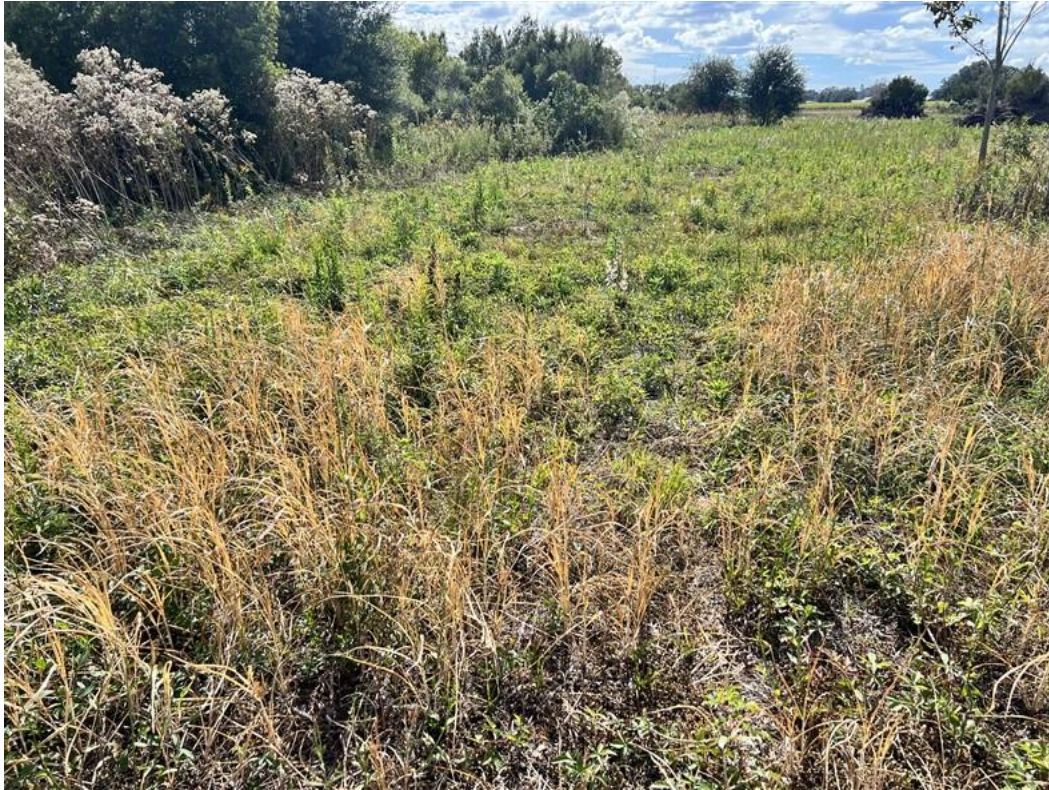
**Figure B.9** Photograph looking to the east of open field areas at Sample Site U03- (CEI 11-08-23)- Upland areas on center-west property area.

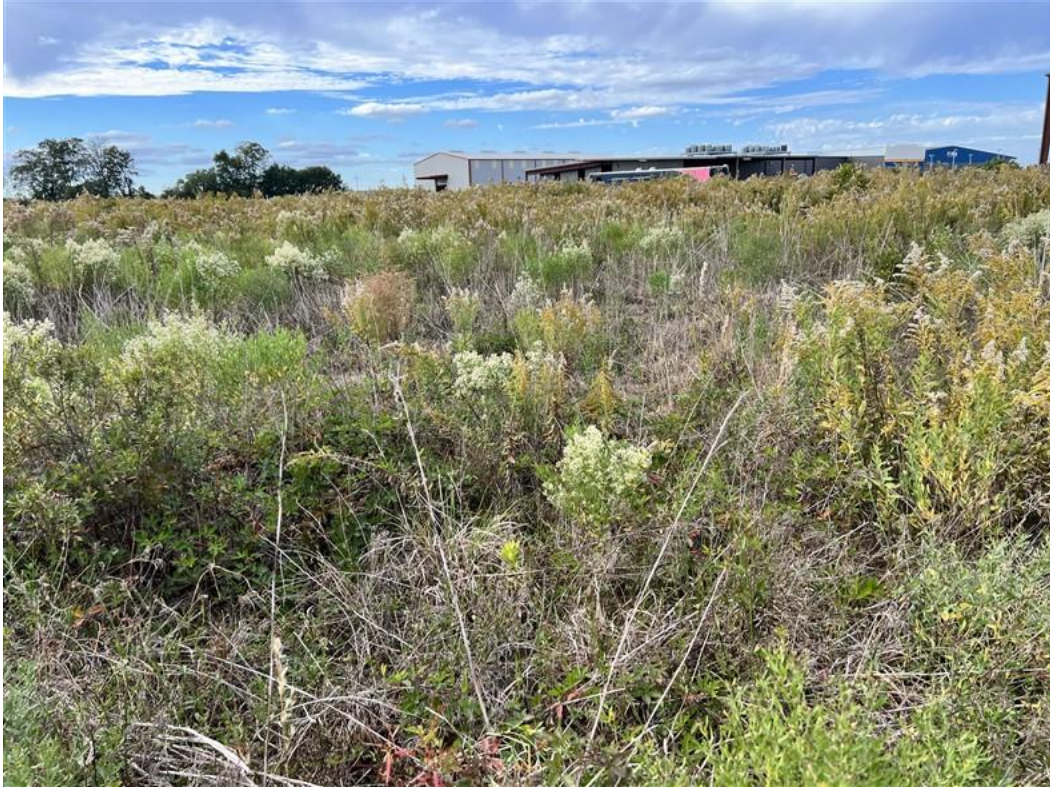
**Figure B.11** Photograph looking west of vegetated areas at Sample Site U04- (CEI 11-08-23)-  
Upland areas on southeast corner of property.

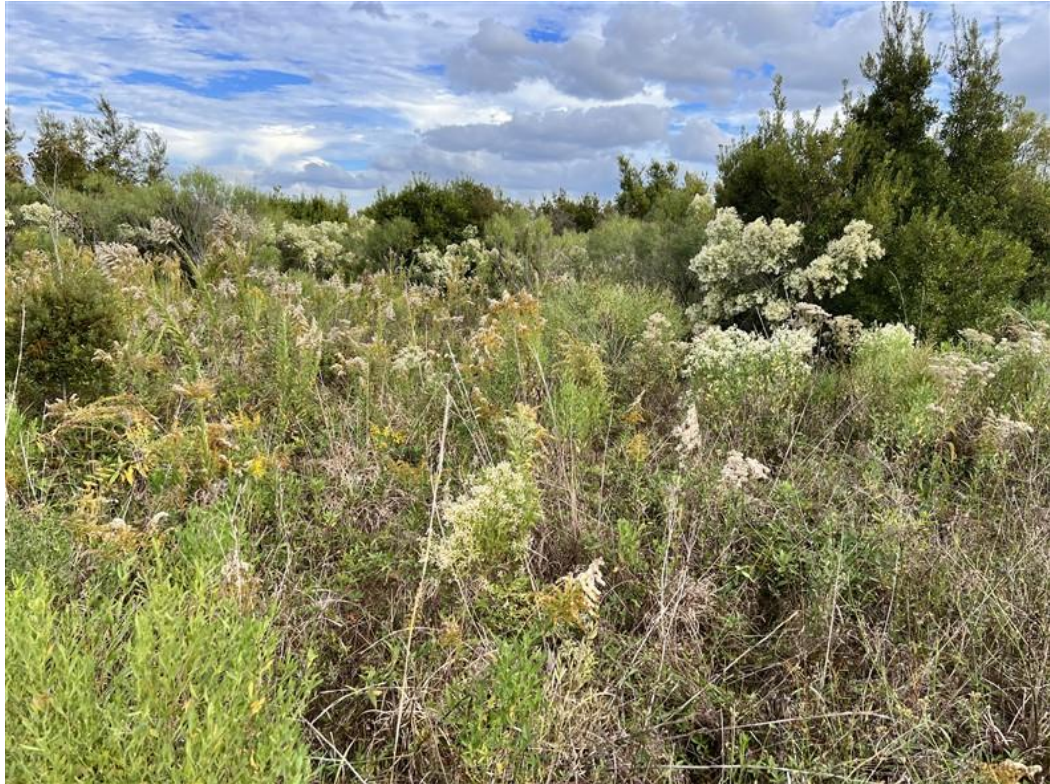
**Figure B.12** Photograph looking east of vegetated areas at Sample Site U04- (CEI 11-08-23)-  
Upland areas on southeast corner of property.

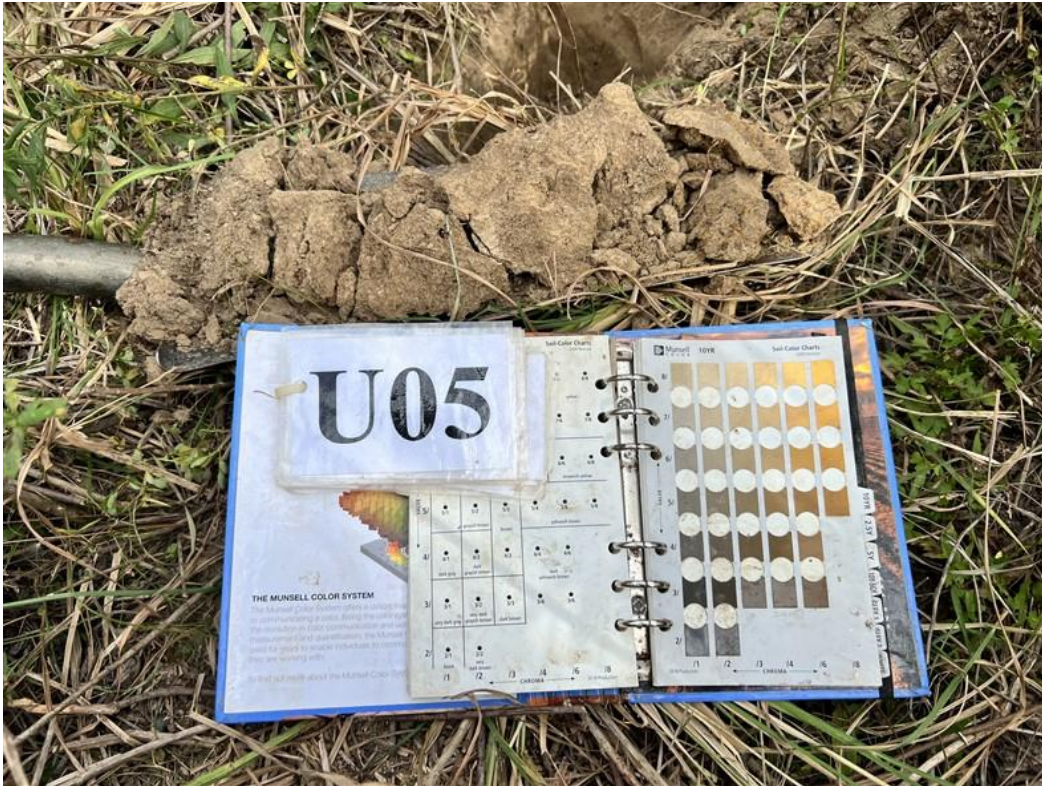
**Figure B.13** Photograph of soil sample from Sample Site U05- (CEI 11-08-23)- Upland areas on Southeast area of property.

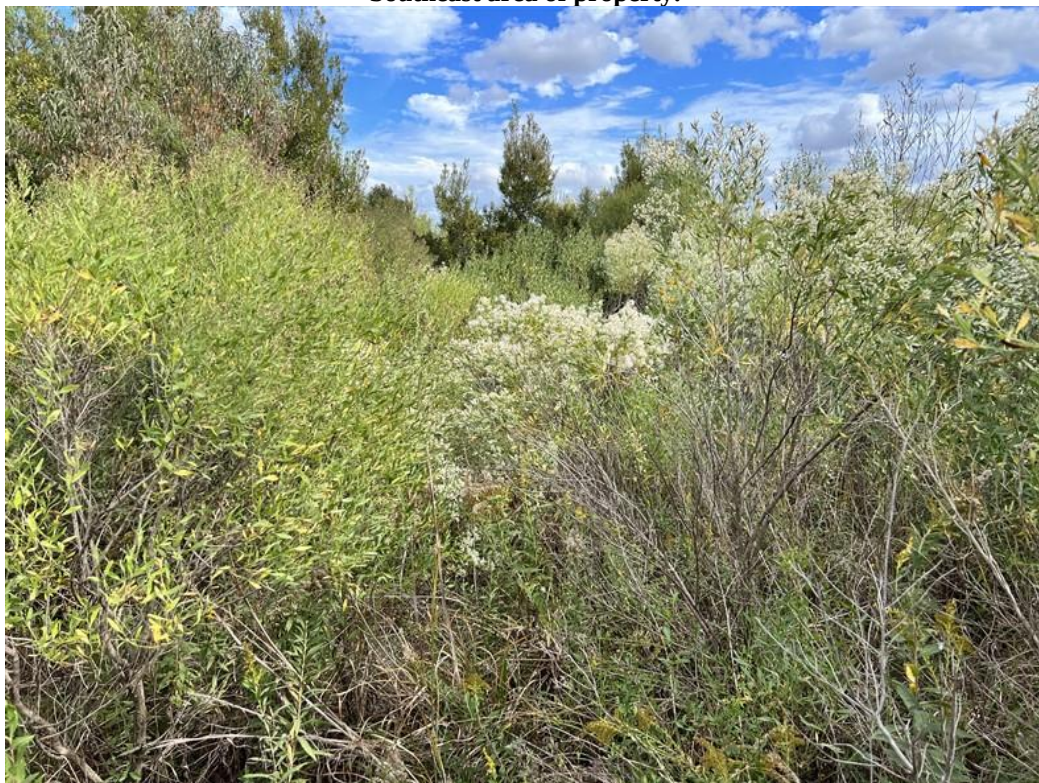
**Figure B.14** Photograph looking west of vegetated areas at Sample Site U05- (CEI 11-08-23)- Upland areas on Southeast area of property.

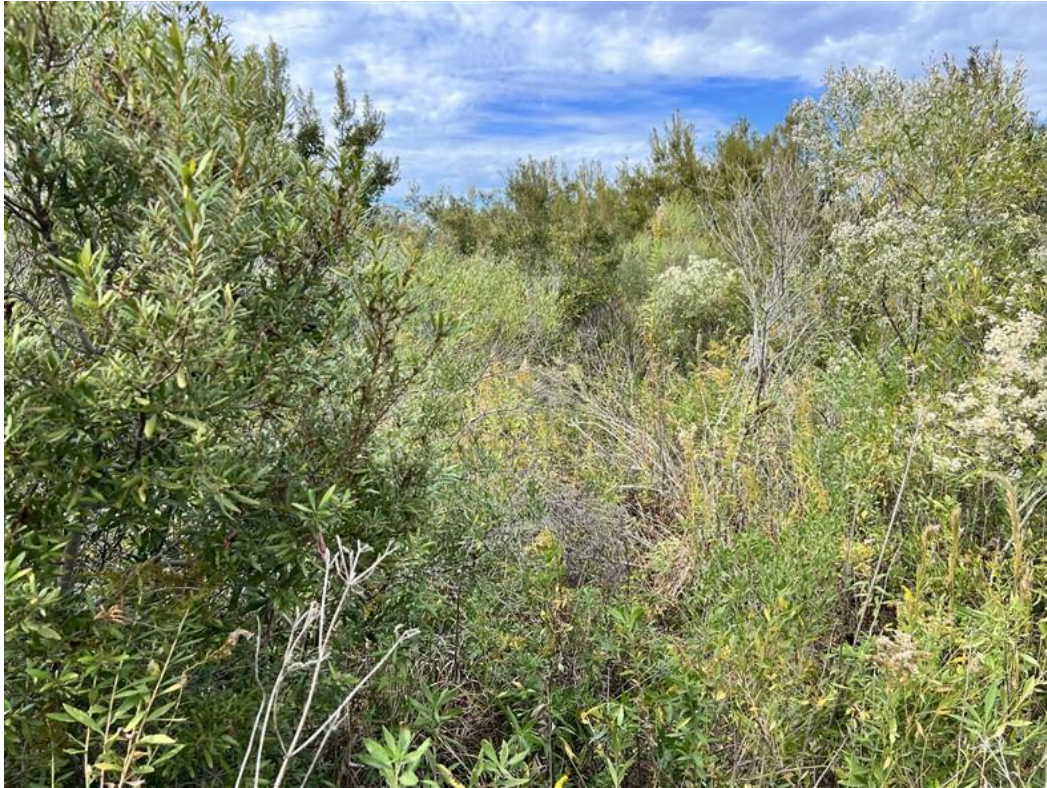
**Figure B.15** Photograph looking east of vegetated areas at Sample Site U05- (CEI 11-08-23)- Upland areas on southeast area of property.

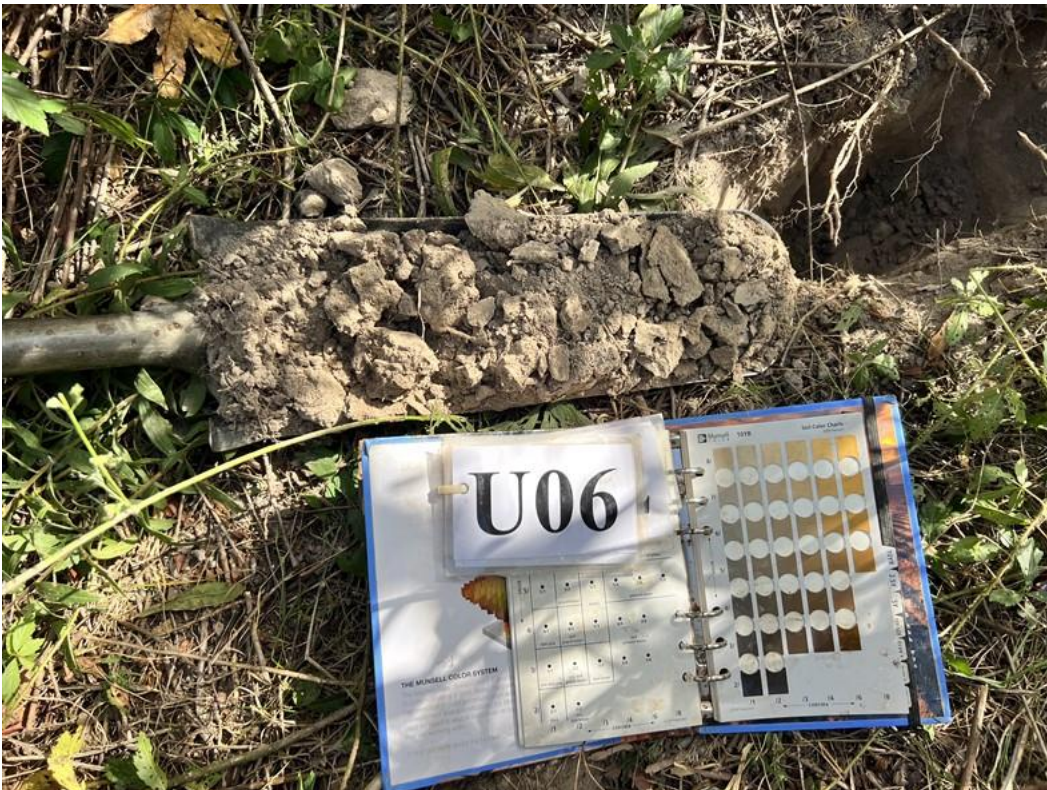
**Figure B.16** Photograph of soil sample from Sample Site U06- (CEI 11-08-23)- Upland areas on Southeast area of property.

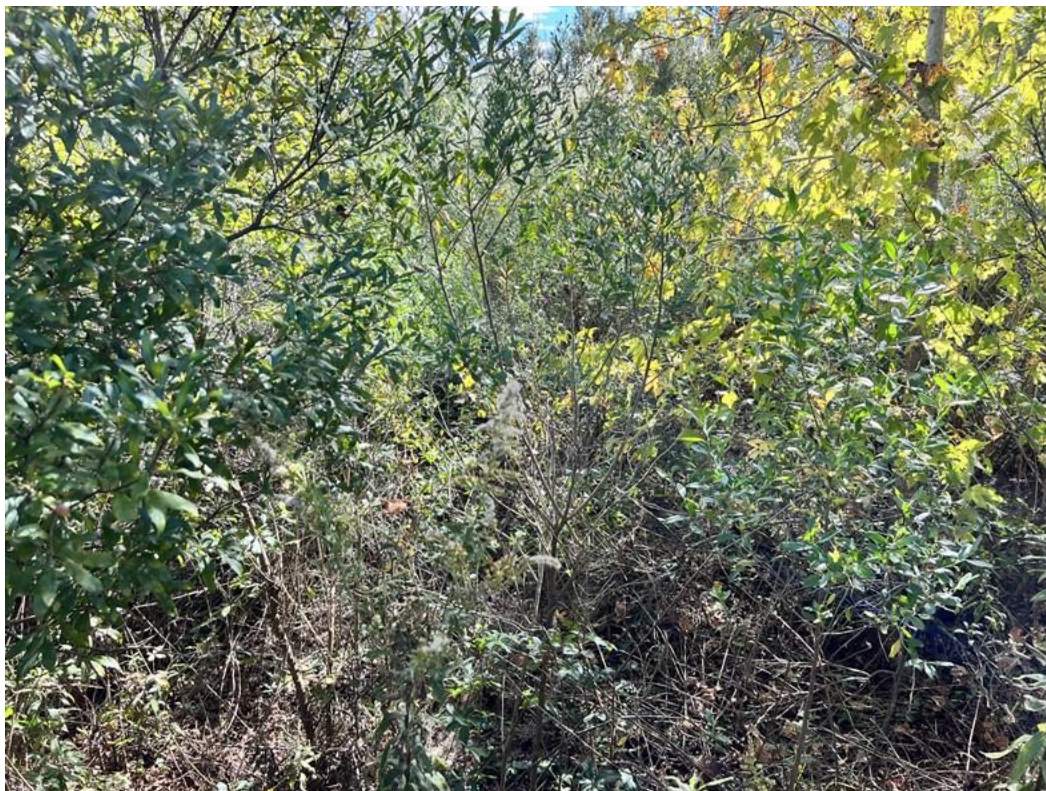
**Figure B.17** Photograph looking west of vegetated areas at Sample Site U06- (CEI 11-08-23)-  
Upland areas on Southeast area of property.

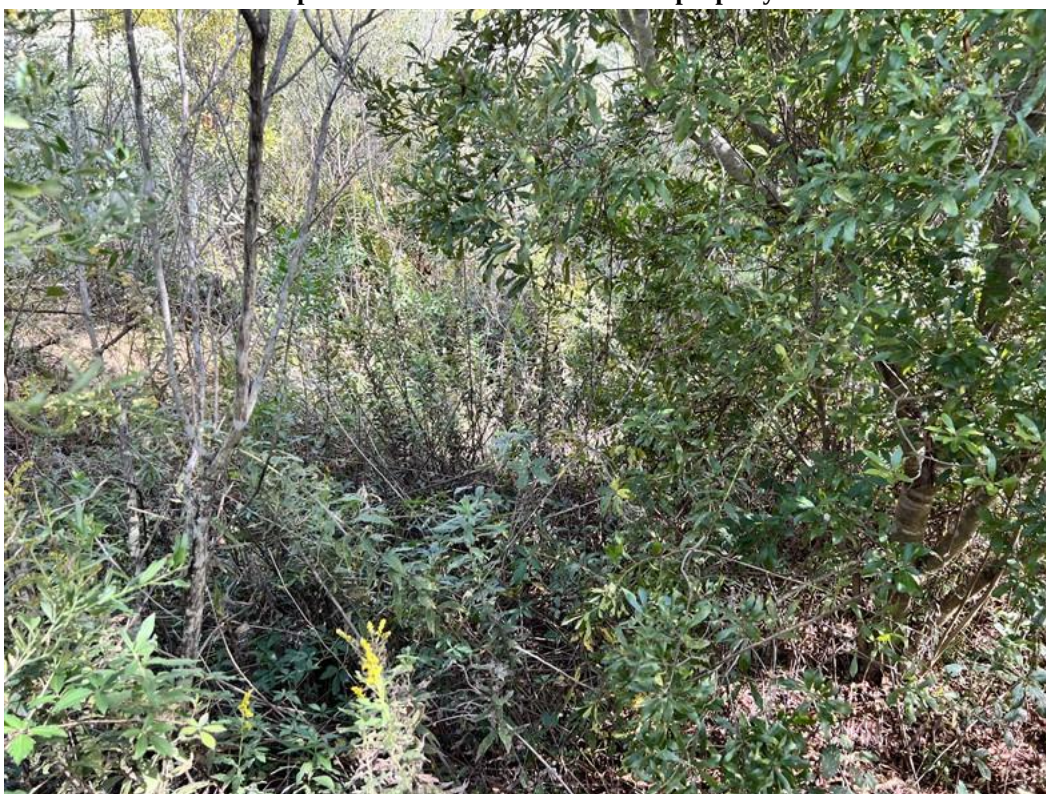
**Figure B.18** Photograph looking east of vegetated areas at Sample Site U06- (CEI 11-08-23)-  
Upland areas on southeast area of property.

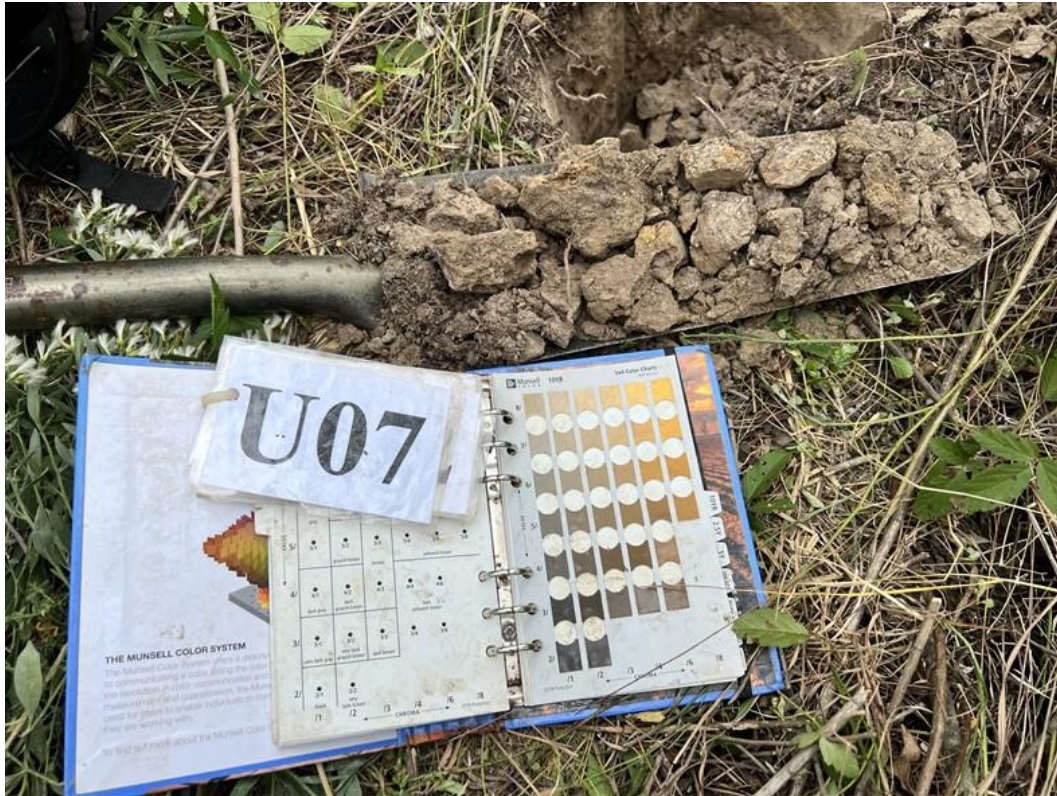
**Figure B.19** Photograph of soil sample from Sample Site U07- (CEI 11-08-23)- Upland areas on Southeast area of property.

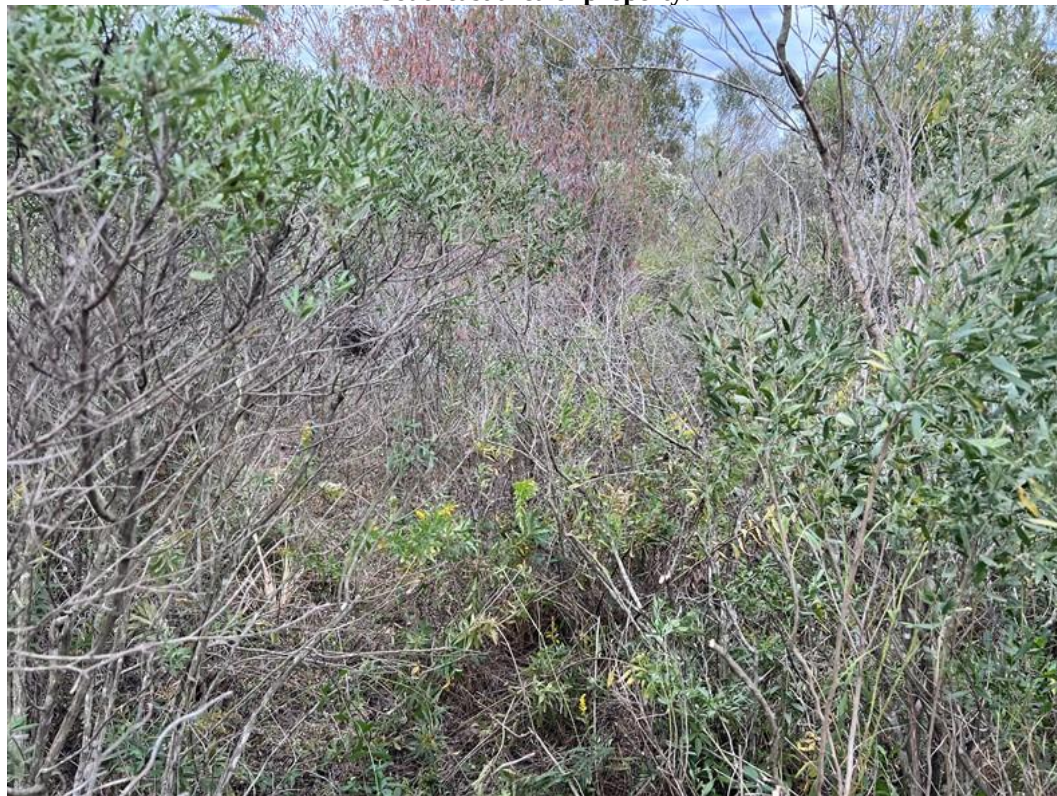
**Figure B.20** Photograph looking west of vegetated areas at Sample Site U07- (CEI 11-08-23)- Upland areas on Southeast area of property.

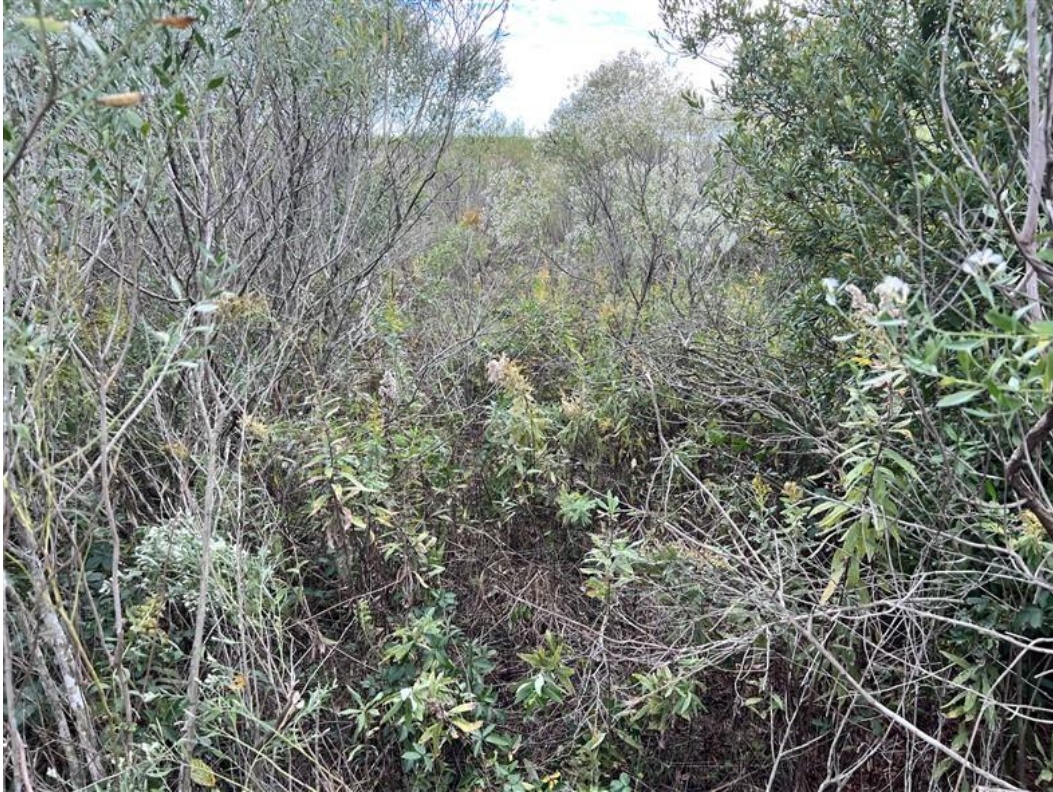
**Figure B.21** Photograph looking east of vegetated areas at Sample Site U07- (CEI 11-08-23)- Upland areas on southeast area of property.

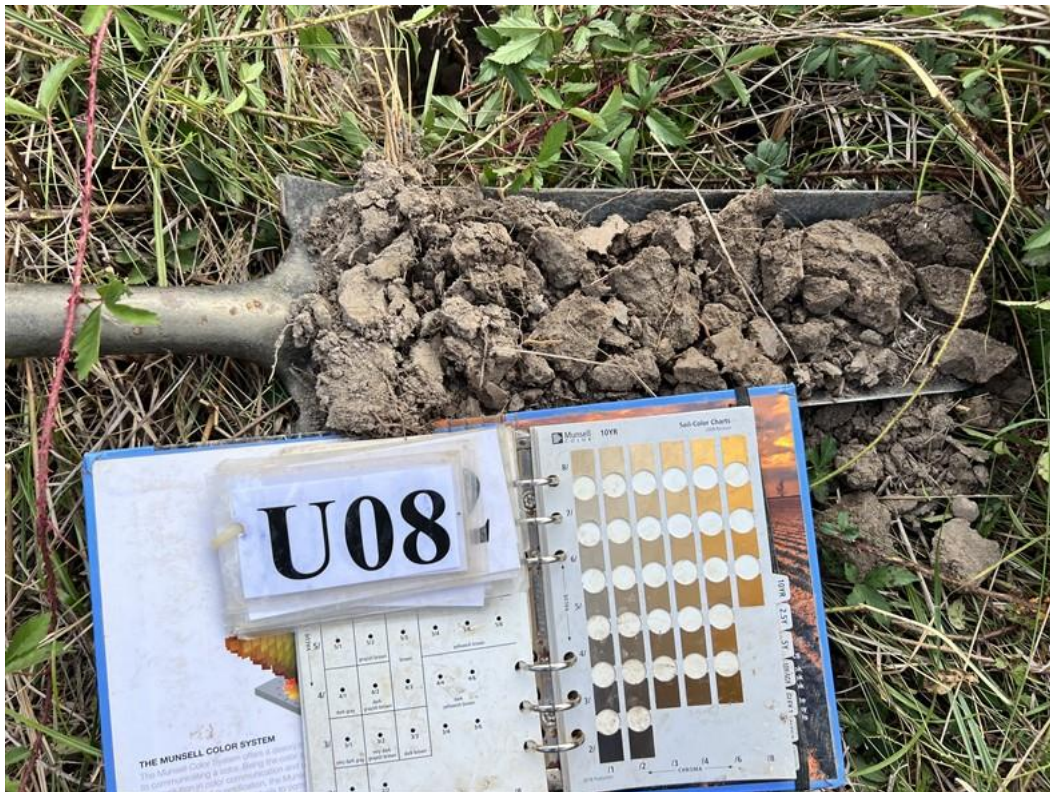
**Figure B.22** Photograph of soil sample from Sample Site U08- (CEI 11-08-23)- Upland areas on Southeast area of property.

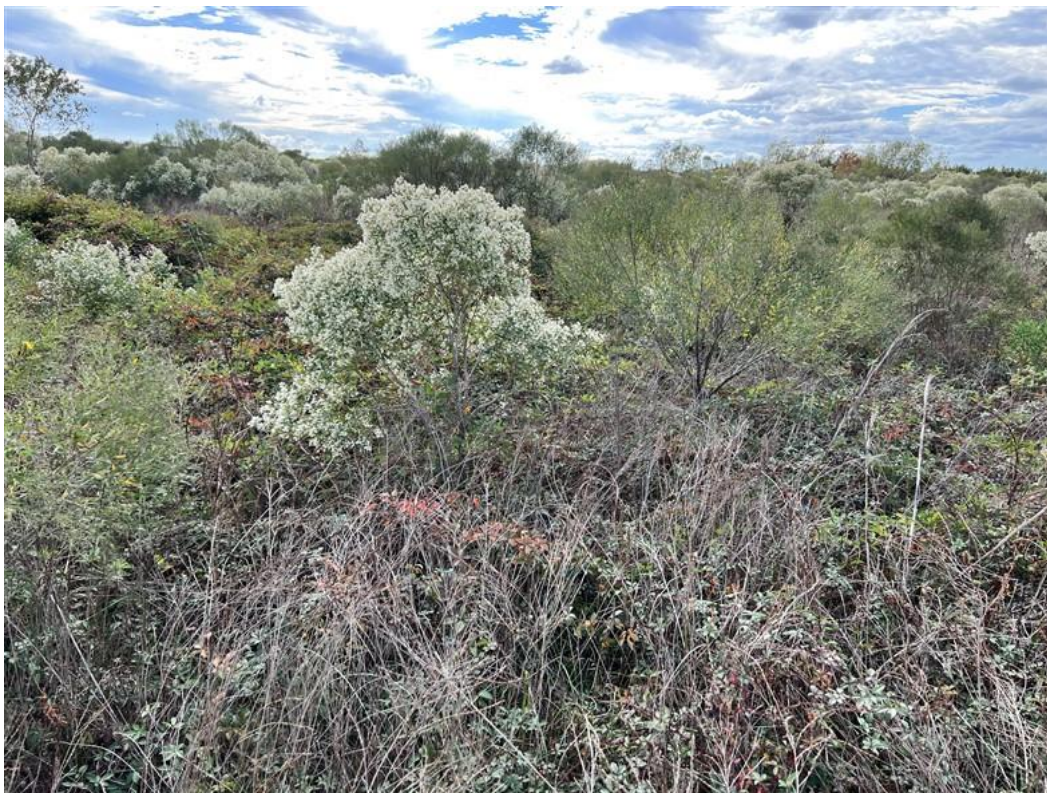
**Figure B.23** Photograph looking west of vegetated areas at Sample Site U08- (CEI 11-08-23)-  
Upland areas on Southeast area of property.

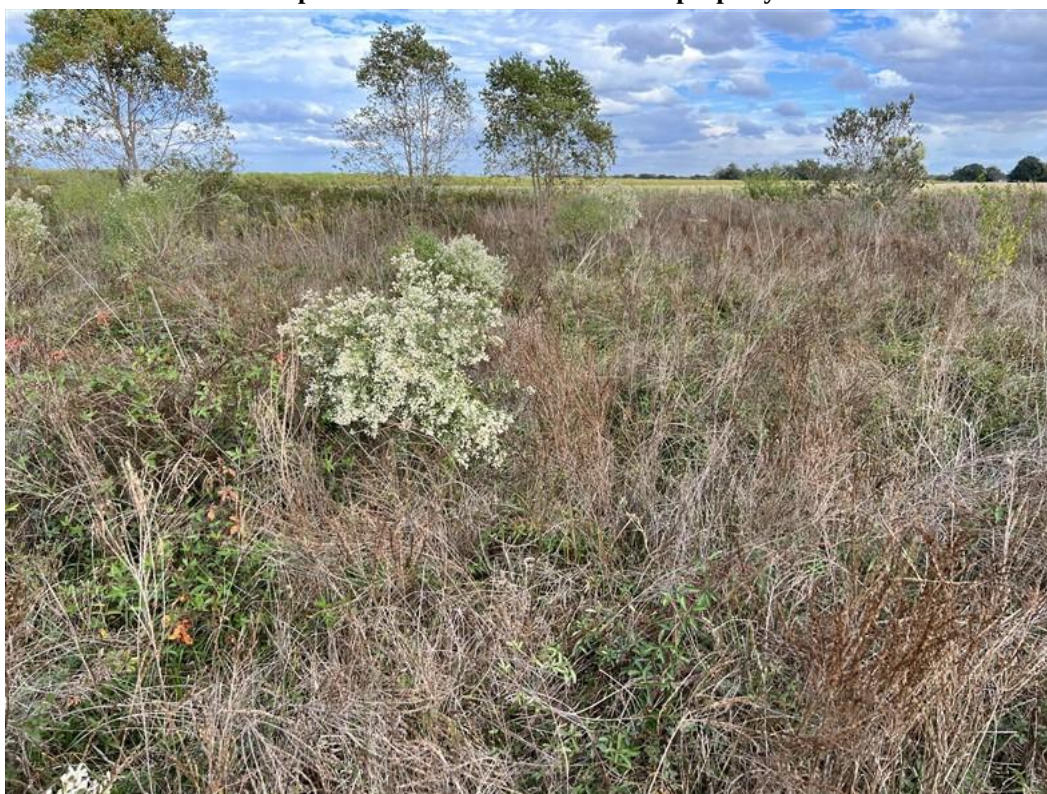
**Figure B.24** Photograph looking east of vegetated areas at Sample Site U08- (CEI 11-08-23)-  
Upland areas on southeast area of property.
