## South Schaefer Site

### Wetlands Delineation Report

## **WETLAND DELINEATION FOR SOUTH SCHAFFER PROPERTY**

**+/-52.74-Acre Tract  
Section 23, Township-11-South, Range-5-East  
St. Martin Parish, Louisiana**

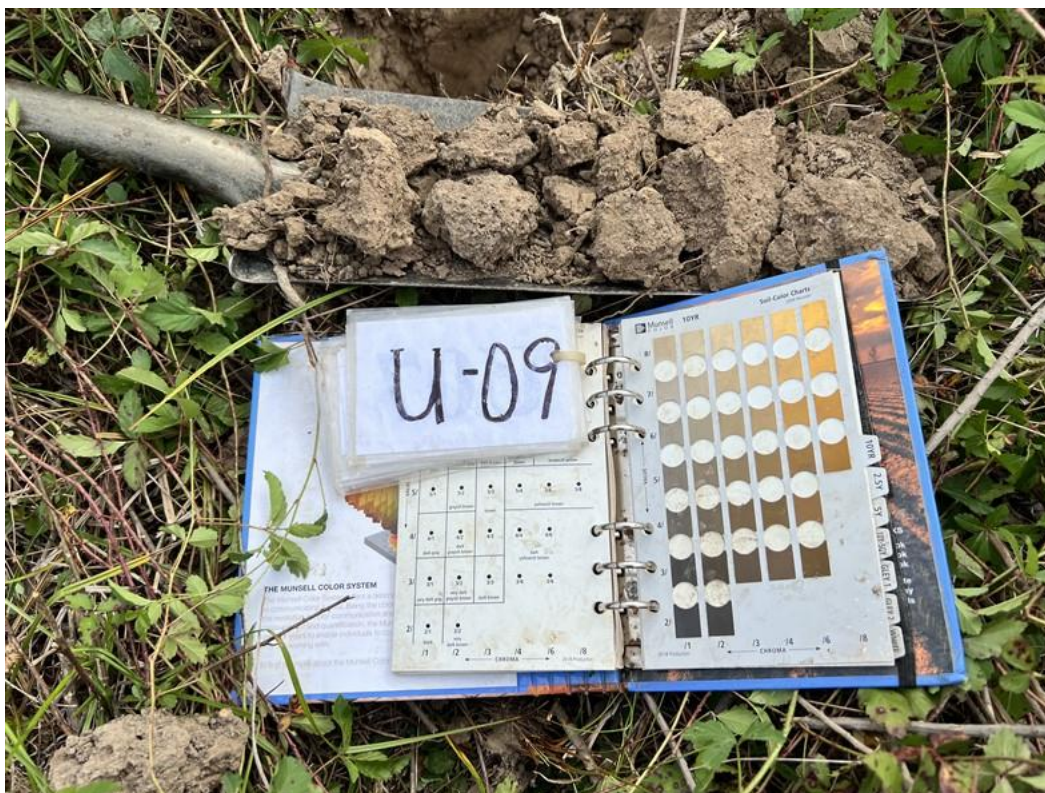
**Figure B.25** Photograph of soil sample from Sample Site U09- (CEI 11-08-23)- Upland areas on Southeast area of property.

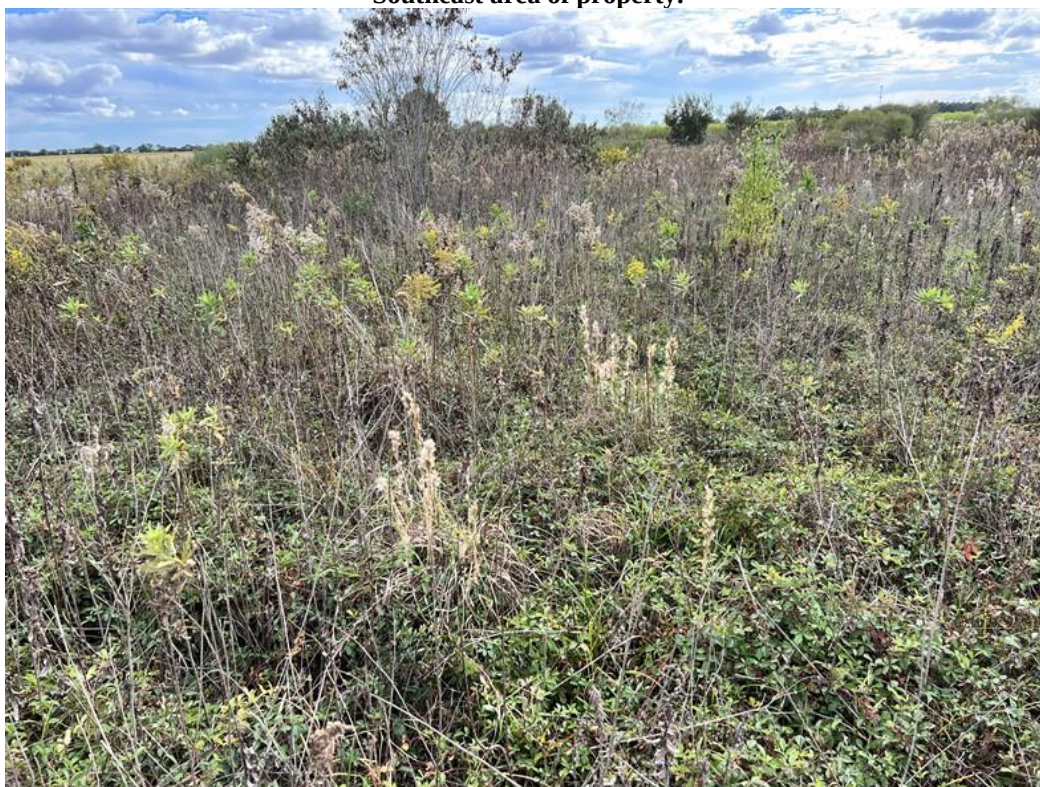
**Figure B.26** Photograph looking west of vegetated areas at Sample Site U09- (CEI 11-08-23)- Upland areas on Southeast area of property.

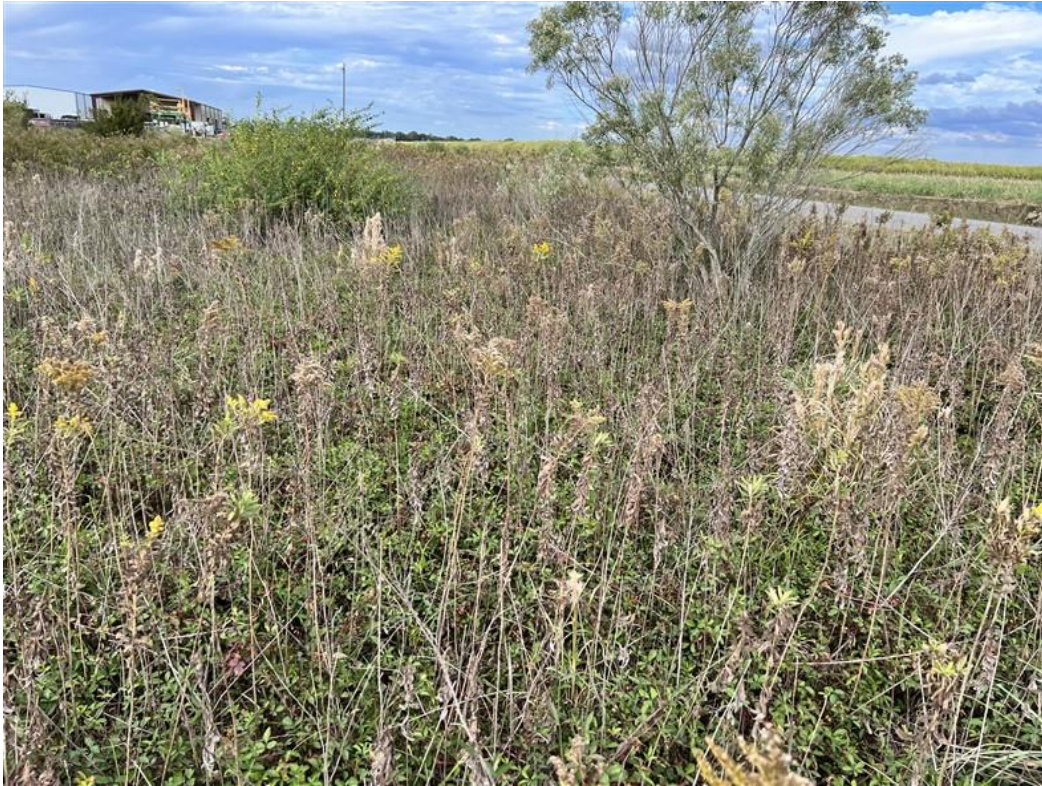
**Figure B.27** Photograph looking east of vegetated areas at Sample Site U09- (CEI 11-08-23)-  
Upland areas on southeast area of property.

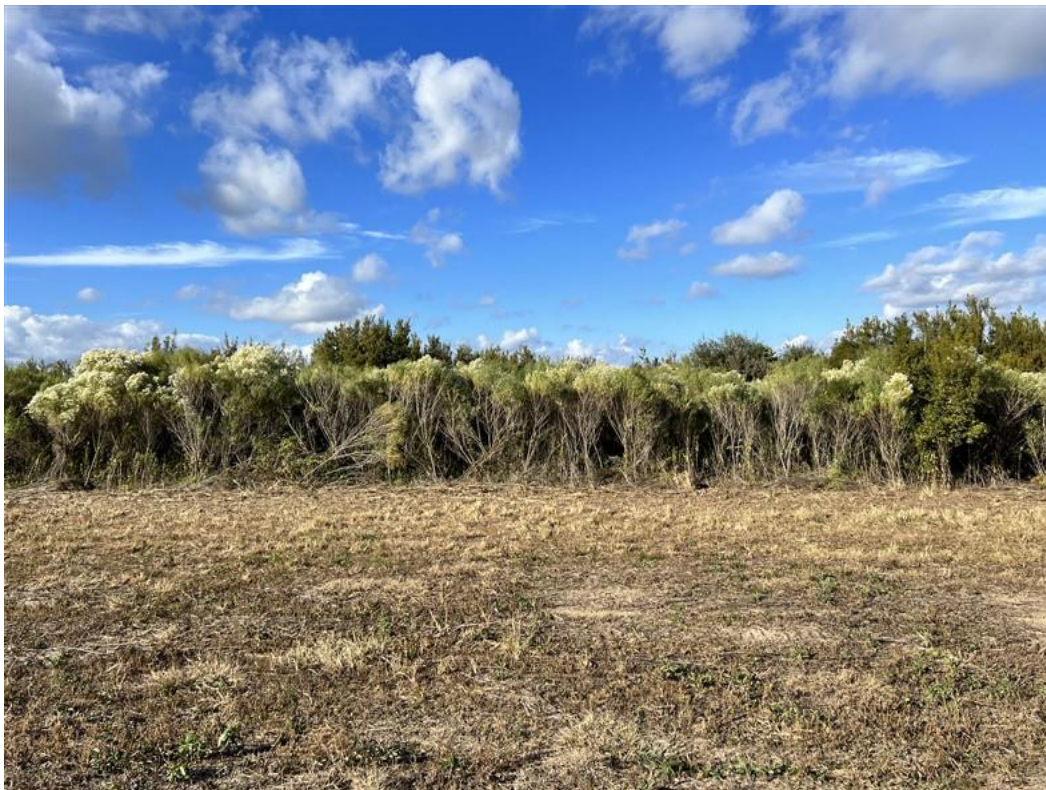
**Figure B.28** View looking to the west along the front part portion of property - (CEI 11-08-23).

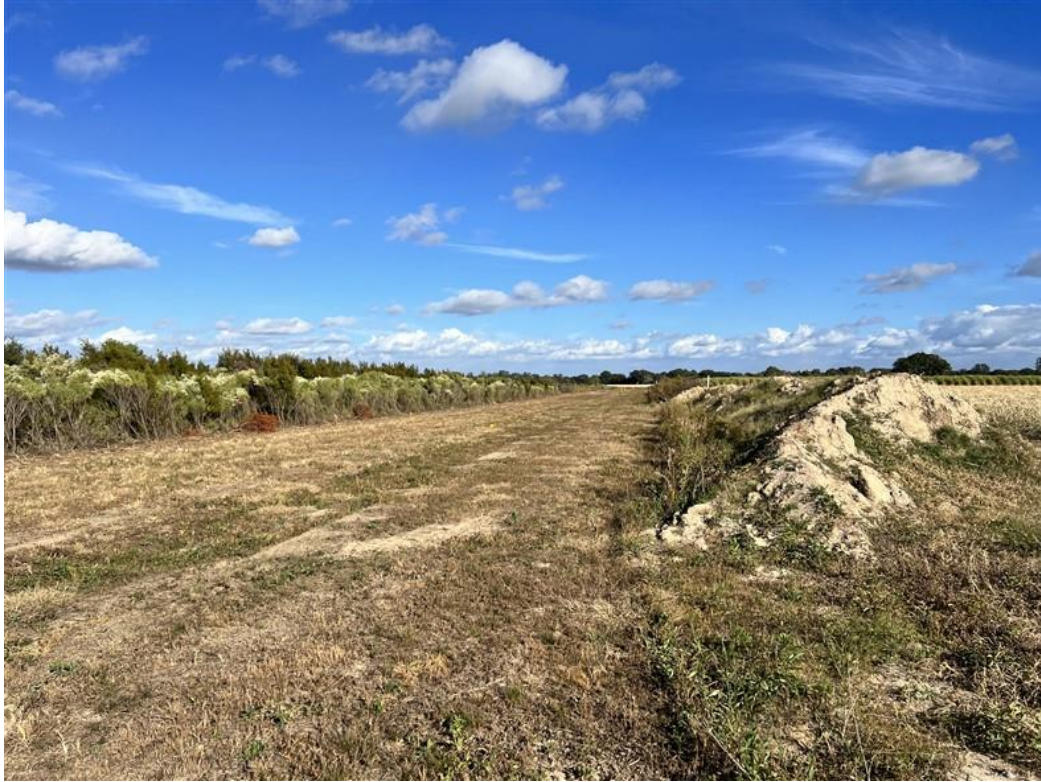
**Figure B.29** View looking to the east from southwest property corner showing the roadside drainage ditch along southern boundary - (CEI 11-08-23).

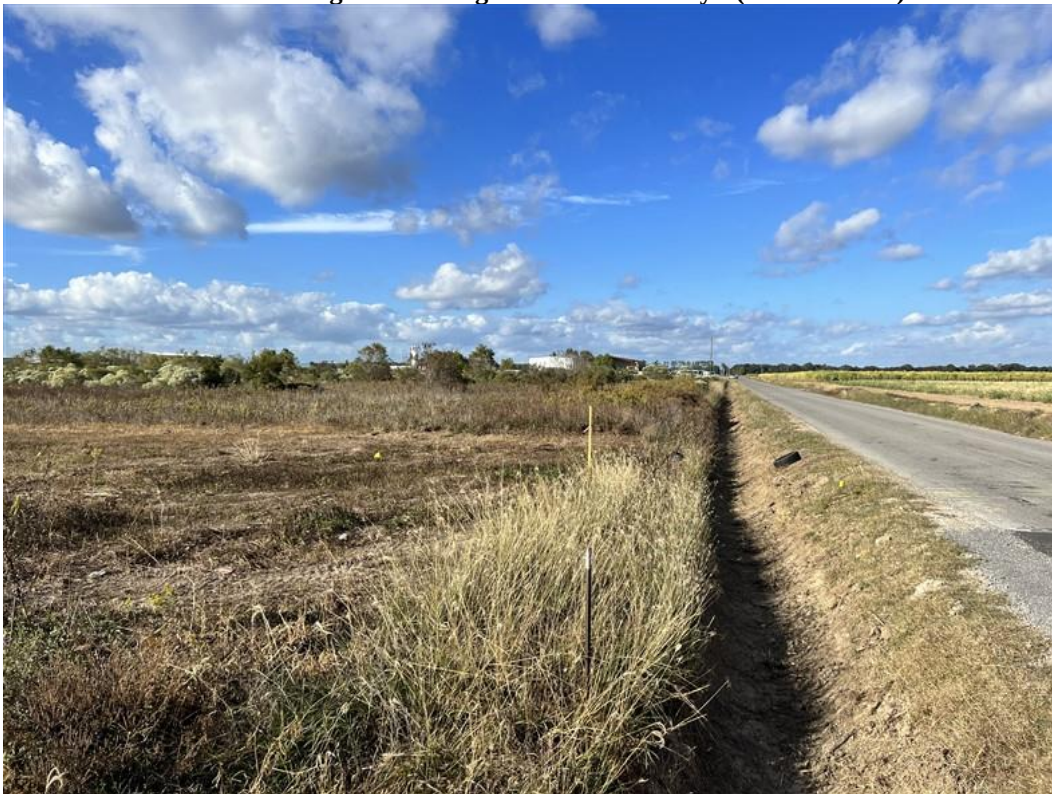
**Figure B.30** View looking to the South from southwest property corner showing the drainage ditch along western boundary - (CEI 11-08-23).

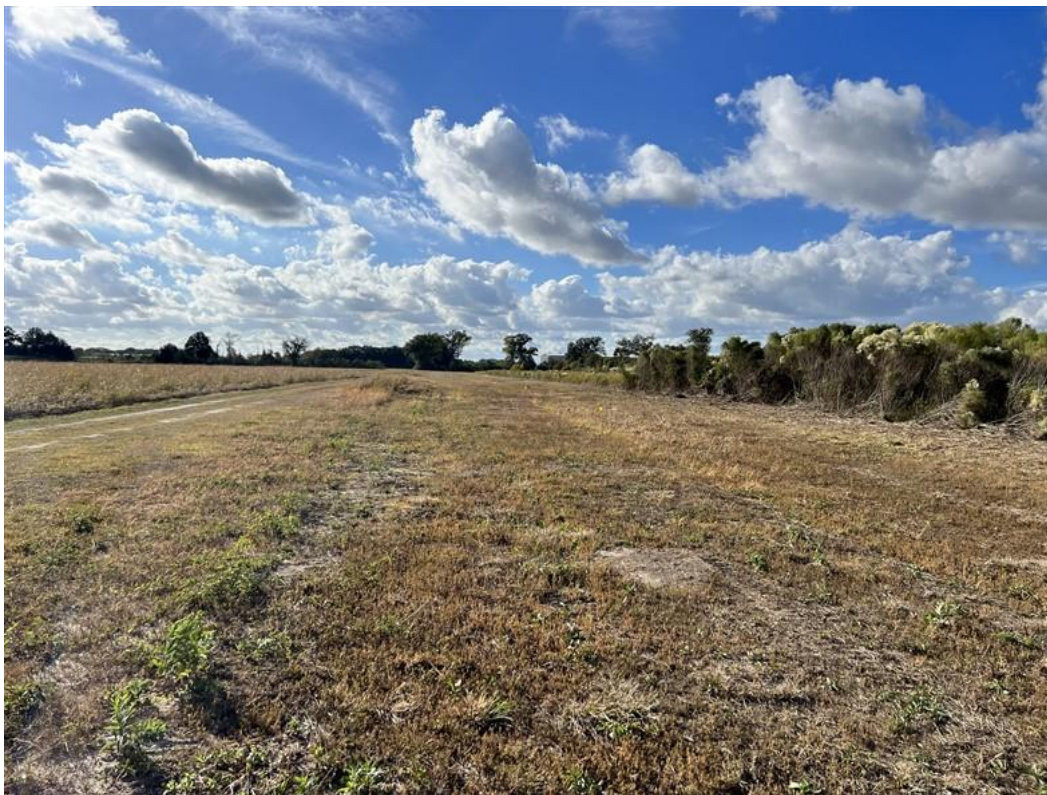
**Figure B.31** View looking to the south from Southwest property corner showing the roadside drainage ditch along the eastern boundary - (CEI 11-08-23).

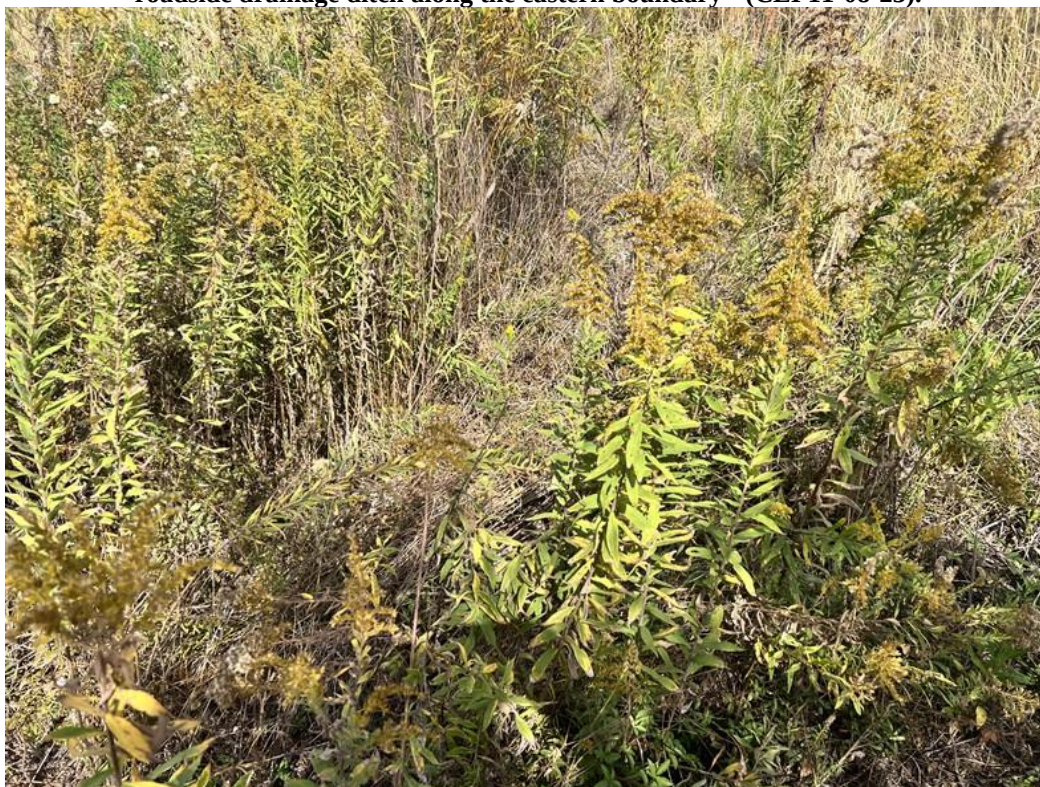
**Figure B.32** View of man-made drainage feature at the center of the property. This drainage feature did not have any observed wetland criteria and only conveys water briefly during rain events- (CEI 11-08-23).

Additional photographs of the man-made drainage features and roadside ditches associated with the property boundaries were included at the end on Appendix B (Figures B.28 through B.32).
