**Exhibit T - Phase I  
Environmental Site  
Assessment & Letter**

RE: H.C. Drew Property (+/- 183 Acres)  
Phase I Environmental Site Assessment

# Phase I Environmental Site Assessment

± 1,000 acre Site B93 – H.C. Drew Property  
Located at the S.E. corner of Highway 90 & Fabacher Road  
Sulphur, Calcasieu Parish, Louisiana

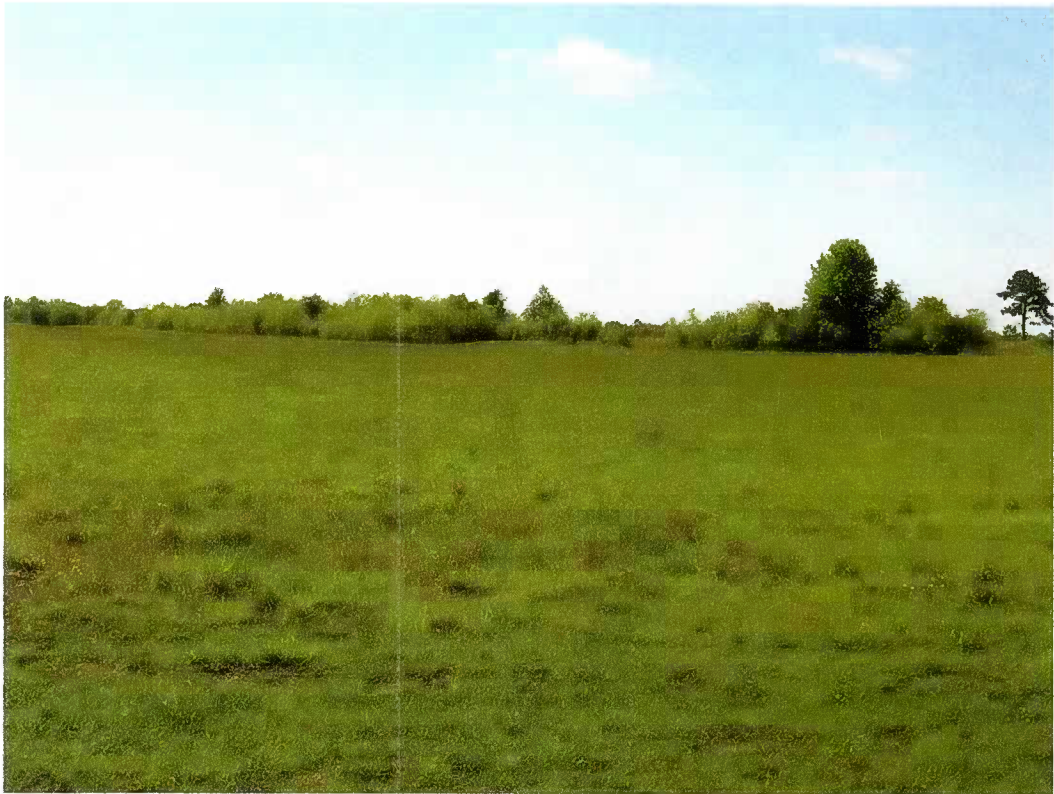
PHOTOGRAPH 1: Typical view of the habitat that dominates across the site.

The sites consist of a relatively flat pasture areas that slops gradually to the east. The sites appear level with the surrounding areas and consists of herbaceous plant species with some small trees and wooded areas scattered throughout. No odors, stressed vegetation, or stained soils were observed on the sites.

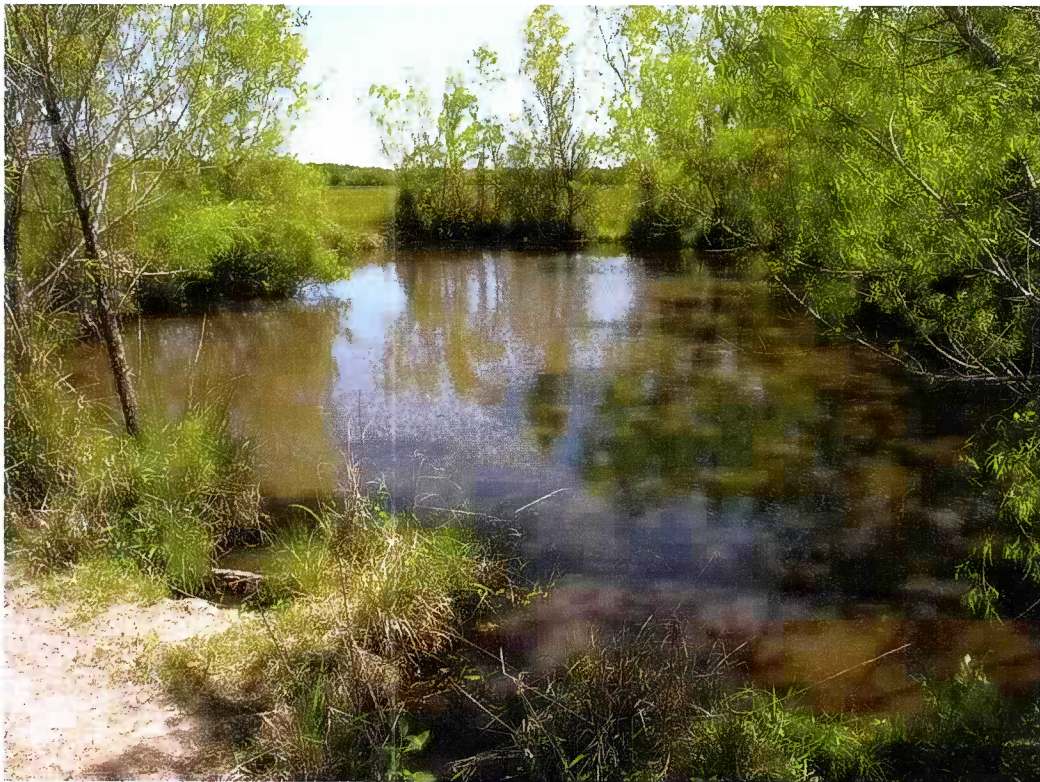
PHOTOGRAPH 2: View of a pond used as a watering hole for cattle.

Storm water appears to flow towards the southern portion of the property. Hwy 90 and Fabacher Road appear higher than the property. No, pits, or lagoons were observed on the sites, however, a shallow pond used as a watering hole for cattle is located on the sites.

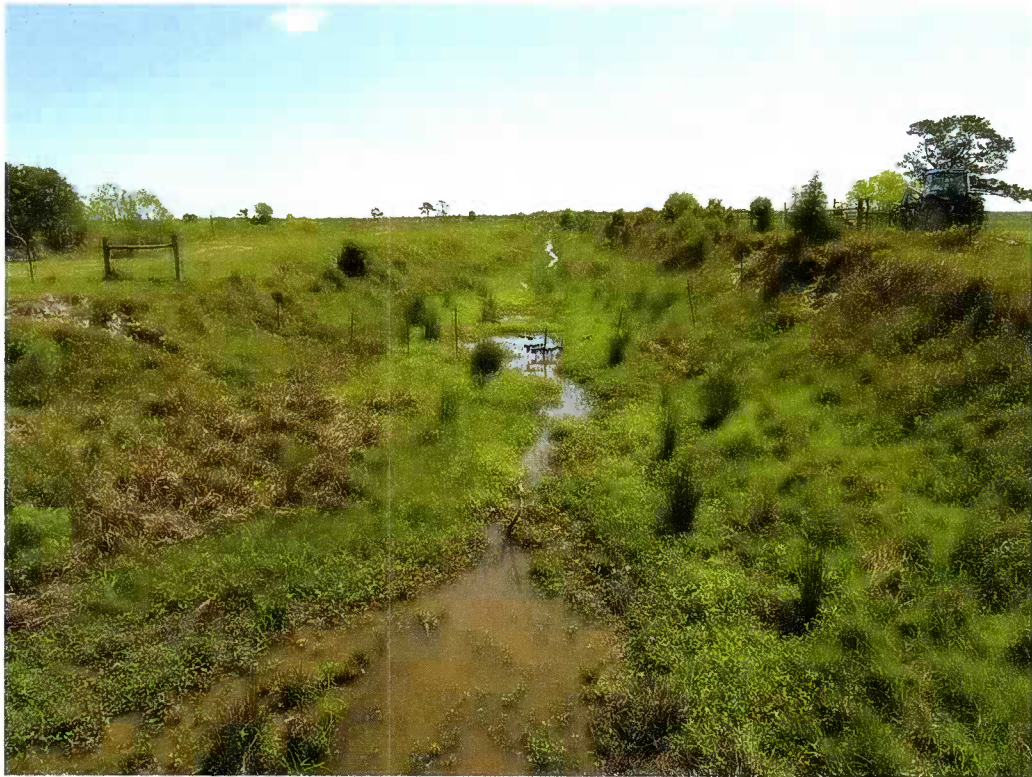
PHOTOGRAPH 3: View of main stream drainage system running through the center of the site.

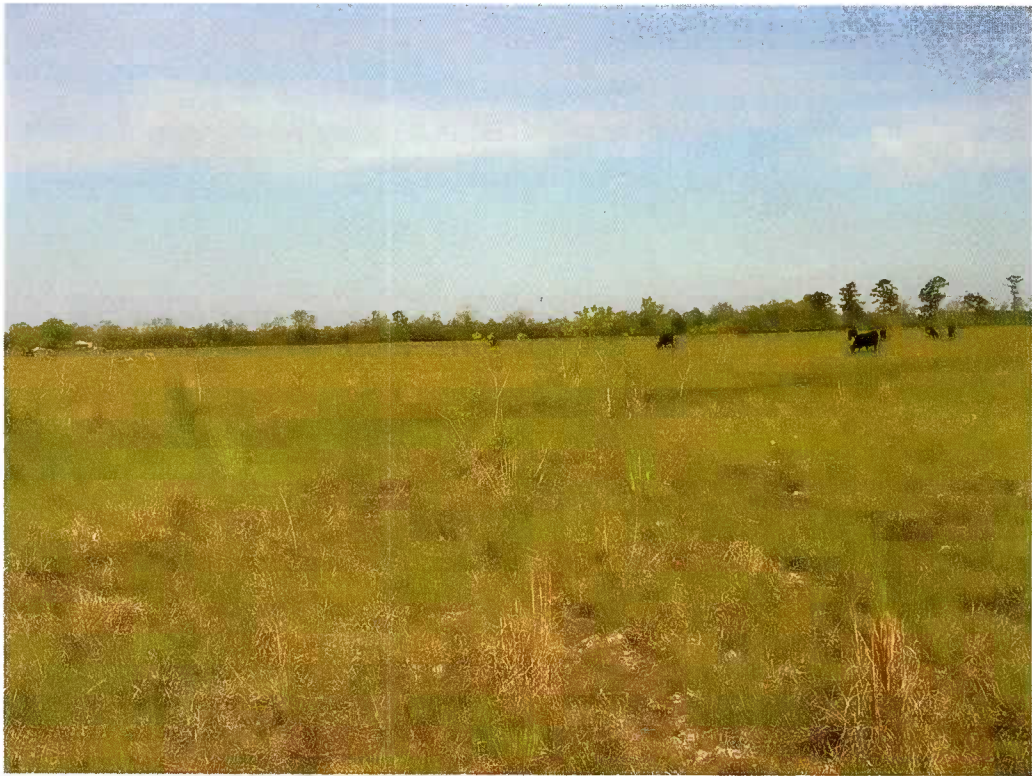
PHOTOGRAPH 4: View of the current uses of the site; cattle pasture.

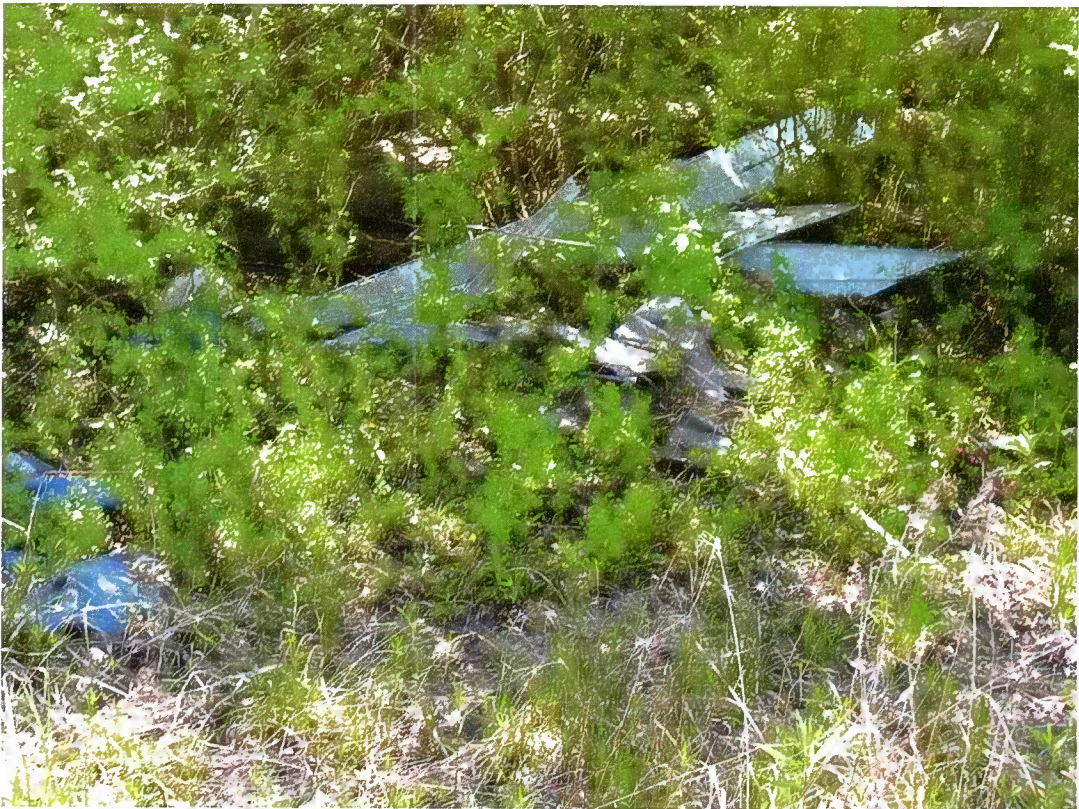
PHOTOGRAPH 8: View of construction debris located near the north central portion of the site.

SJB observed some construction debris that constitutes as solid waste storage or disposal areas during the site inspection. None of the debris appear to be hazardous or petroleum based of any kind.
