**PHASE I ENVIRONMENTAL SITE ASSESSMENT**

**PROPOSED GATEWAY II SITE  
LA HWY 30  
GEISMAR, LA**

**ENGINEERING ASSOCIATES, INC.  
1415 DELPLAZA DR., SUITE B  
BATON ROUGE, LOUISIANA 70815**

**MARCH, 2013**

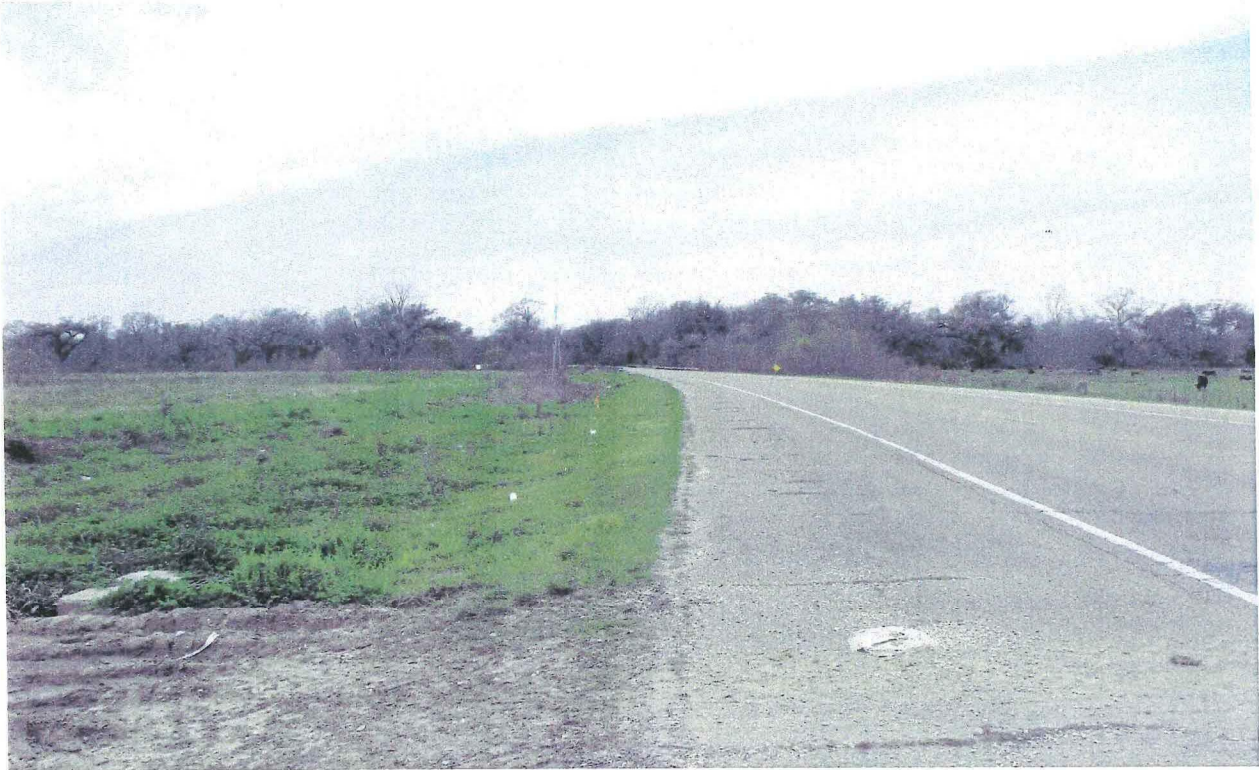
LA Hwy 30 Looking West (Subject Property on Left)

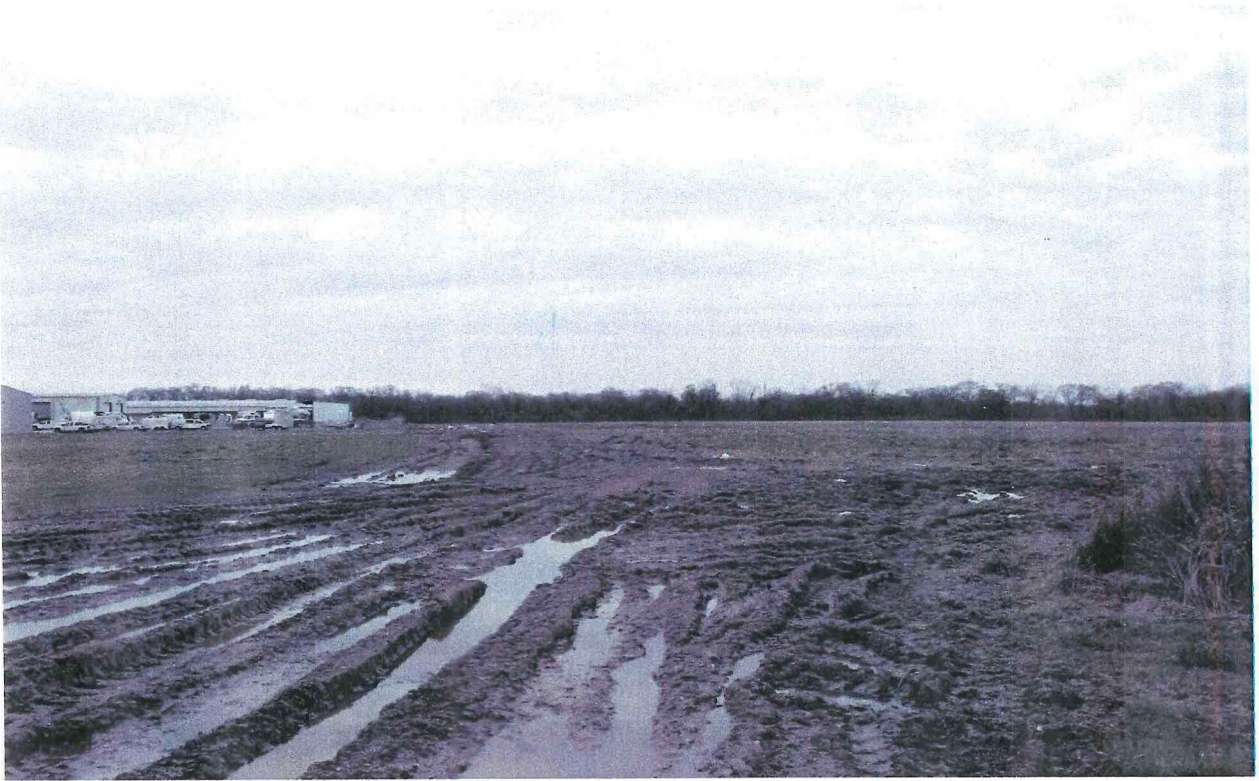
Looking South Along East Property Line (Subject Property on Right)

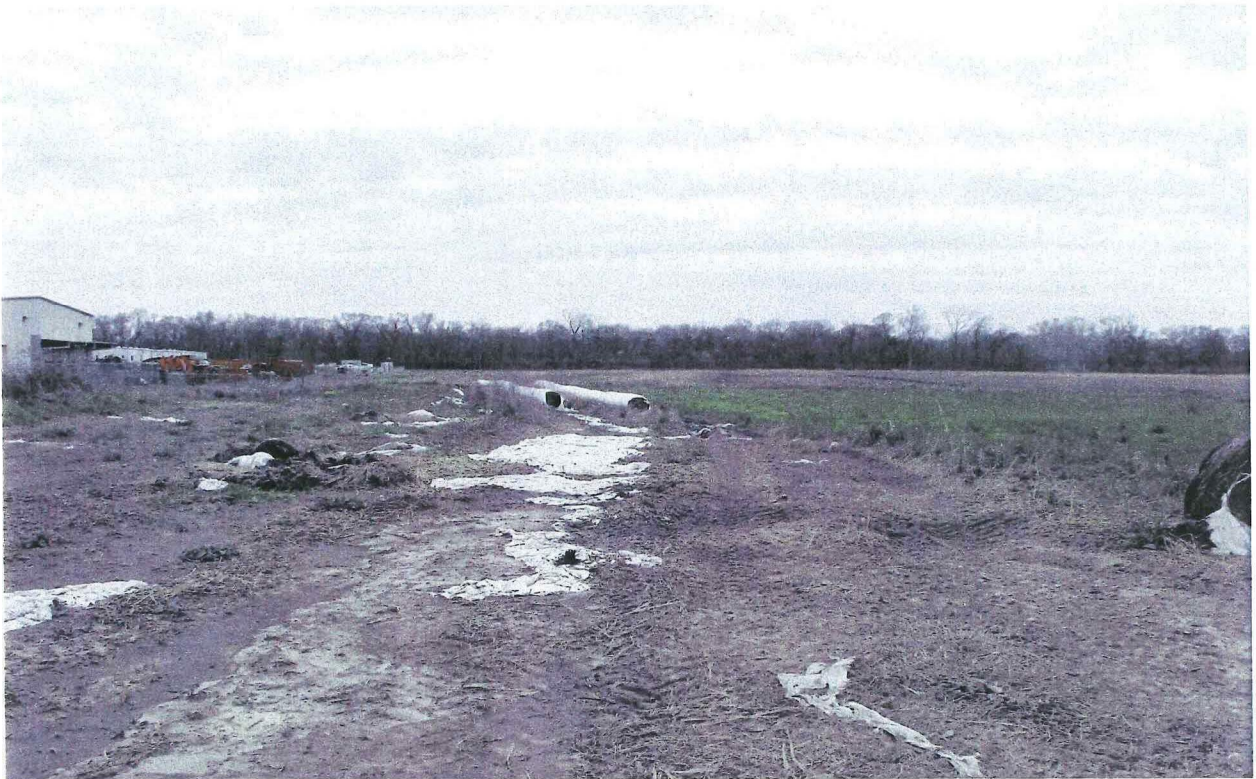
Pieces of white plastic material were observed to be strewn along a portion of the extreme easterly side of the subject property. Approximately 20 rolls of hay that are covered with white plastic material are located on the easterly side of the property, several hundred feet south of LA Hwy 30. The rolls of hay are being stored by others on the subject property at the permission of Superstar Holdings, L.L.C. and are transported offsite as they are needed. It appears that as the rolls of hay are being transported, the white plastic covering the hay is being discarded on the ground.

Plastic Scattered along Easterly Property Line of Subject Property (Plastic Used to Wrap Rolls of Hay)

- A white plastic material used to cover rolls of hay was observed to be strewn on the ground along the easterly side of the subject property. The plastic material should be collected and properly disposed.
- The subject property is located immediately west of an industrial park that includes at least one environmentally regulated facility. The facility (Champion Technologies) appears to maintain various chemicals in containers and tanks on the Champion Technologies site. While no environmental concerns are known to be associated with the Champion Technologies site, its presence and the potential presence of other nearby regulated facilities should be noted.

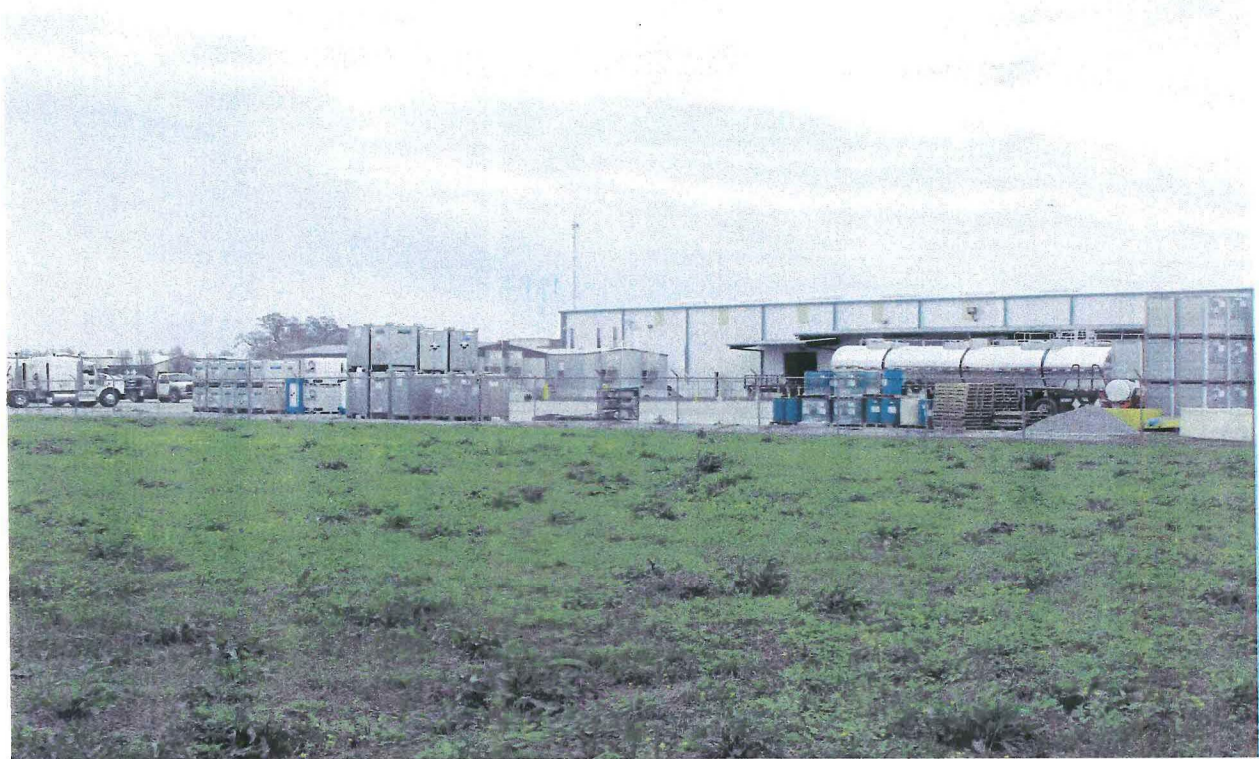
As previously stated, an industrial park is located east of and immediately adjacent to the subject property. None of the various businesses located in the industrial park were listed as environmentally regulated facilities in the environmental database report acquired by our office. However, the electronic files of the LDEQ were reviewed under the names of four facilities located in the industrial park in order to confirm the presence or absence of environmental permits associated with the facilities. The facilities included Clean Harbors Catalyst Technologies, Hagemeyer North America, and Vacuum Truck Rentals, for which no files were found during performance of our electronic file review. The fourth facility reviewed, Champion Technologies, is listed as a small quantity generator of hazardous waste in the LDEQ files. It appears that the facility also maintains a discharge permit for its stormwater discharges and for the discharge of treated sanitary sewer waste. The Champion Technologies site blends various chemicals for commercial sale according to LDEQ records. Numerous 55-gallon drums and larger vessels, presumably containing various chemicals, were observed on the Champion Technologies site at the time of our site visit. While no environmental concerns are known to be associated with the Champion Technologies site, the presence of the facility immediately adjacent to the southeast corner of the subject property should be noted.

Chemical Storage Containers on Champion Technologies Site (Adjacent To And East of Subject Property)

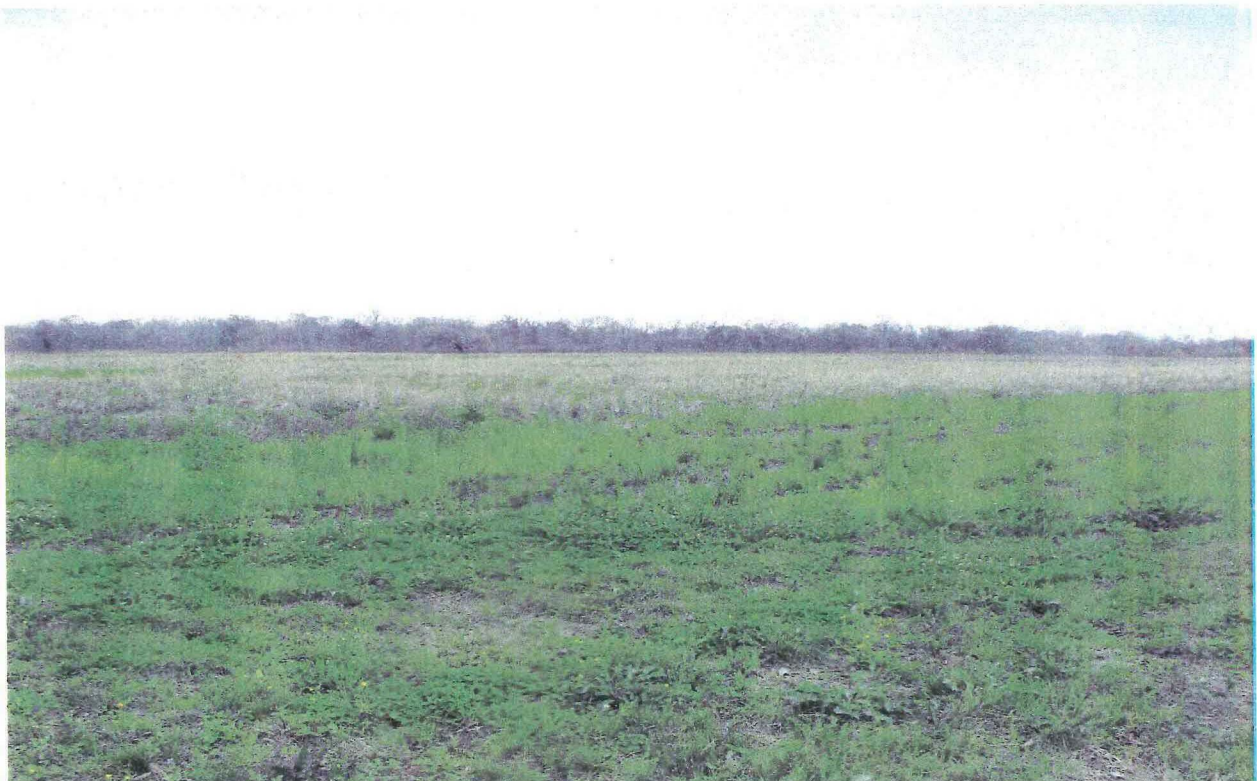
As previously stated, Engineering Associates personnel visited the subject property on February 28, 2013. The subject property is cleared and covered with pasture grass. A few trees are scattered throughout the property, however, the subject property is predominately cleared. No structures are located on the subject property.

Typical Interior of Subject Property
