Cenac Park Wetlands Delineation Report

Cenac Park Site Lafayette Parish, Louisiana

Prepared for
One Acadiana

March 2020

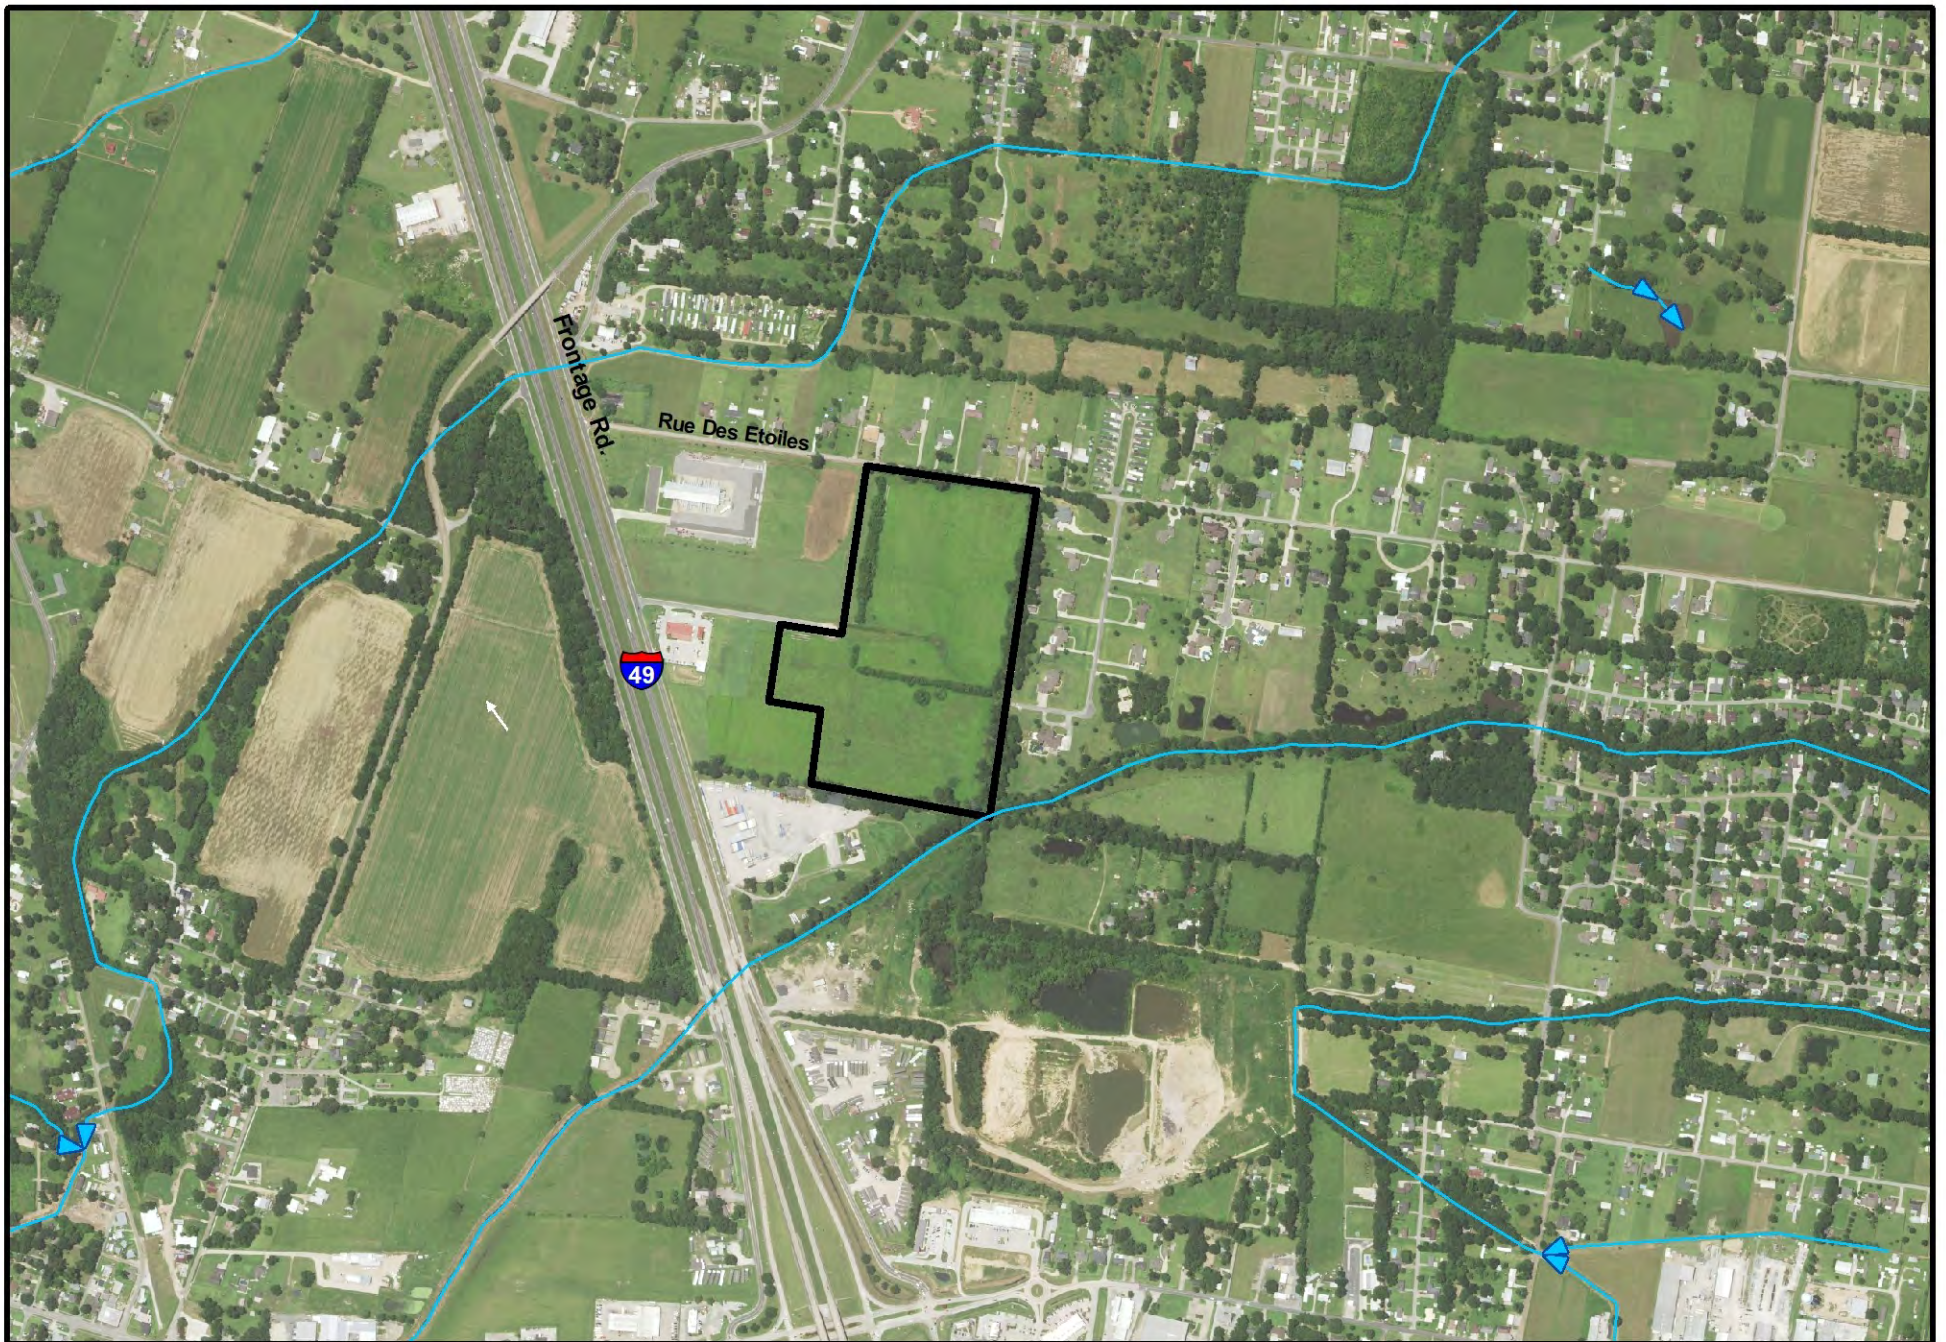
FIGURE 2
Existing Conditions Map
 Routine Wetland Delineation
 Cenac Site
 Lafayette Parish, Louisiana

Figures 2 and 3 shows the distribution of the soil series across the Site and surrounding area.

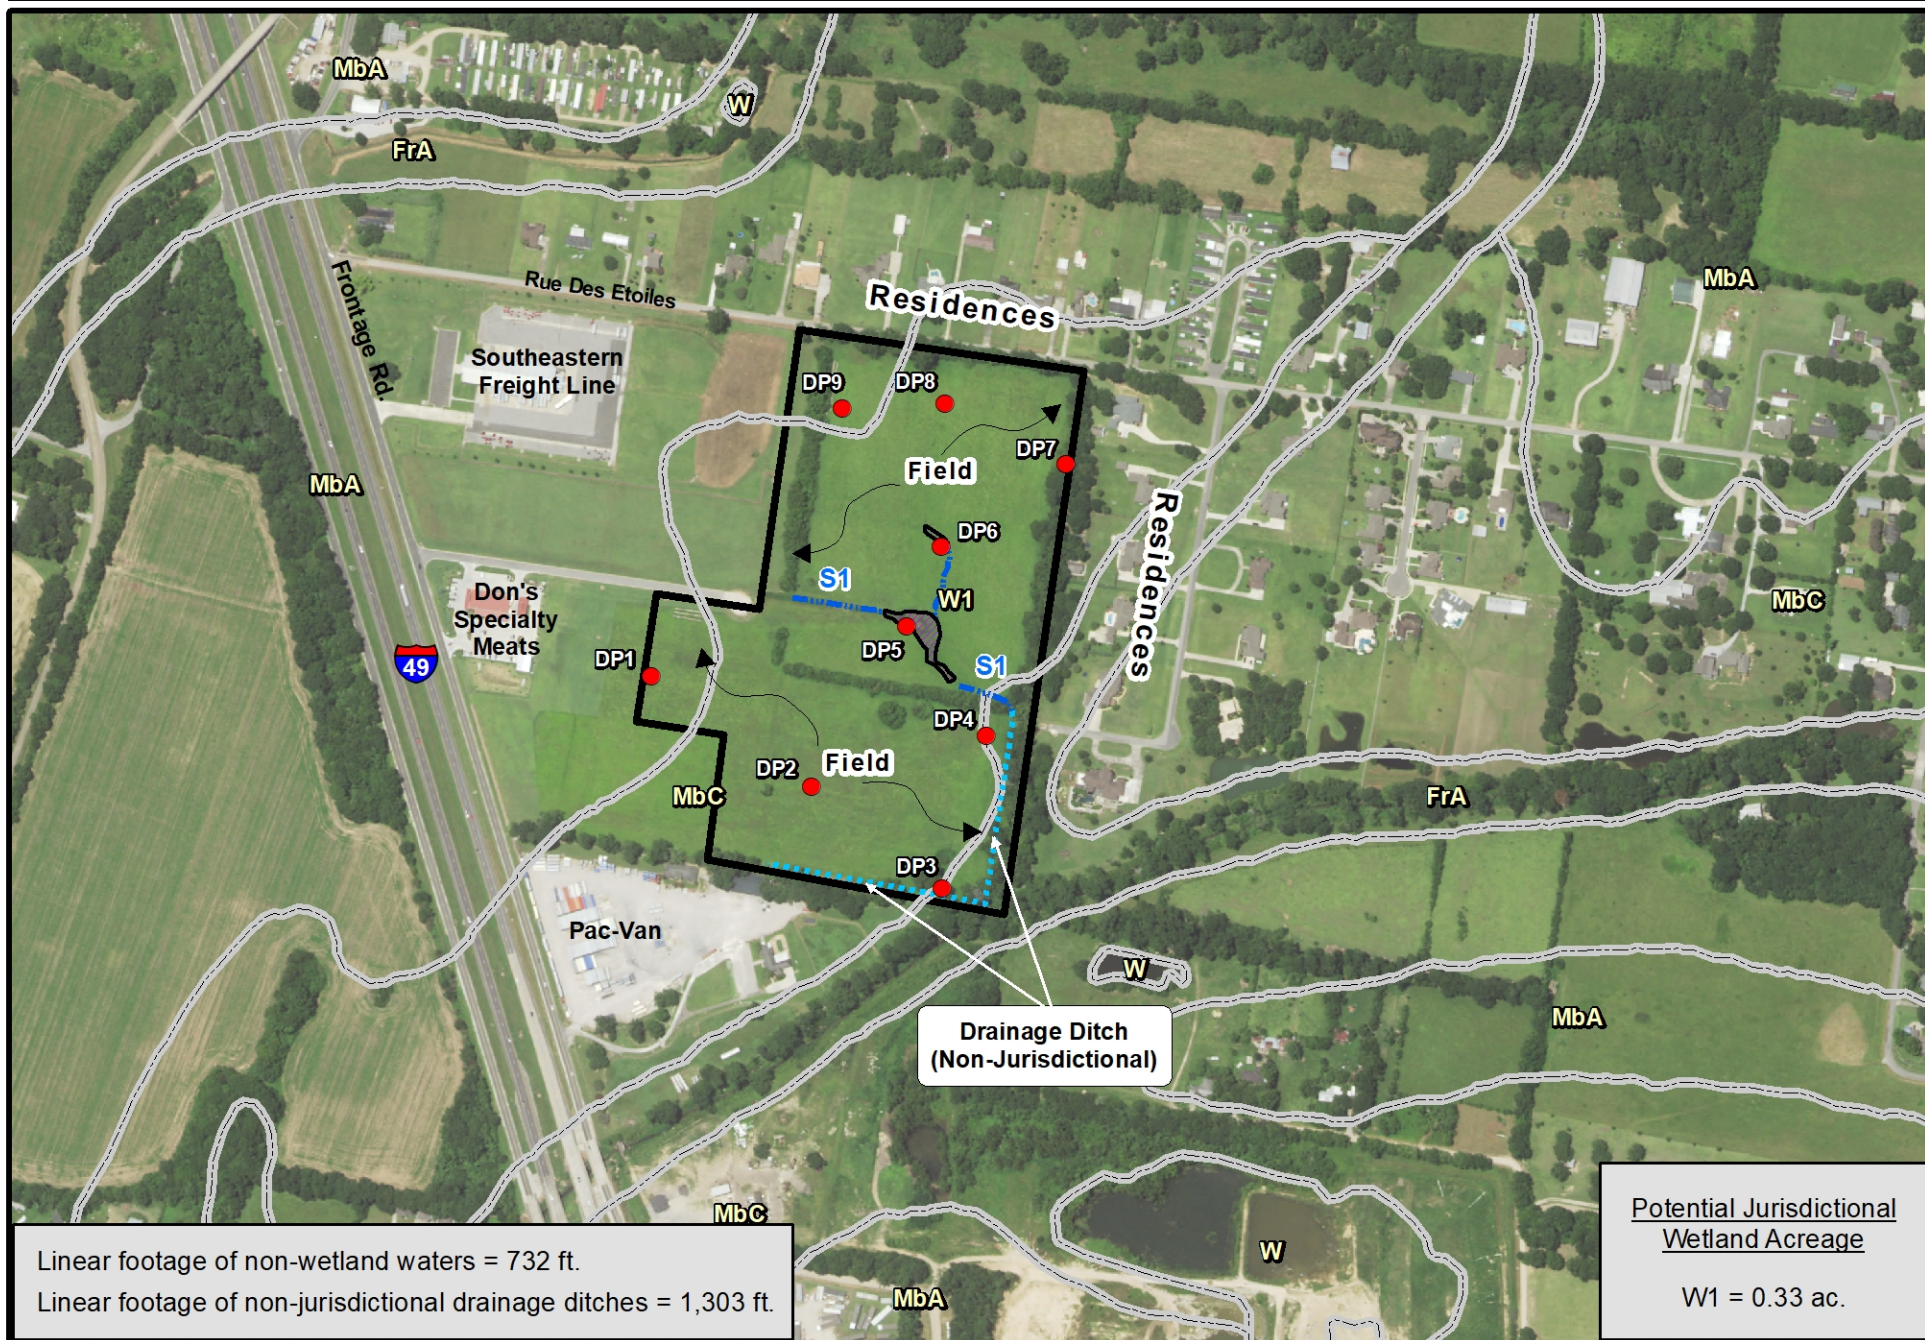
FIGURE 3
Preliminary Jurisdictional Wetlands Map
Routine Wetland Delineation
Cenac Site
Lafayette Parish, Louisiana

The site is located in Carencro, Lafayette Parish, Louisiana (Figure 1). The site is irregularly shaped and is approximately 35 acres (Figure 3). The Site is bordered by Rue Des Etoiles Road to the north; Gauthiers' Rental (Pac Van) to the south; residential subdivision to the east; Southeaster Freight Lines and Don's Specialty Meats to the west. The site is in Section 94, Township 8 South, Range 4 East and can be accessed off Rue de Cotton Road from the Interstate 49 Service Road.

Field investigations identified one potential jurisdictional wetland and a non-wetland Water of the U.S. on the Site. The Preliminary Jurisdictional Wetland Map (Appendix A, Figures 3 and 4) shows the non-wetland waters identified during this investigation.

DP8, and DP9. Dominant vegetation consists of mostly FAC species and typical species found throughout the upland parts of the site include: Bermuda grass (*Cynodon dactylon*), Annual rye grass (*Festuca perennis*), Little bluestem (*Schizachyrium scoparium*), Butterweed (*Packera glabella*), Wild geranium (*Geranium pretense*), Beaked cornsalad (*Valerianella radiata*) and muscadine (*Vitis rotundifolia*). The dominant trees and shrubs found in the forested area include: water oak (*Quercus nigra*), sweet pecan (*Carya illinoensis*) and Chinese privet (*Ligustrum sinense*) (see Appendix A, Figures 3 and 4).

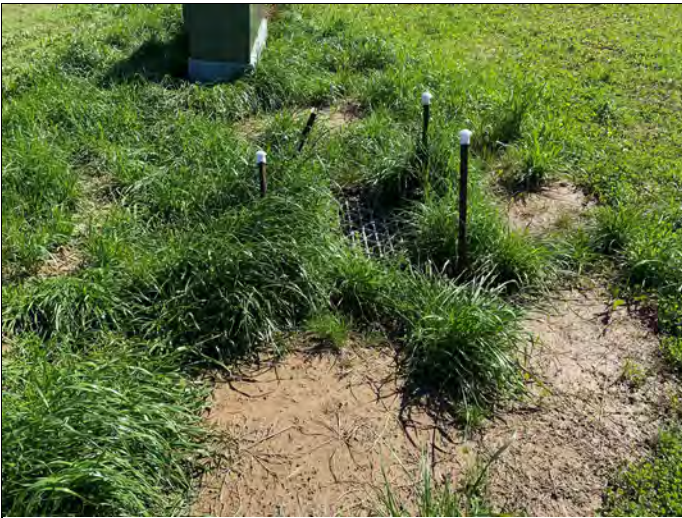
3. Storm drain adjacent to Rue de Cotton Road

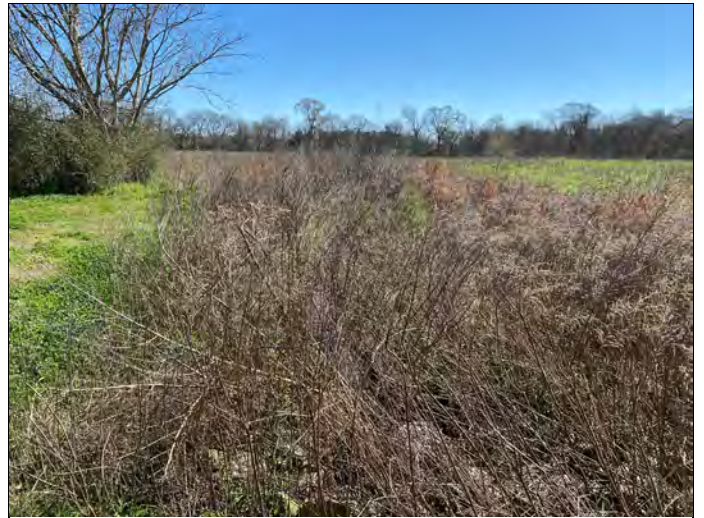
4. Overgrown part of S1 at the end of Rue de Cotton Road

- **S1** is an ephemeral stream that originates on the west side of the property at the end of Rue de Cotton Road. The stream is connected to the municipal drainage system which runs along Rue de Cotton Road. Based on the odor and discoloration of the water, the drainage system appears to convey wastewater from the businesses along Interstate 49. The stream itself was overgrown with senesced vegetation at the time of the site visit and standing water was observed. S1 is approximately 850 feet long and mean high water appeared to be approximately 6-12 inches based on the water line visible. A small drain also included as part of the S1 drainage system flows north to south into the main S1 channel. It is approximately 250 feet long and appears to capture much of the surface runoff from the northern most field and hydrologic movement appears to be southward. S1 forms W1 at the base of the slight hill.

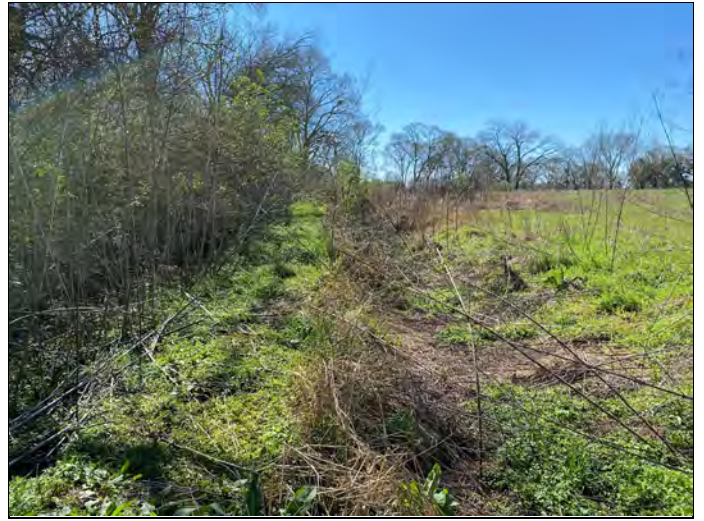
8. Drainage ditch along the east edge of the site

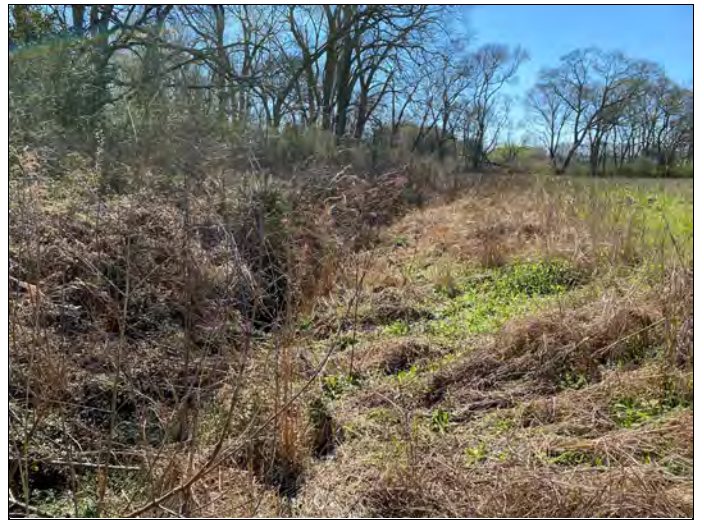
10. Ditch along the southern edge of the site

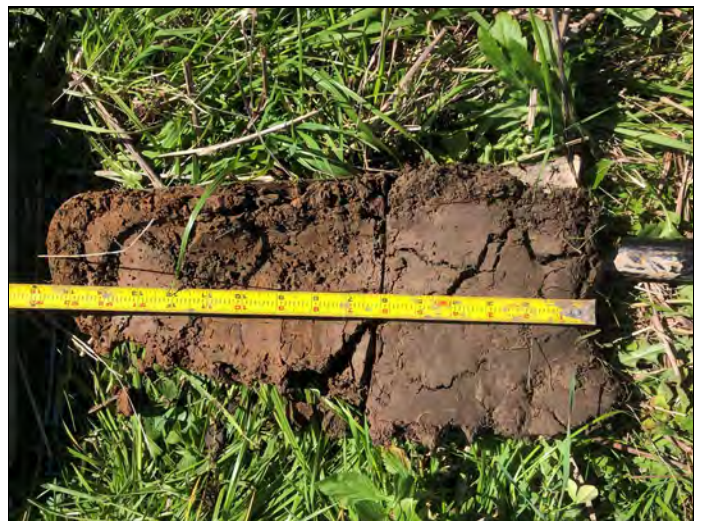
Depth (inches)	Matrix		Redox Features				Texture	Remarks
	Color (moist)	%	Color (moist)	%	Type ¹	Loc ²		
0-6	10YR 3/2	100					Silt	Dark brown
6-16	10YR 4/3	100					Silt/ clay	Light brown

12. DP1 soils

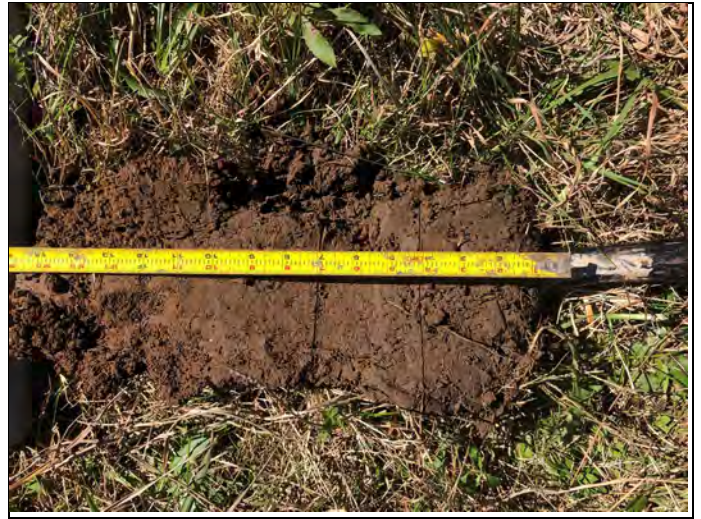
Depth (inches)	Matrix		Redox Features				Texture	Remarks
	Color (moist)	%	Color (moist)	%	Type ¹	Loc ²		
0-3	10YR 3/2	100					Silt	Dark brown
3-6	10YR 3/3	100					Silt	
6-16	10YR 3/4	100					Silt/ clay

14. DP2 soils

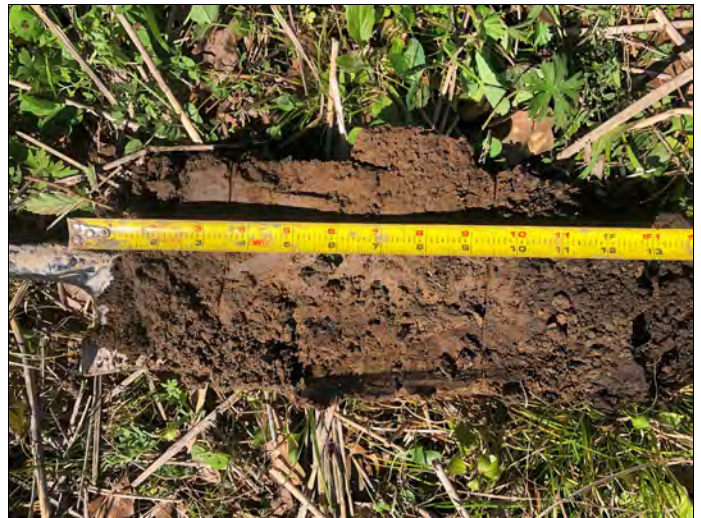
Depth (inches)	Matrix		Redox Features				Texture	Remarks
	Color (moist)	%	Color (moist)	%	Type ¹	Loc ²		
0-3	10YR 3/3	100					Silt	Dark brown
3-9	10YR 3/4	100					Silt	Light brown
9-16	10YR 2/2	100					Silt	Black

16. DP3 soils

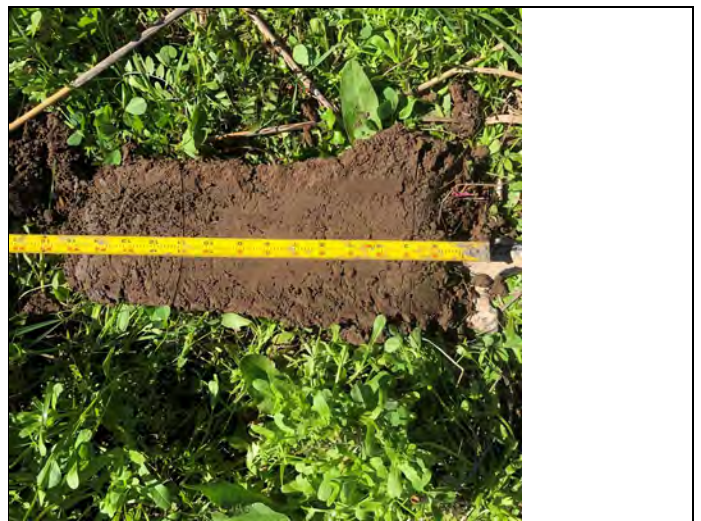
Depth (inches)	Matrix		Redox Features				Texture	Remarks
	Color (moist)	%	Color (moist)	%	Type ¹	Loc ²		
0-3	10YR 3/2	100					Silt	Dark brown
3-11	10YR 3/3	100					Silt	Lighter Brown
11-16	10YR 2/2	100					Silt	Dark Brown/ Almost Black

18. DP4 soils

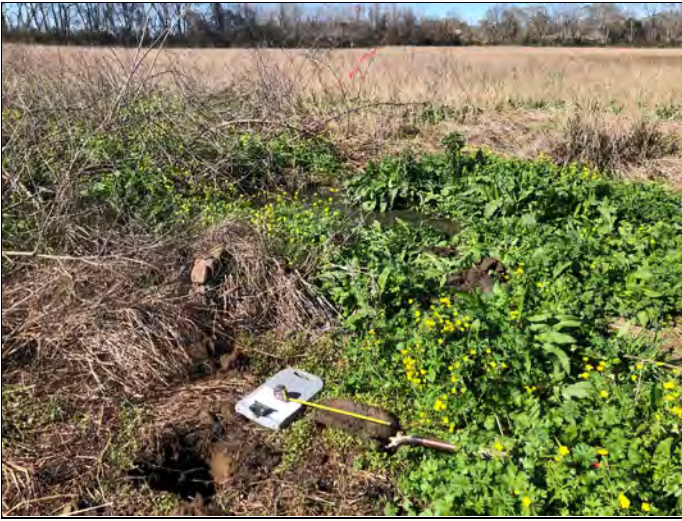
Field Observations: Surface Water Present? Yes <u> </u> No <u>X</u> Depth (inches): <u> </u> Water Table Present? Yes <u> </u> No <u>X</u> Depth (inches): <u> </u> Saturation Present? Yes <u>X</u> No <u> </u> Depth (inches): <u> </u> (includes capillary fringe)		Wetland Hydrology Present? Yes <u>X</u> No <u> </u>	
Describe Recorded Data (stream gauge, monitoring well, aerial photos, previous inspections), if available: USGS 7.5-minute topographic map, aerial photographs			
Remarks: Hydrology indicators observed. Site is located at the base of a hillslope, beginning at an ephemeral stream. It appears, hydrological movement is to the southeast. Data point was taken within 5 feet of surface water.

19. DP5 landscape view

W1 is palustrine emergent (PEM) wetland that has formed adjacent to and at the end of an ephemeral stream (S1) that crosses the site. The wetland data points include DP5, and DP6 and dominant vegetation consists of mostly FAC species including: Kidney weed (*Dichondra micrantha* - FAC), Creeping buttercup (*Ranunculus repens* - FAC), Curly dock (*Rumex crispus* - FAC), Annual rye grass (*Festuca perennis* - FAC), Brazilian Vervain (*Verbena brasiliensis* - FAC), and Beaked cornsald (*Valerianella radiata* - FAC).

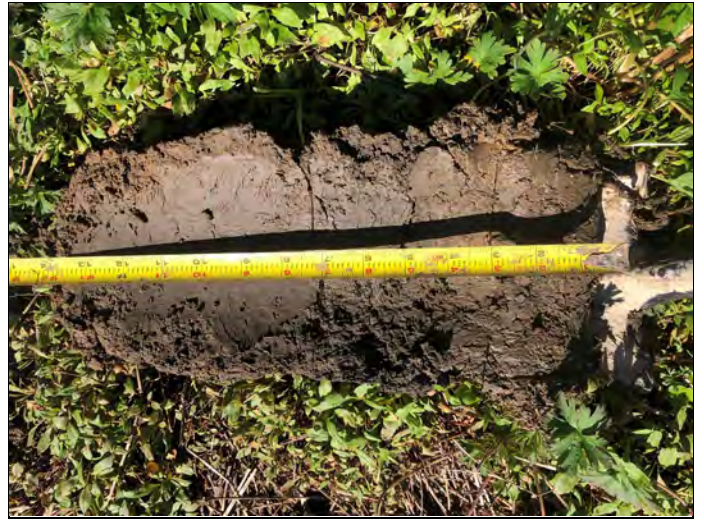
Depth (inches)	Matrix		Redox Features				Texture	Remarks
	Color (moist)	%	Color (moist)	%	Type ¹	Loc ²		
0-3	10YR 3/2	95	10YR 4/3	5	D	M	Silt	Brown with reddish streaking
3-7	10YR 2/2	100					Silt	Dark Brown
7-16	10YR 3/2	100					Silt

20. DP5 soils

- Primary wetland hydrology indicators present include surface water, high water table, saturation, and watermarks. Secondary indicators include drainage patterns, and geomorphic position.
- The primary hydric soil indicator includes dark surfaces.

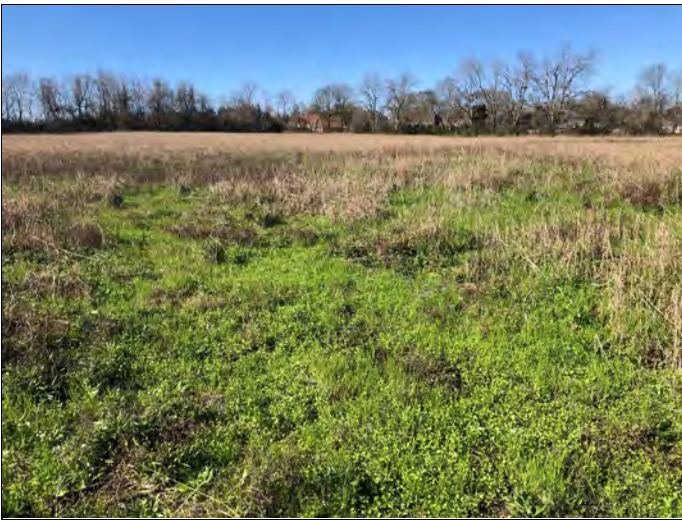
Field Observations: Surface Water Present? Yes <u> </u> No <u>X</u> Depth (inches): <u> </u> Water Table Present? Yes <u> </u> No <u>X</u> Depth (inches): <u> </u> Saturation Present? Yes <u>X</u> No <u> </u> Depth (inches): <u> </u> (includes capillary fringe)		Wetland Hydrology Present? Yes <u>X</u> No <u> </u>
Describe Recorded Data (stream gauge, monitoring well, aerial photos, previous inspections), if available: USGS 7.5-minute topographic map, aerial photographs		
Remarks: Hydrology indicators observed. Site is located at the base of a hillslope, beginning at an ephemeral stream. It appears, hydrological movement is to the south and connects to DP5 site. Data point was taken within 5 feet of surface water.

21. DP6 landscape view

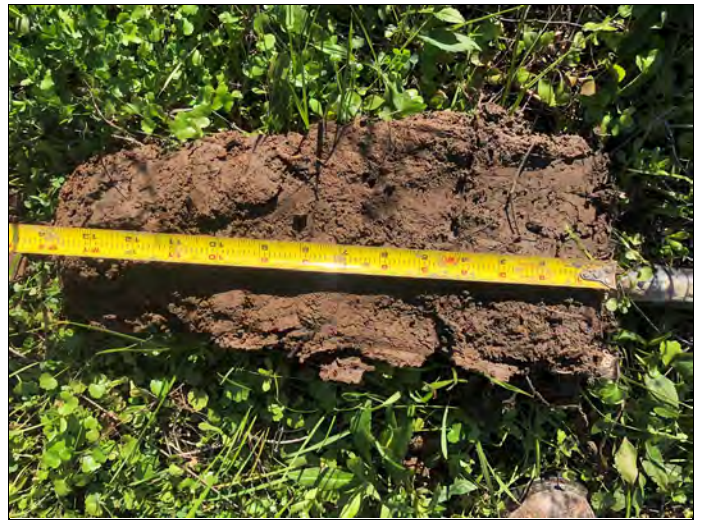
Depth (inches)	Matrix		Redox Features				Texture	Remarks
	Color (moist)	%	Color (moist)	%	Type ¹	Loc ²		
0-5	10YR 3/2	100					Silt	Dark brown/ moist
5-16	10YR 3/3	100					Silt

22. DP6 soils

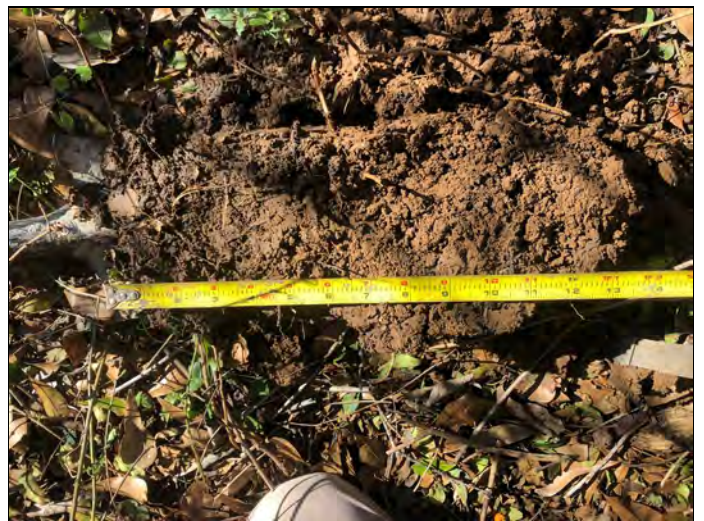
Depth (inches)	Matrix		Redox Features				Texture	Remarks
	Color (moist)	%	Color (moist)	%	Type ¹	Loc ²		
0-3	10YR 3/2	100					Silt loam	Dark brown/ moist
3-6	10YR 4/2	100					Silt loam	
6-16	10YR 4/3	100					Silt loam

24. DP7 soils

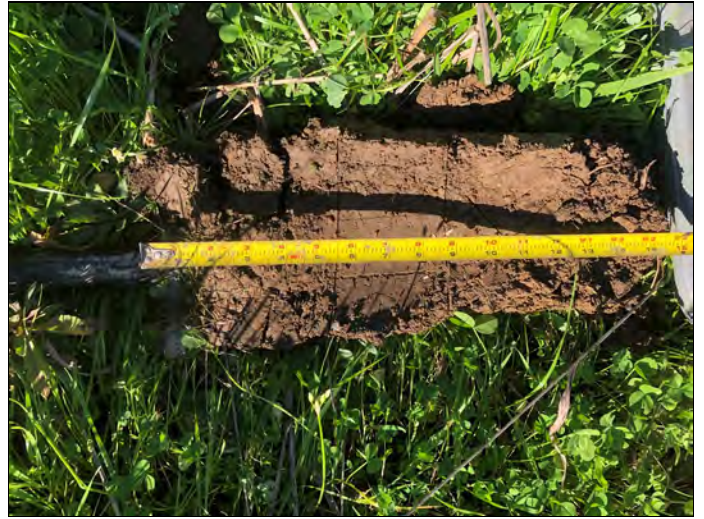
Depth (inches)	Matrix		Redox Features				Texture	Remarks
	Color (moist)	%	Color (moist)	%	Type ¹	Loc ²		
0-5	7.5YR 3/2	100					Silt	
5-9	10YR 3/2	100					Silt/ clay	
9-16	10YR 3/3	100					Silt/ clay	Streaking

26. DP8 soils

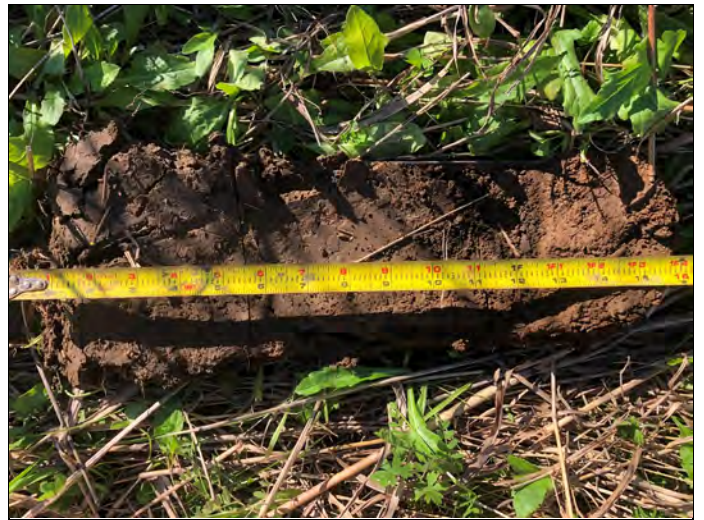
Depth (inches)	Matrix		Redox Features				Texture	Remarks
	Color (moist)	%	Color (moist)	%	Type ¹	Loc ²		
0-5	10YR 3/2	100					Silt	Dark brown/ moist
5-11	10YR 4/3	100					Silt	
11-16	10YR 4/4	100					Silt

28. DP9 soils
