Exhibit 10.
Wetlands & Environmental Report

ENVIRONMENTAL OVERVIEW

TOWN OF MONTGOMERY, LOUISIANA

31 ACRE INDUSTRIAL SITE

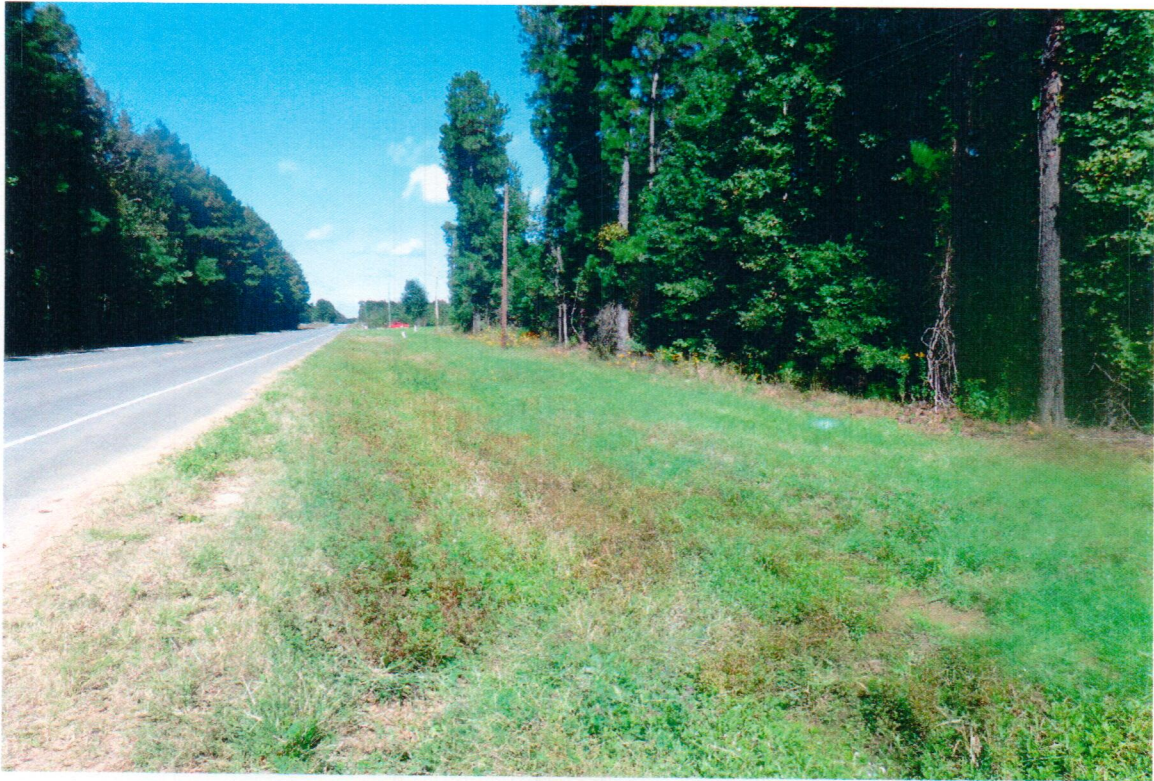
Photograph: 1

Photo Description: This view is in a northward direction along the east side of U.S. Hwy. 71. This proposed 31 acre industrial site is to the right of the highway.

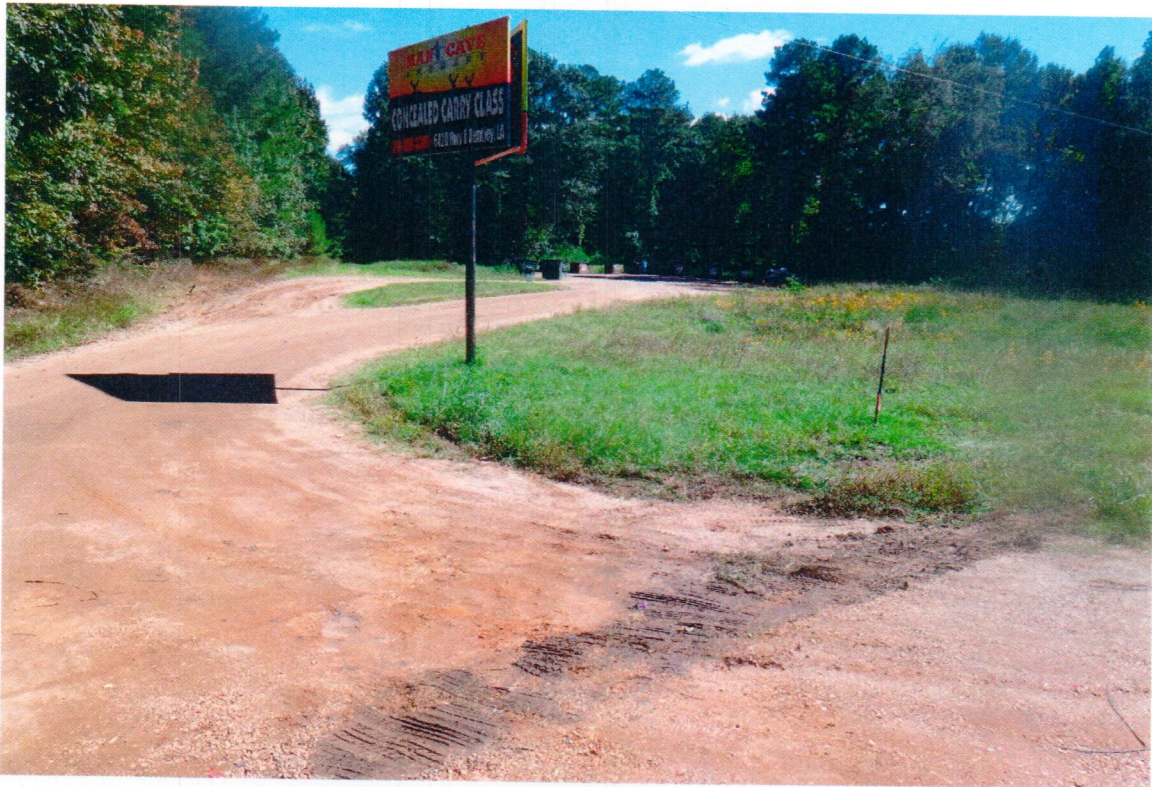
Photograph: 2

Photo Description: This is a small area being used as a collect point for local household garbage. This area will be removed from this location. The dirt road extends through the proposed project site.

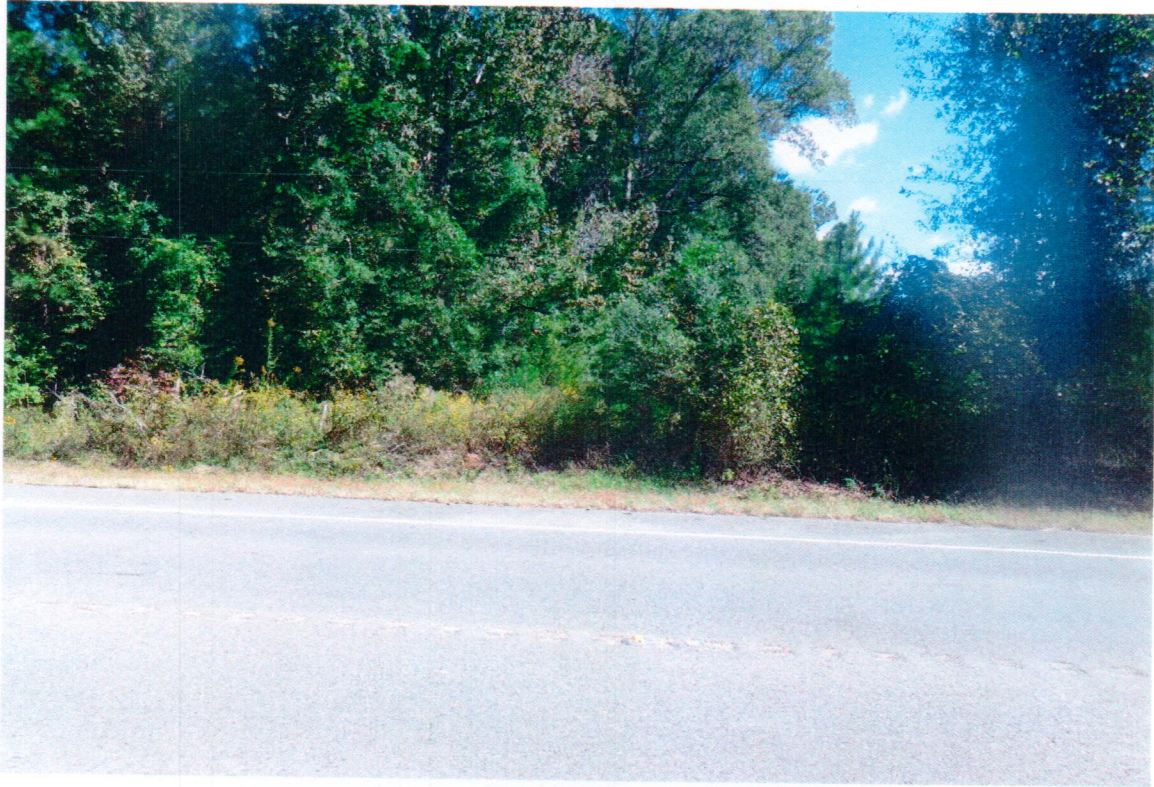
Photograph: 3

Photo Description: This view from U.S. Hwy. 71 looking east along the south boundary of the proposed site. The soils at this point are moderately well drained and are identified as Malbis fine sandy loam. Wetland criteria is not associated with these soils.

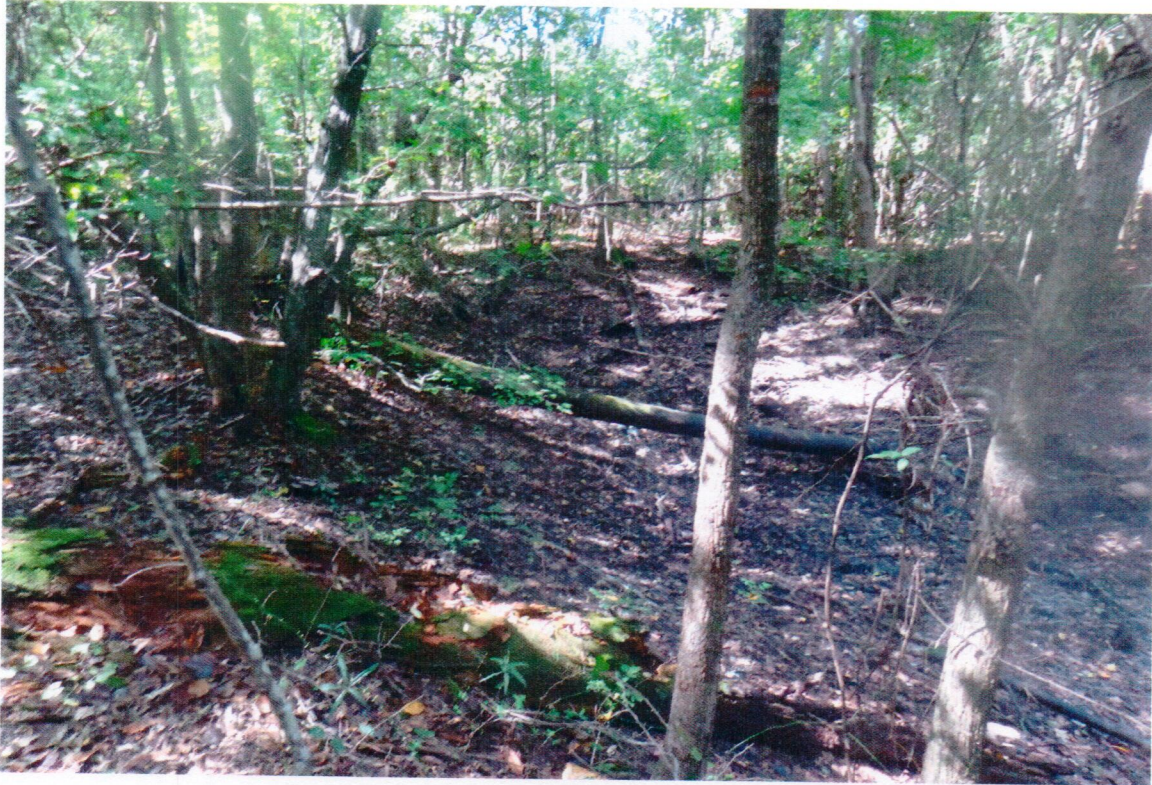
Photograph: 4

Photo Description: This is a small manmade dugout pond that was built several years ago. The purpose of this water impoundment was for furnishing a water supply for livestock. This area in most years will go dry during the late summer and early fall. The area is identified on enclosed maps. This is a Non-Jurisdictional feature and is not regulated by the "404 Clean Water Act". At the time of the site visit there was no water in this impoundment.

In Summary, the proposed project will not impact any intermittent and/or perennial drains. There is a small man made dugout on site. This water impoundment was constructed years ago as a water supply for livestock. The small dugout dries up during the late summer and early fall. This water body is not Jurisdictional under the 404 Clean Water Act. There are no issues to be addressed concerning Threatened or Endangered Species, historical and/or cultural sites and 404 Jurisdictional areas. This environmental overview provides reasonable certification that a diligent and reasonable effort was made on the day of the study to ascertain that all environmental issues were addressed.

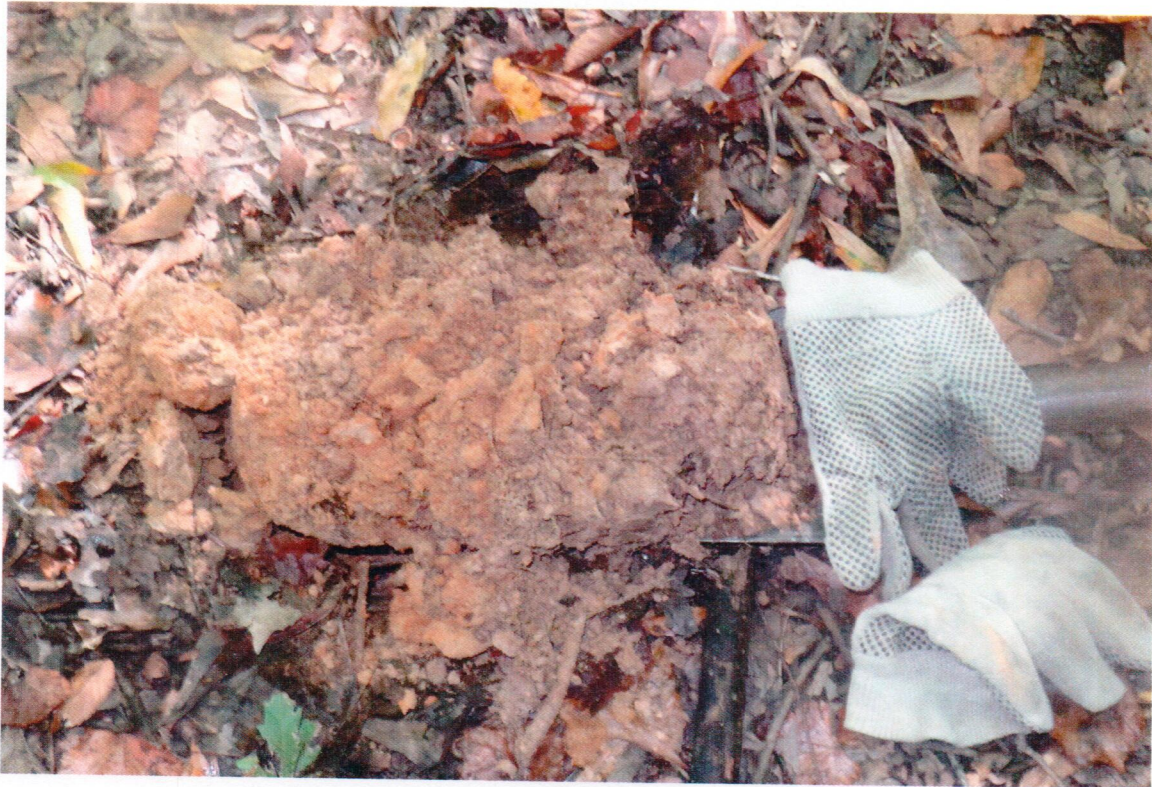
Photograph: 5

Photo Description: This sample was taken approximately 50 feet from the dugout pond. The upper 6 inches of the soil is brownish and the lower part is a yellowish brown silty clay loam soil. The soil profile indicates that the criteria for hydric soils is not present. The soil is identified as Gurdon silt loam and is classified as Aquic Paleudults. Wetland criteria is not present.

This soil is somewhat poorly drained and is identified as Gurdon. These soils are classified as Aquic Paleudults. Hydric soils are not present due to hydrology and soil properties at the site.

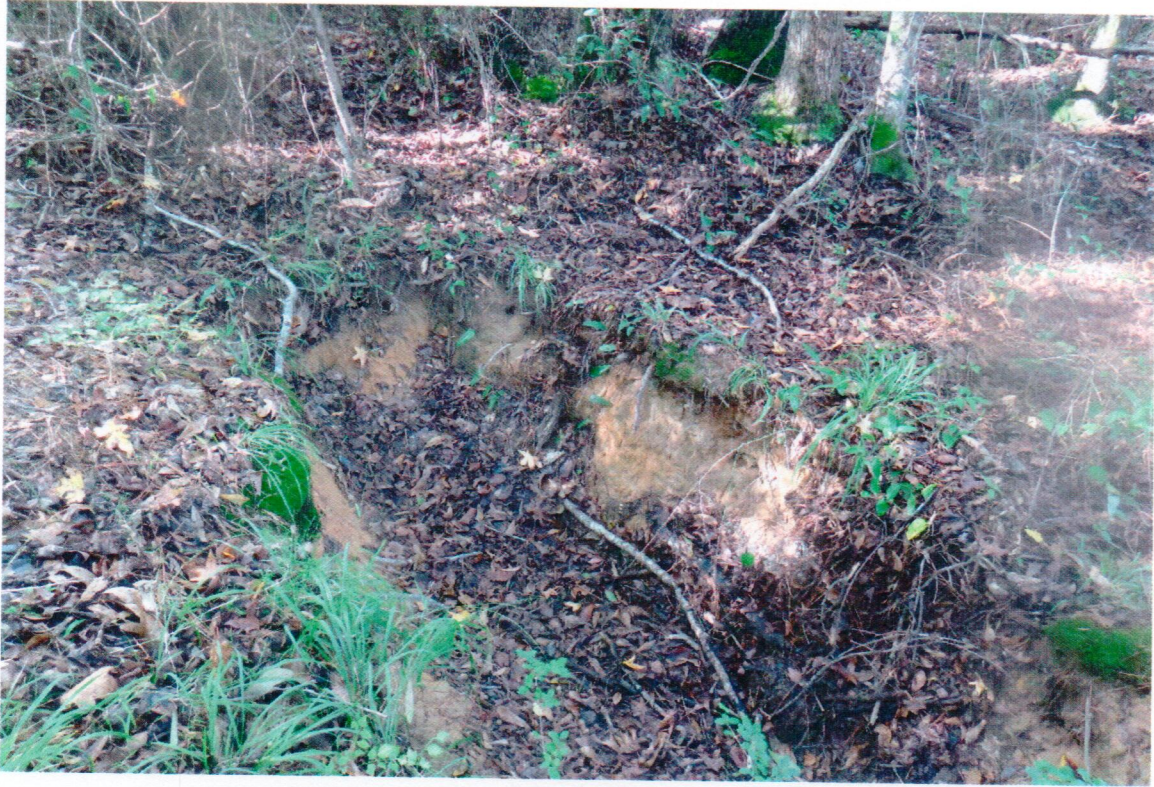
Photograph: 6

Photo Description: This location is near the northwest corner of the site. The yellowish brown subsoil layers indicates this soil is moderately well drained and is identified as Malbis fine sandy loam. These soils are classified as Plinthic Paleudults. They are not associated with wetland conditions.

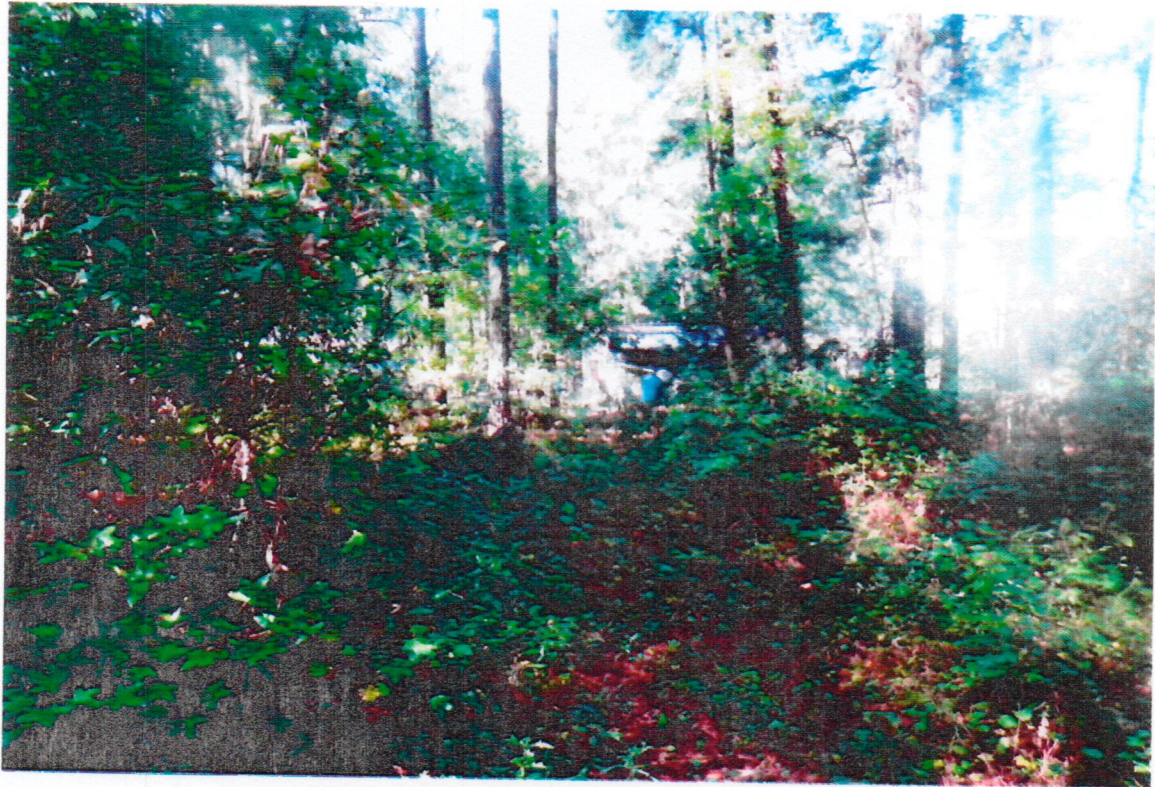
Photograph: 7

Photo Description: This structure is along the west side of the project site and is off site. The soils are well drained and are identified as Ruston fine sandy loam. They are classified as Typic Paleudults. Ruston soils are never associated with wetland conditions.

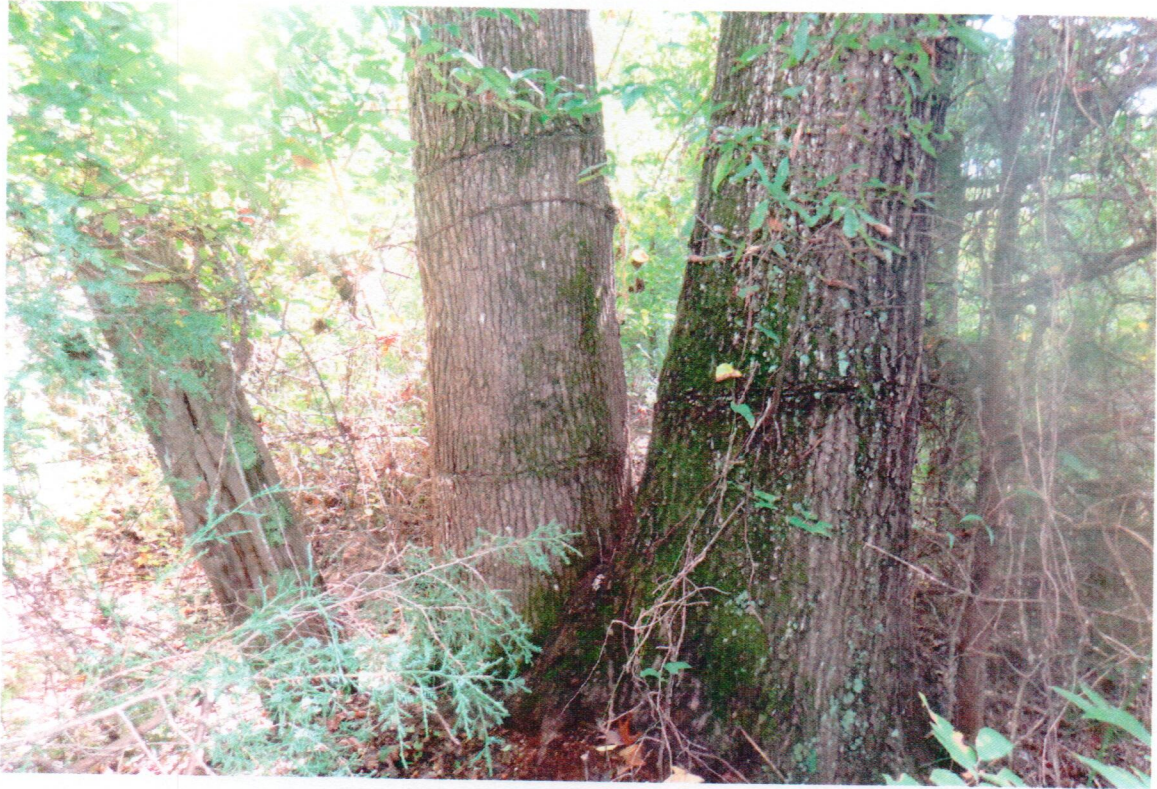
Photograph: 8

Photo Description: This is the southeast corner of the proposed site. This corner has been established for many years as indicated by the corner post and the two large sweet gum trees. On close examination, you can see the girdle marks made by barbwire in the trees. These soils are moderately well drained and are identified as Malbis fine sandy loam. Wetland conditions are not present at this site.
