Exhibit FF. West Feliciana Industrial Park Site Wetlands Delineation Report

Wetland Data Report

West Feliciana Industrial Park Site

West Feliciana Parish, Louisiana

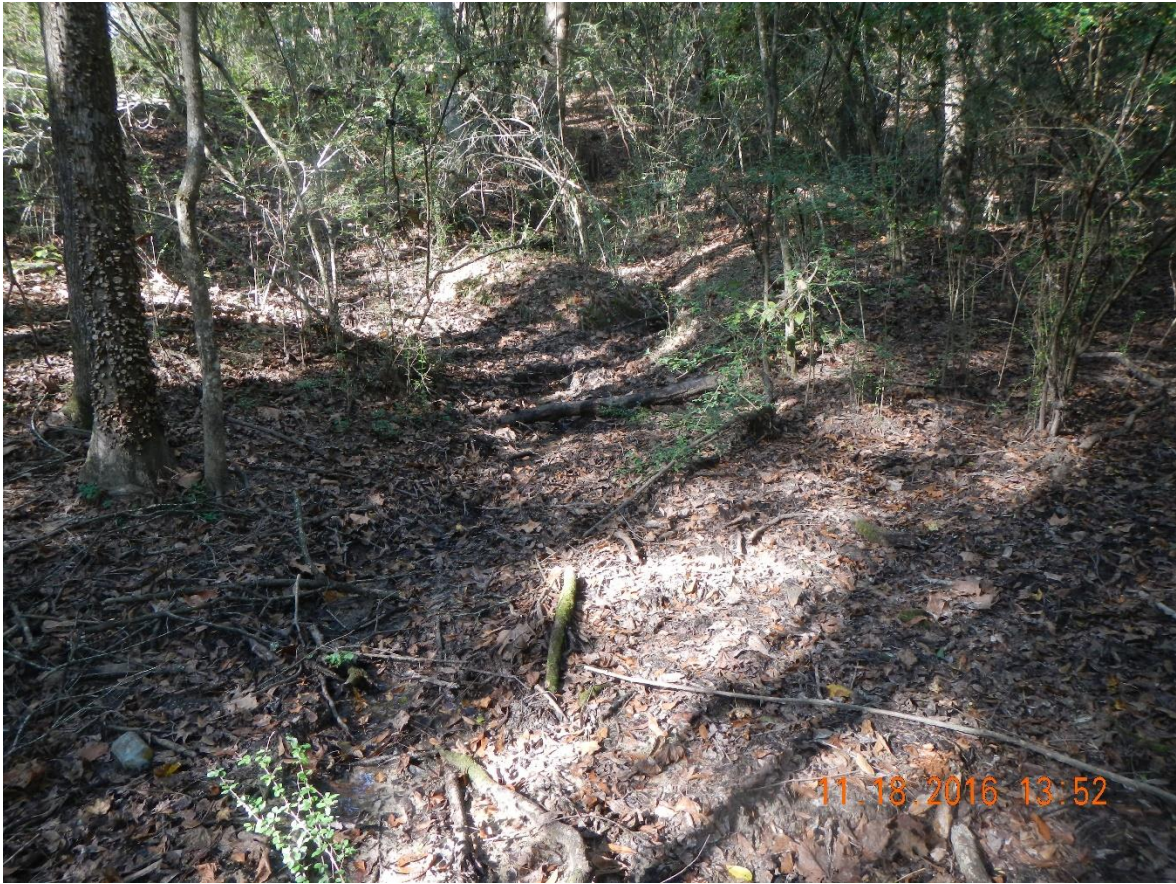
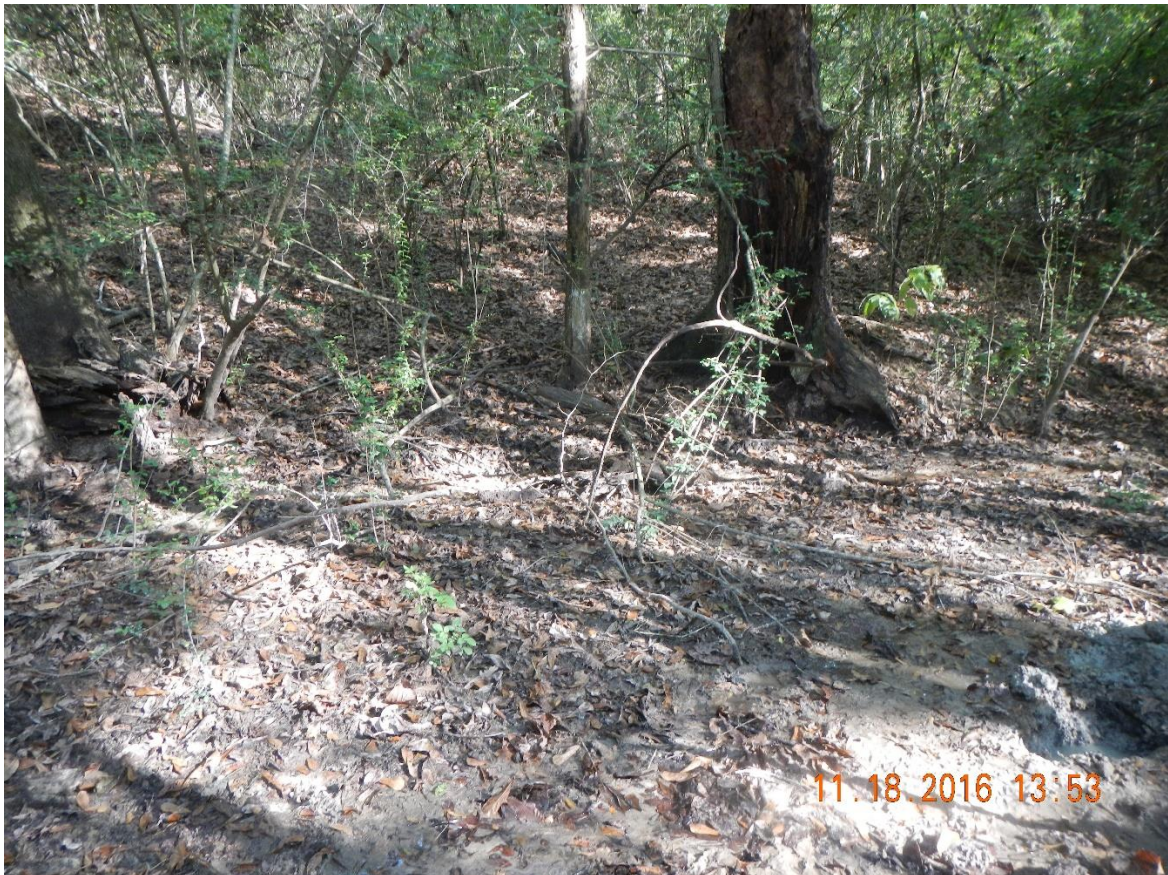
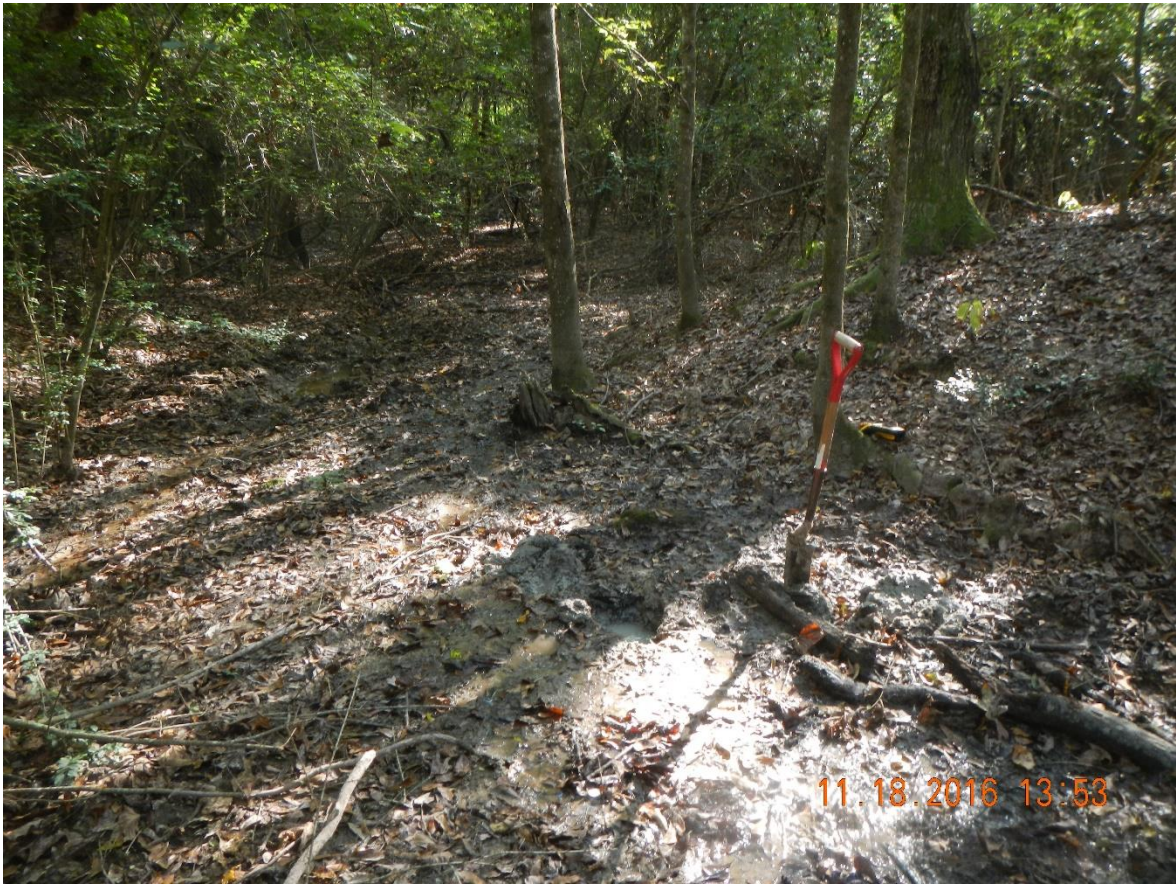
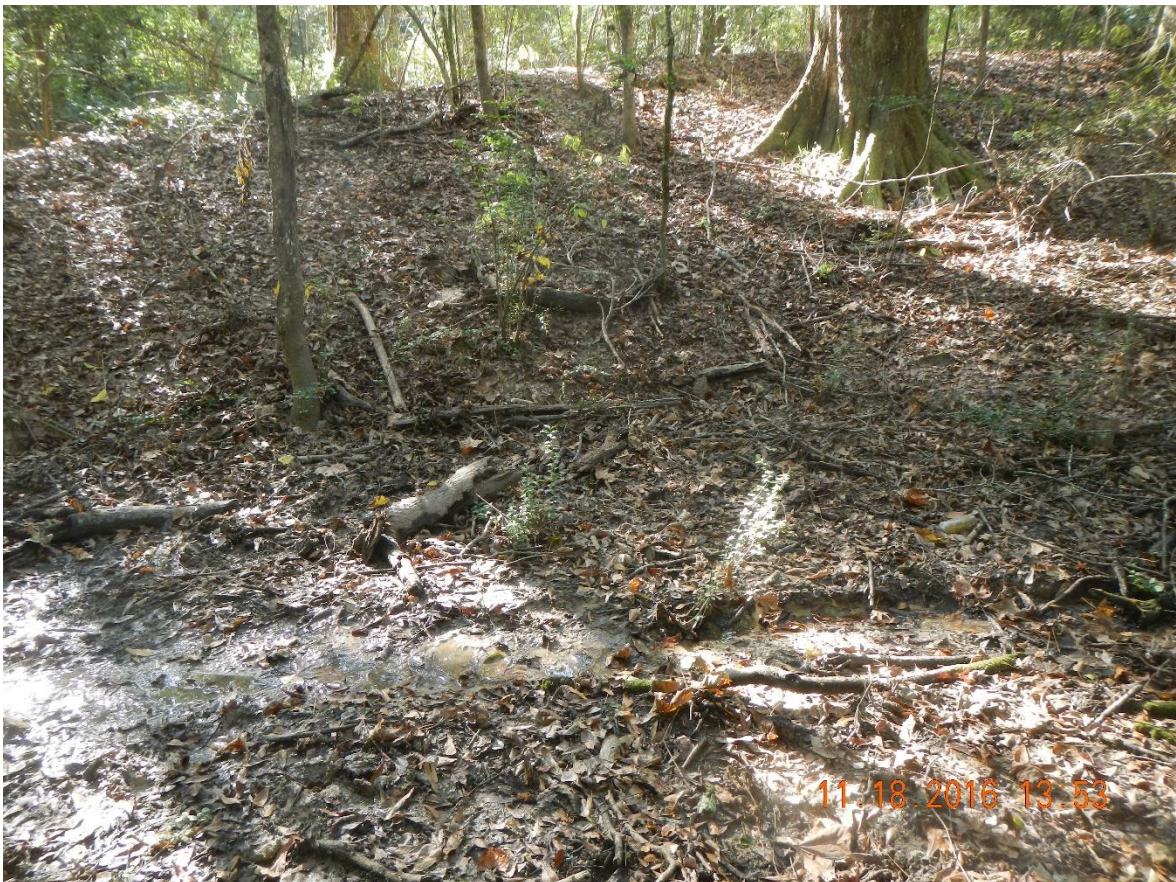
Vegetation at DP1 facing north taken 11/18/2016

Vegetation at DP1 facing east taken 11/18/2016

Vegetation at DP1 facing south taken 11/18/2016

Vegetation at DP1 facing west taken 11/18/2016

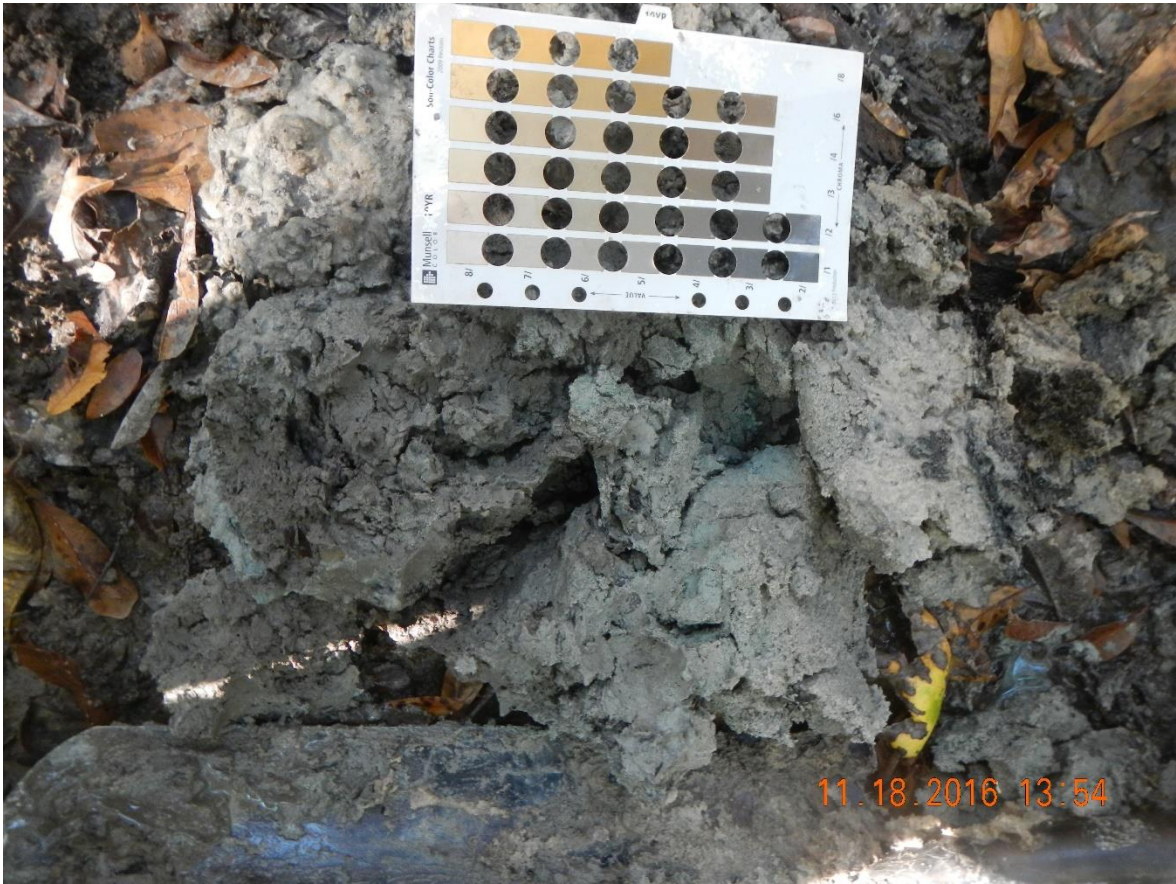
Depth (Inches)	Matrix		Redox Features				Texture	Remarks
	Color (moist)	%	Color (moist)	%	Type*	Loc**		
0-3	10YR 7/1	100					Sand	
3-6	GLE Y1 5/5GY	75	GLE Y1 5/10GY	25	RM	M	Clay	
6-16	10YR 5/1	100					Clay Loam

Soil profile at DP1 taken 11/18/2016

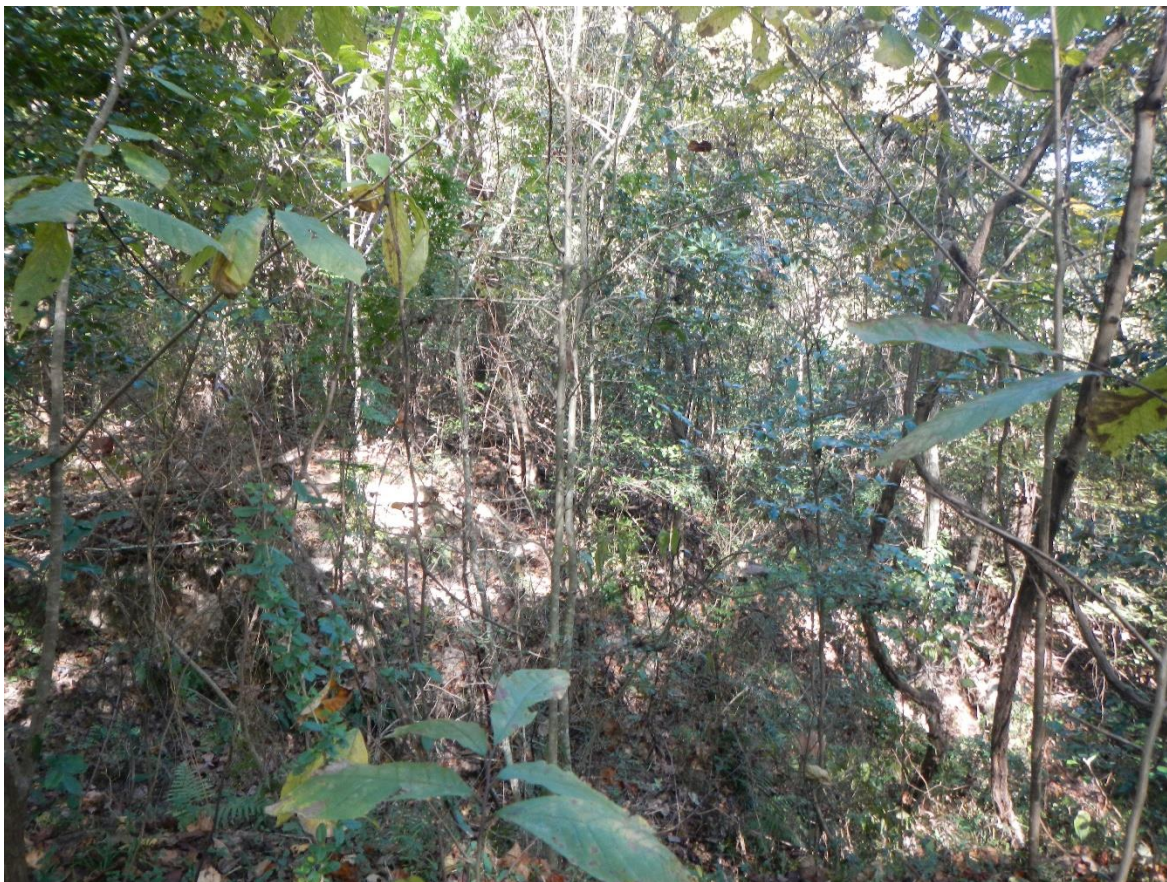
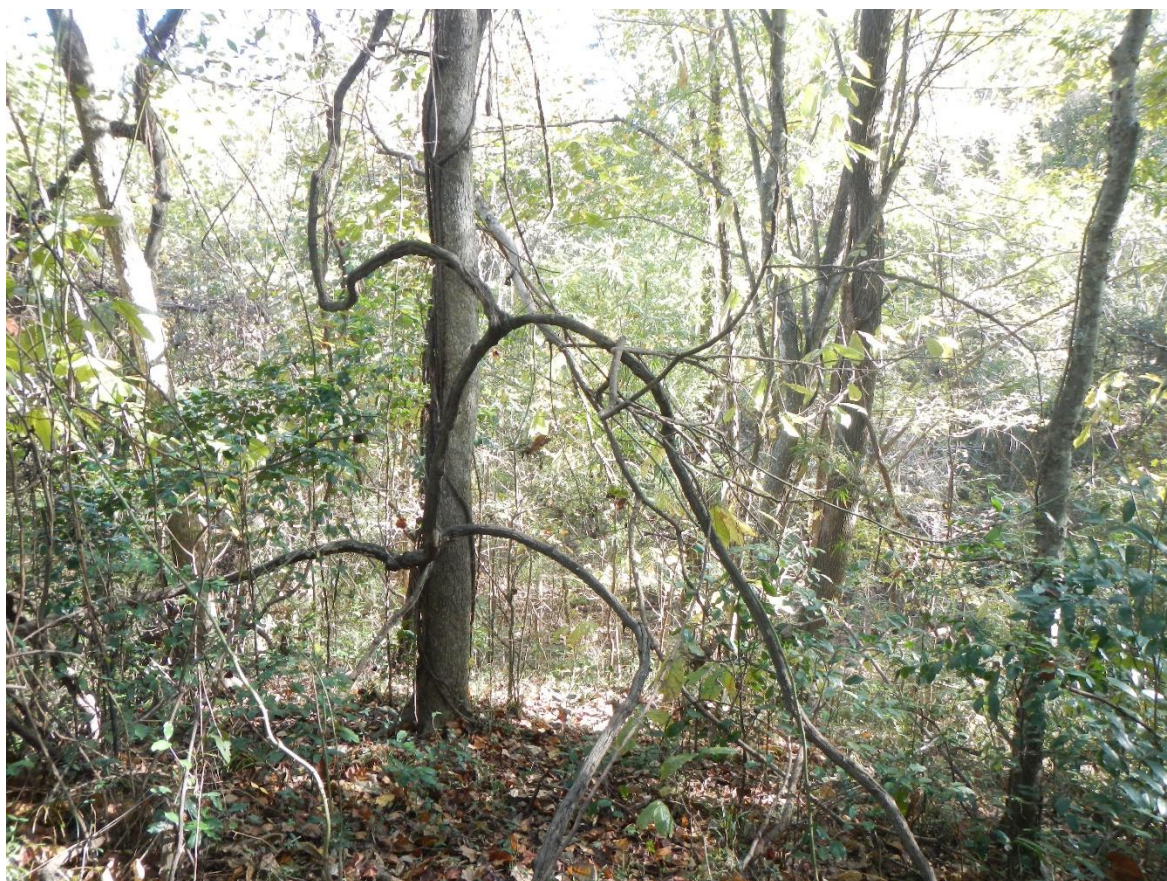
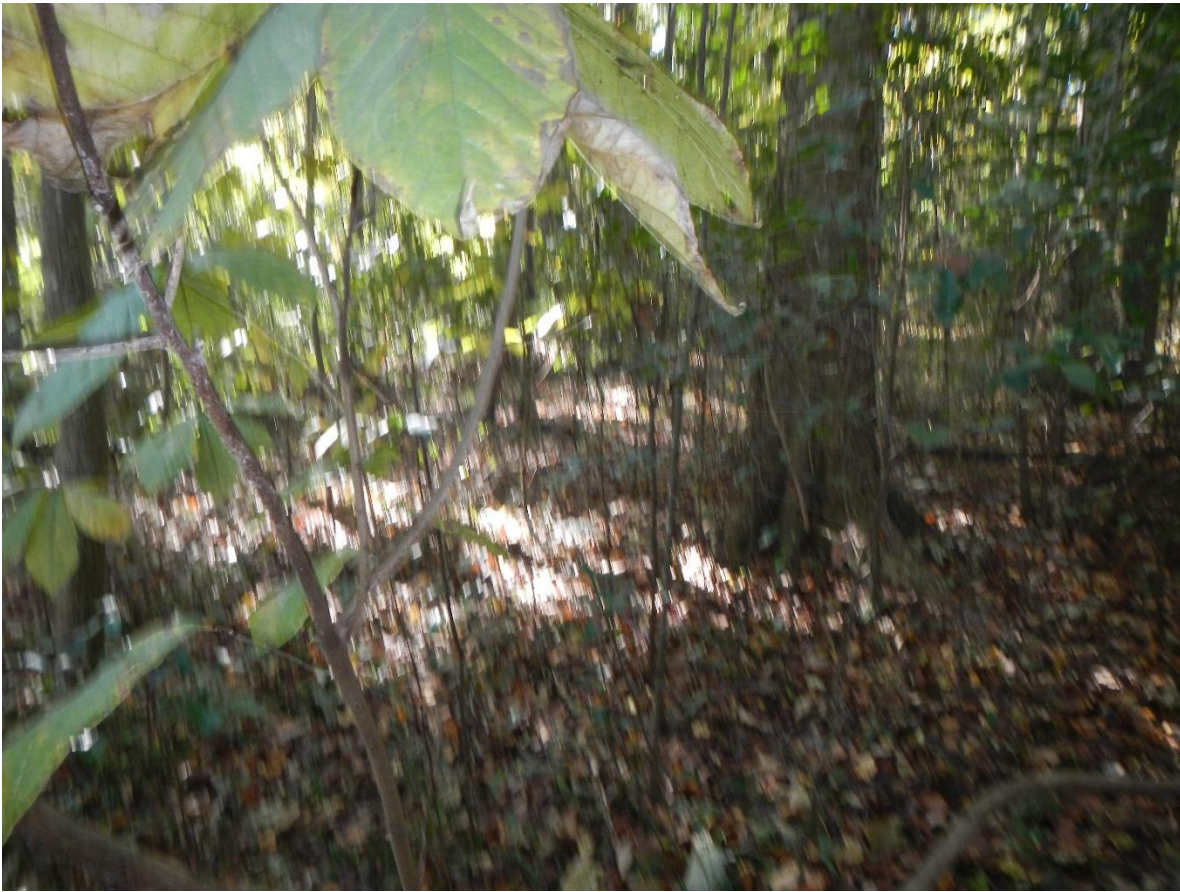
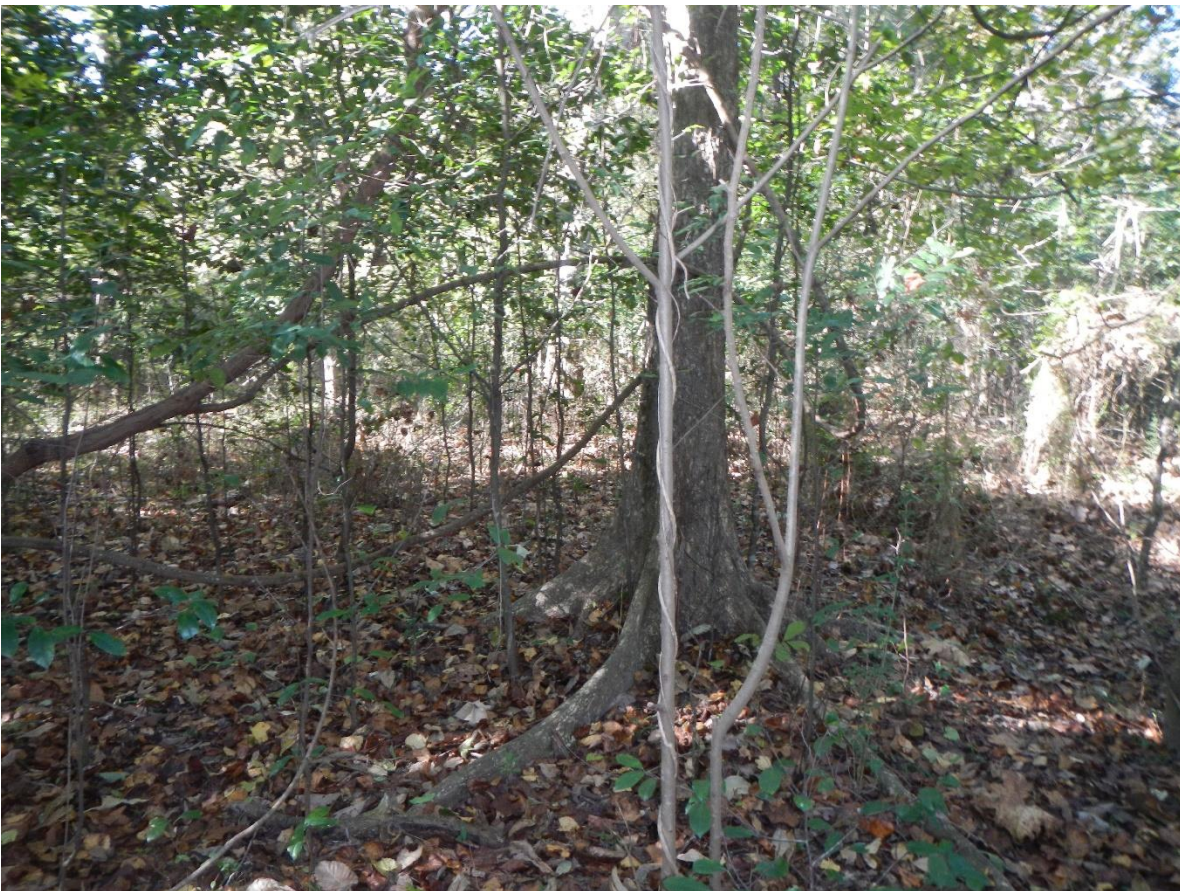
Vegetation at DP2 facing north taken 11/21/2017

Vegetation at DP2 facing east taken 11/21/2017

Vegetation at DP2 facing south taken 11/21/2017

Vegetation at DP2 facing west taken 11/21/2017

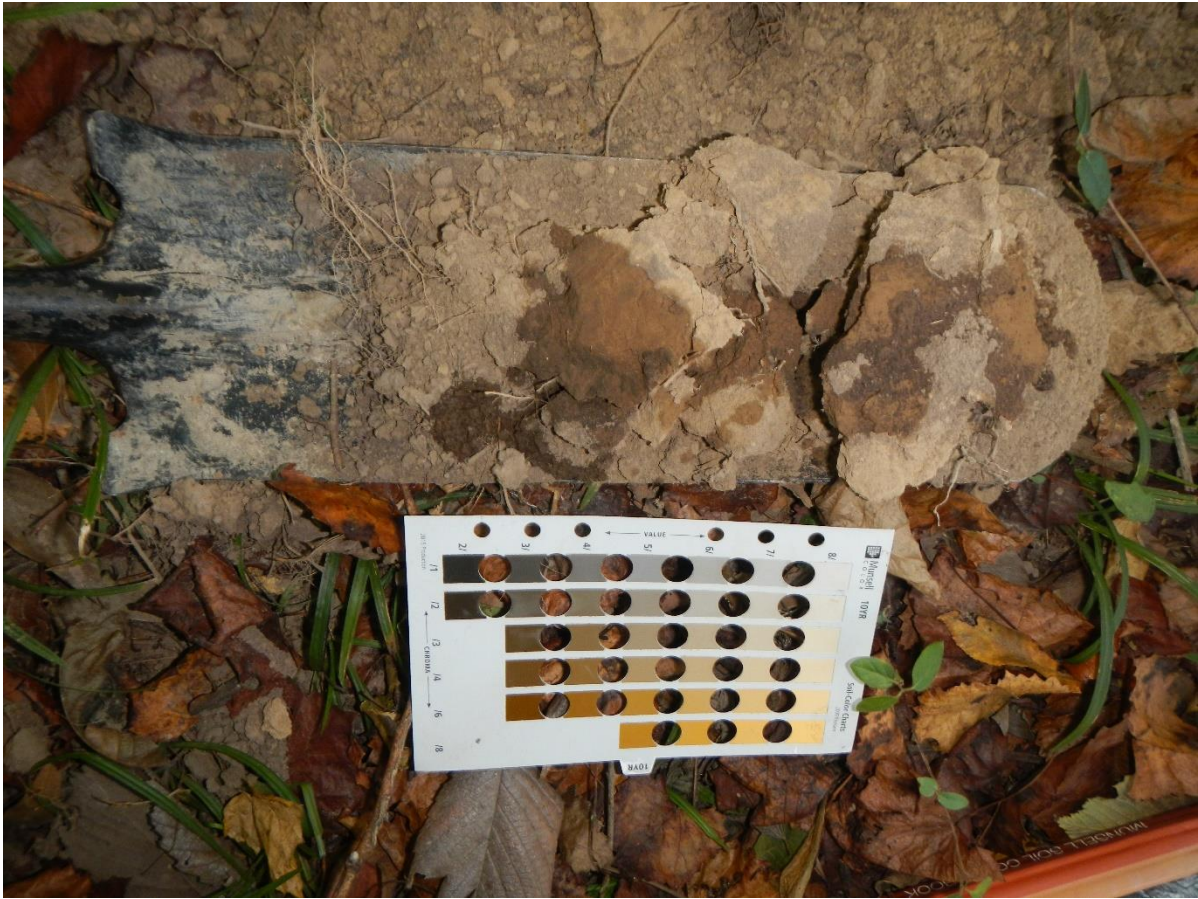
Depth (Inches)	Matrix		Redox Features				Texture	Remarks
	Color (moist)	%	Color (moist)	%	Type*	Loc**		
0-16	10YR 4/4	100					Fine Silt-Sand

Soil profile at DP2 taken 11/21/2017

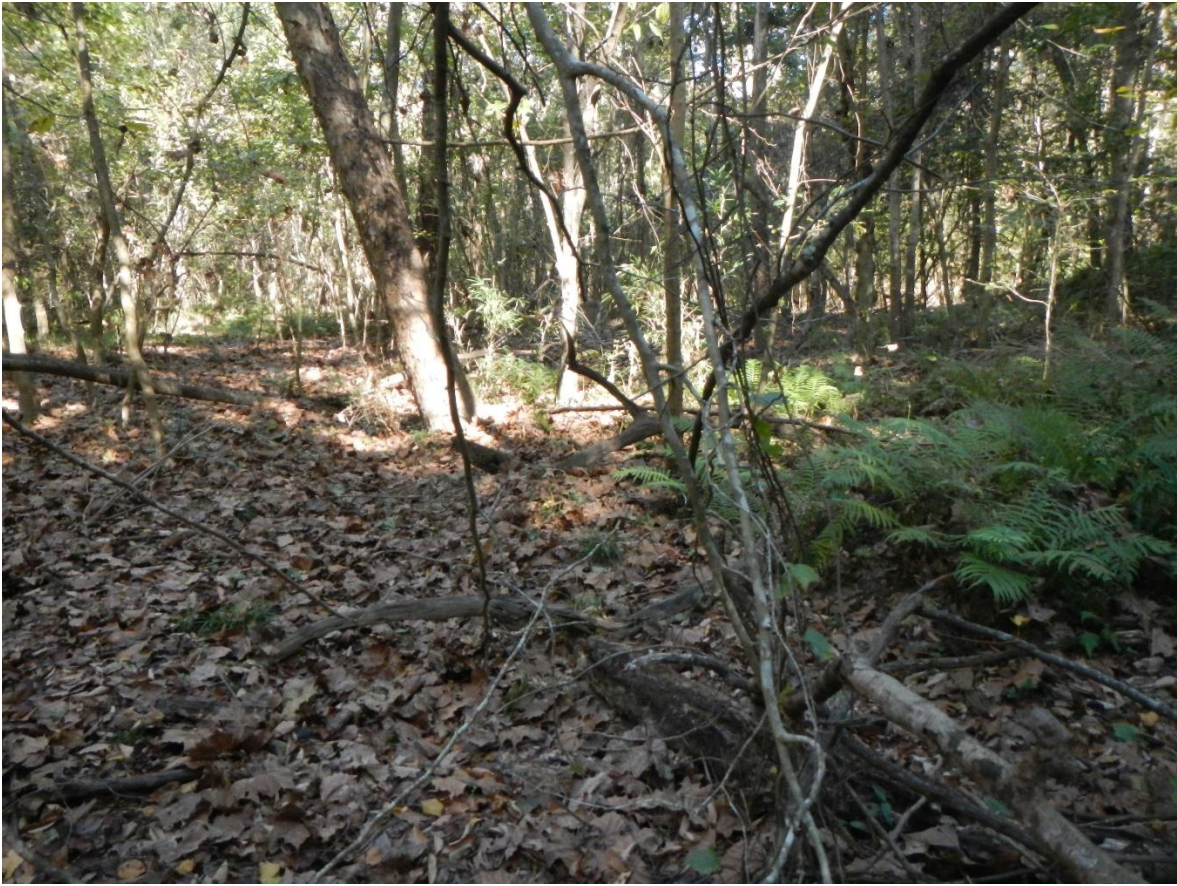
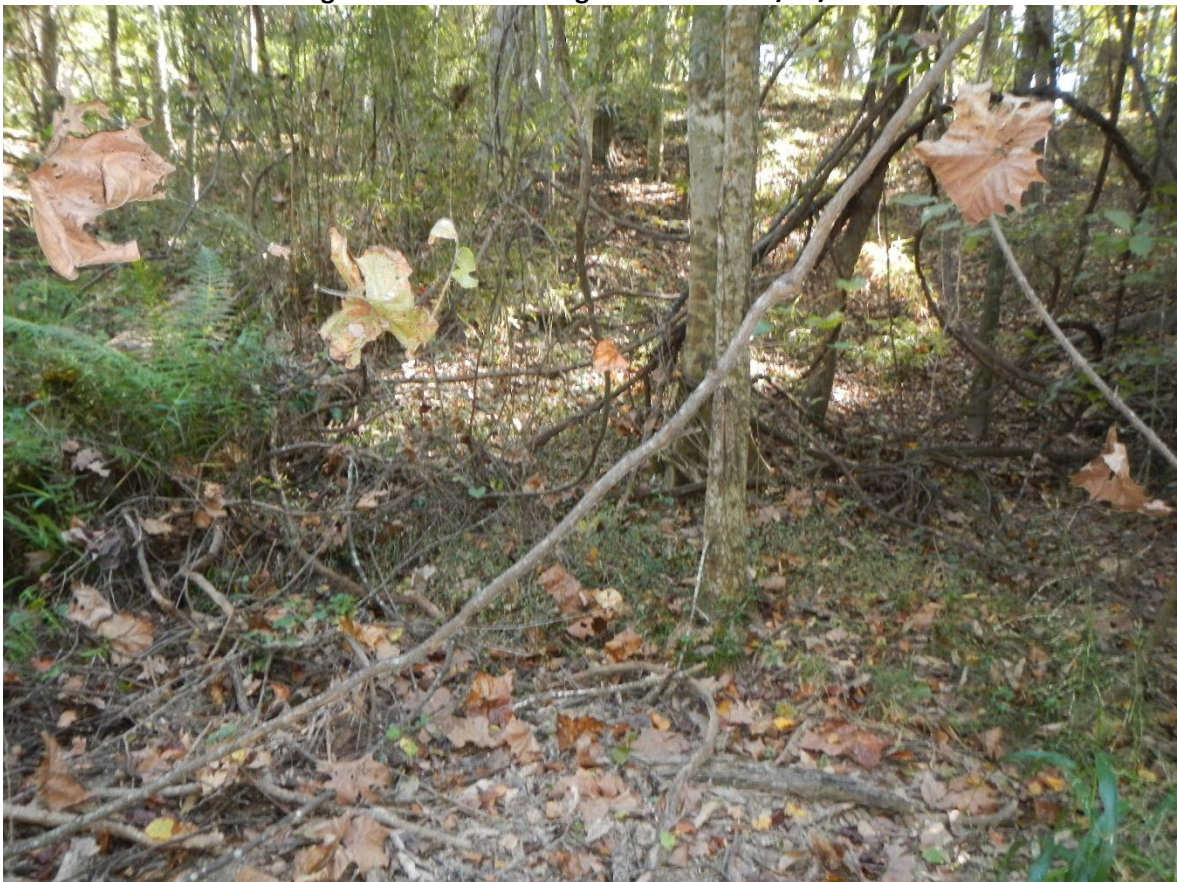
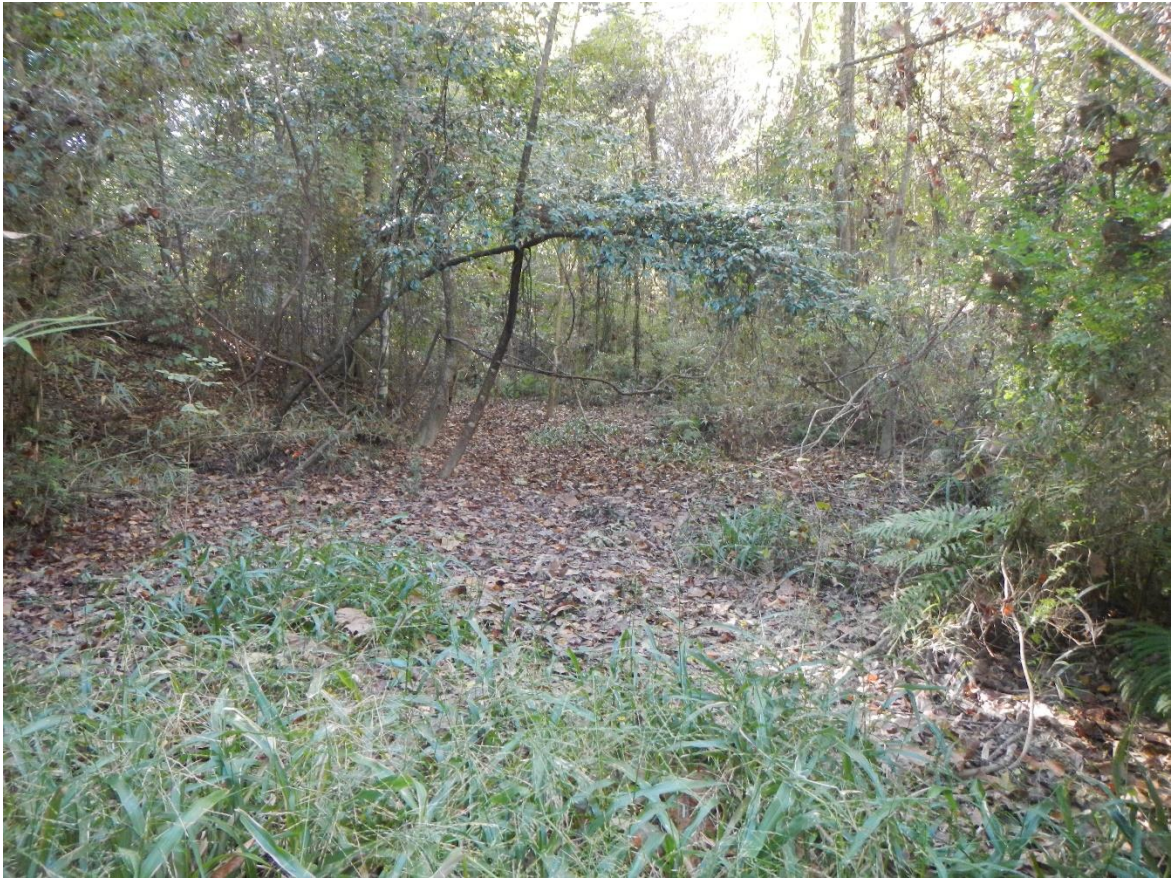
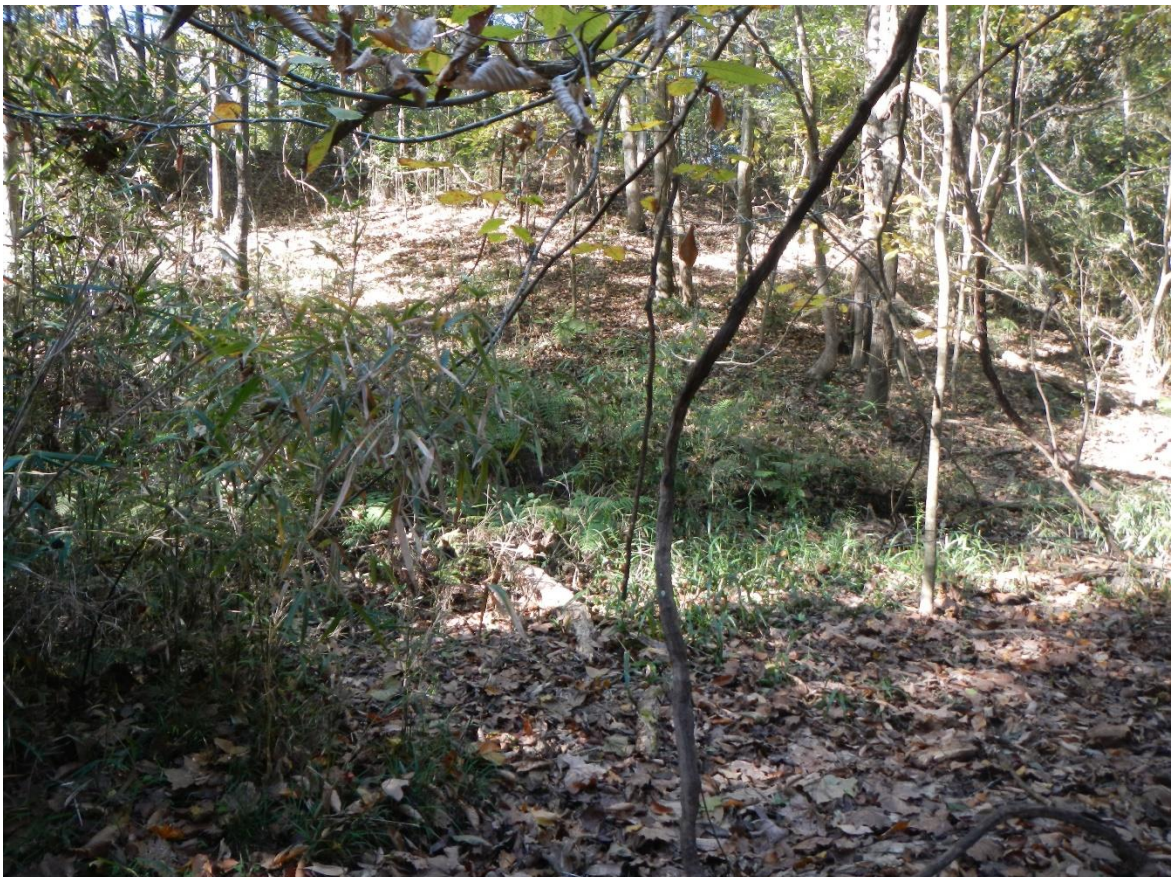
Vegetation at DP3 facing north taken 11/21/2017

Vegetation at DP3 facing east taken 11/21/2017

Vegetation at DP3 facing south taken 11/21/2017

Vegetation at DP3 facing west taken 11/21/2017

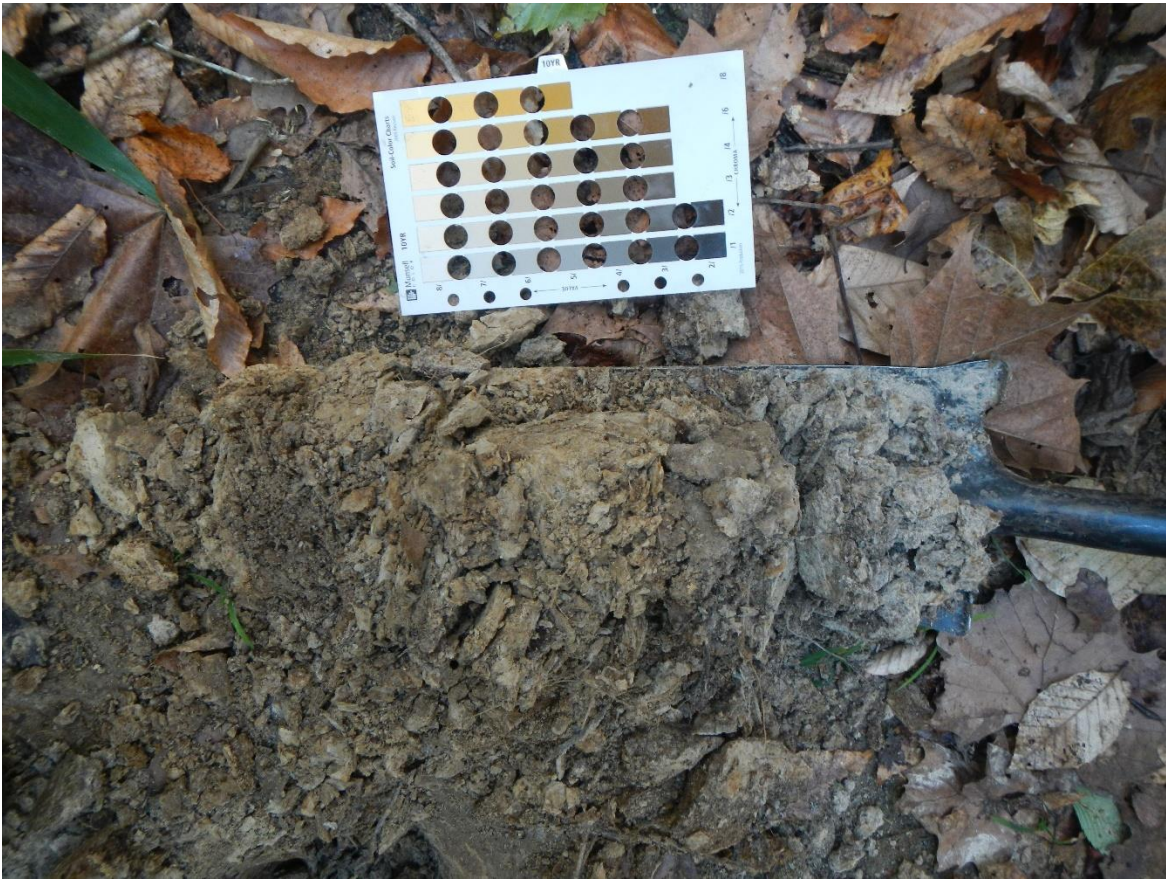
Depth (Inches)	Matrix		Redox Features				Texture	Remarks
	Color (moist)	%	Color (moist)	%	Type*	Loc**		
0-16	10YR 5/2	85	10YR5/6	15	C	M	Fine Silt-Sand

Soil profile at DP3 taken 11/21/2017

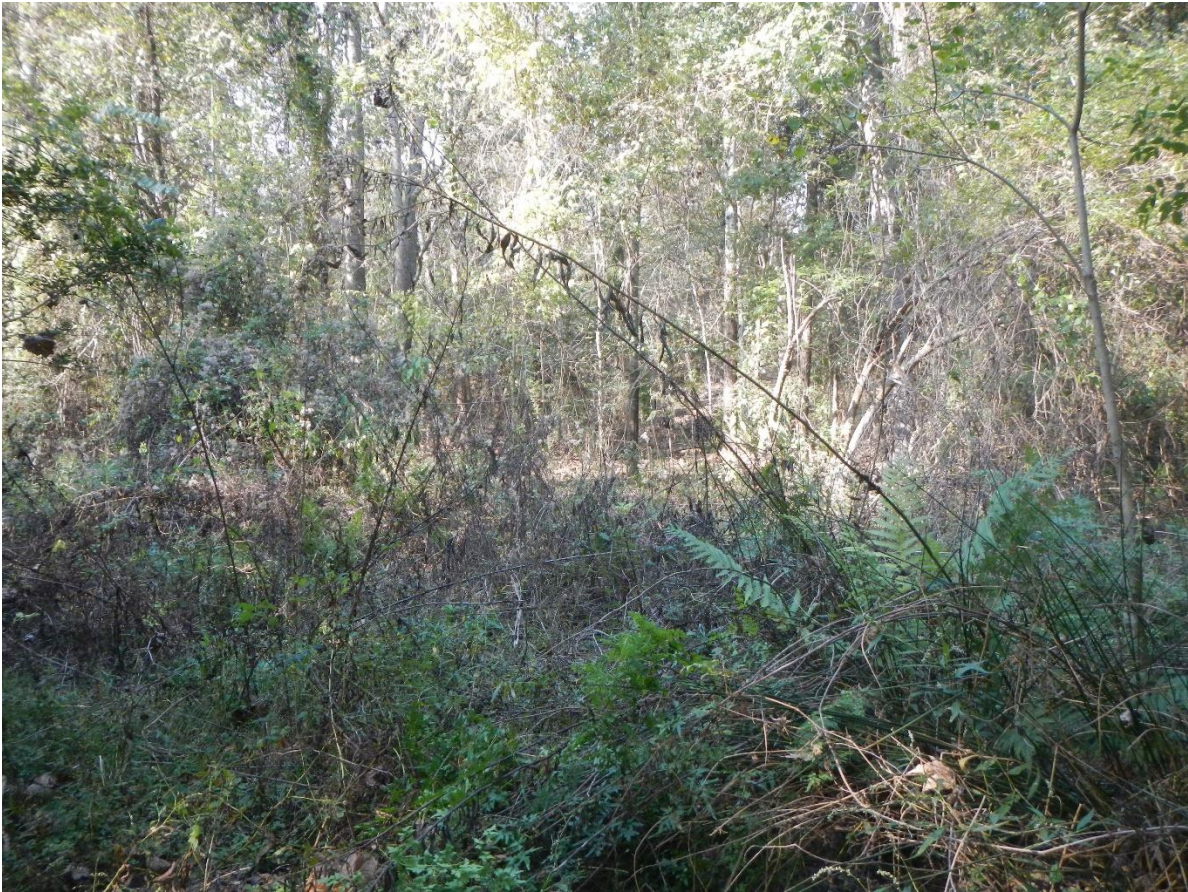
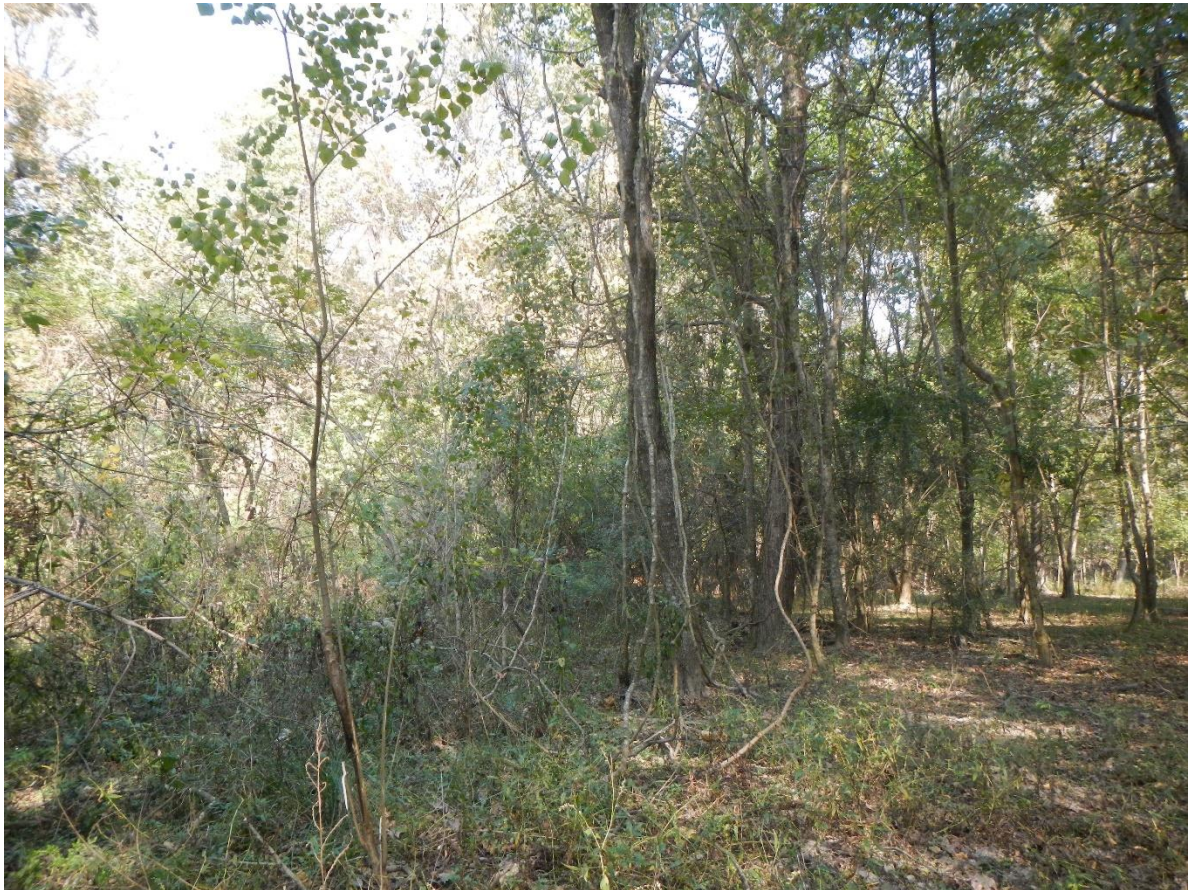
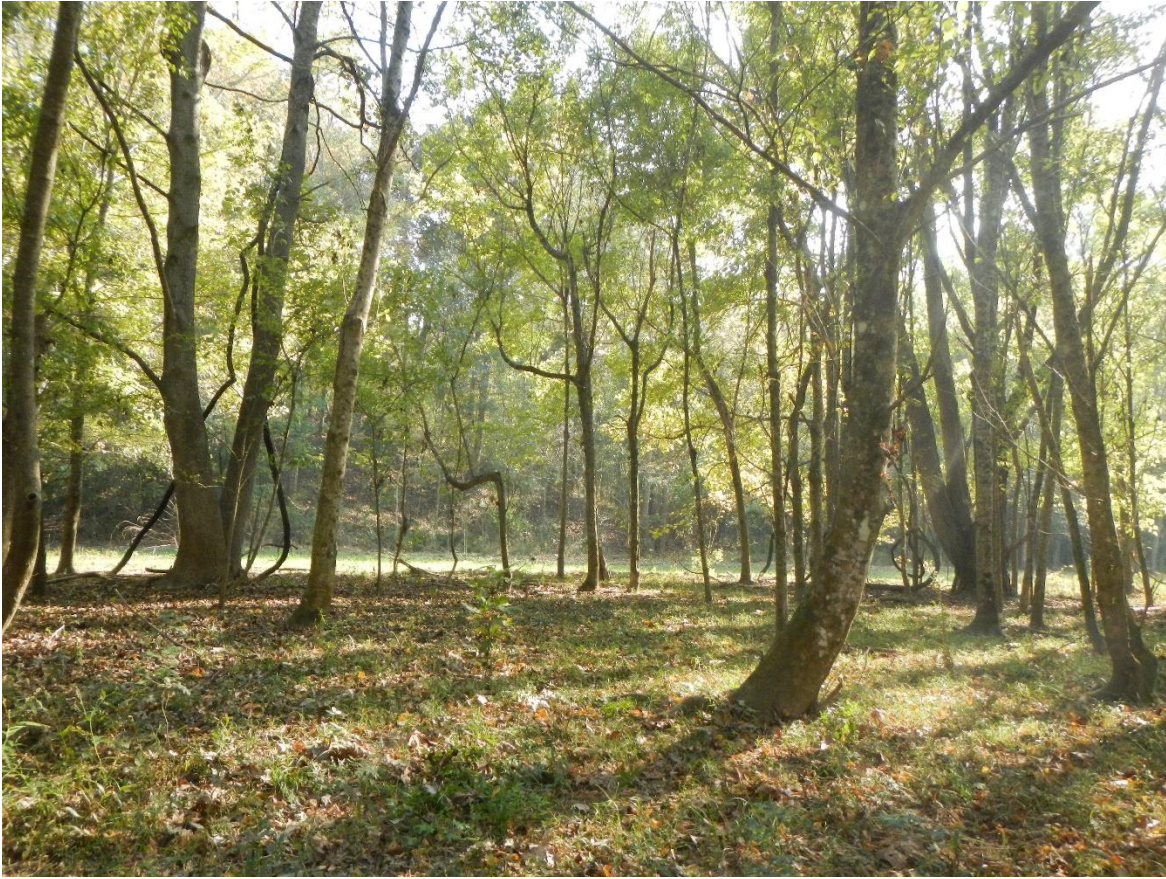
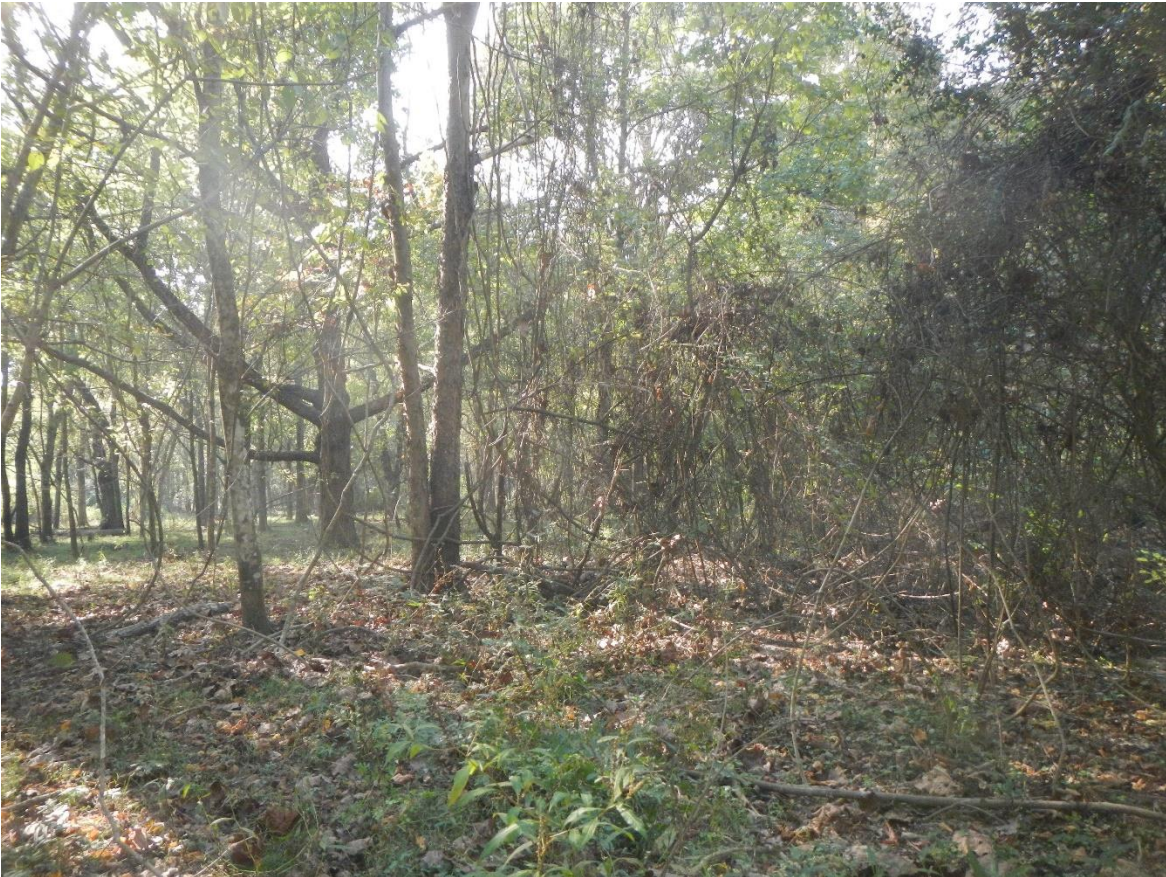
Vegetation at DP4 facing north taken 11/22/2017

Vegetation at DP4 facing east taken 11/22/2017

Vegetation at DP4 facing south taken 11/22/2017

Vegetation at DP4 facing west taken 11/22/2017

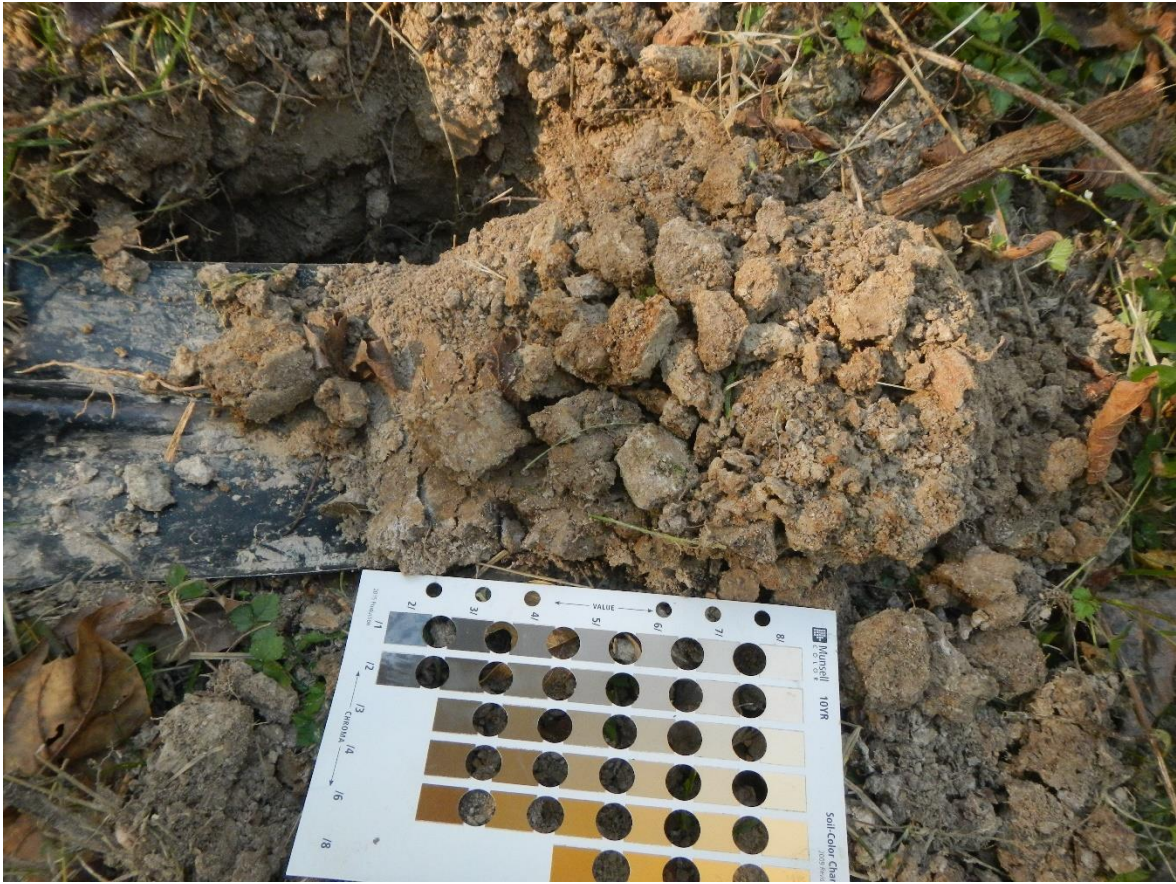
Depth (Inches)	Matrix		Redox Features				Texture	Remarks
	Color (moist)	%	Color (moist)	%	Type*	Loc**		
0-16	10YR 6/2	75	10YR 5/8	25	C	PL	Fine silt-sand

Soil profile at DP4 taken 11/22/2017
