Exhibit FF. West Feliciana Industrial Park Site Wetlands Delineation Report

Wetland Data Report

West Feliciana Industrial Park Site

West Feliciana Parish, Louisiana

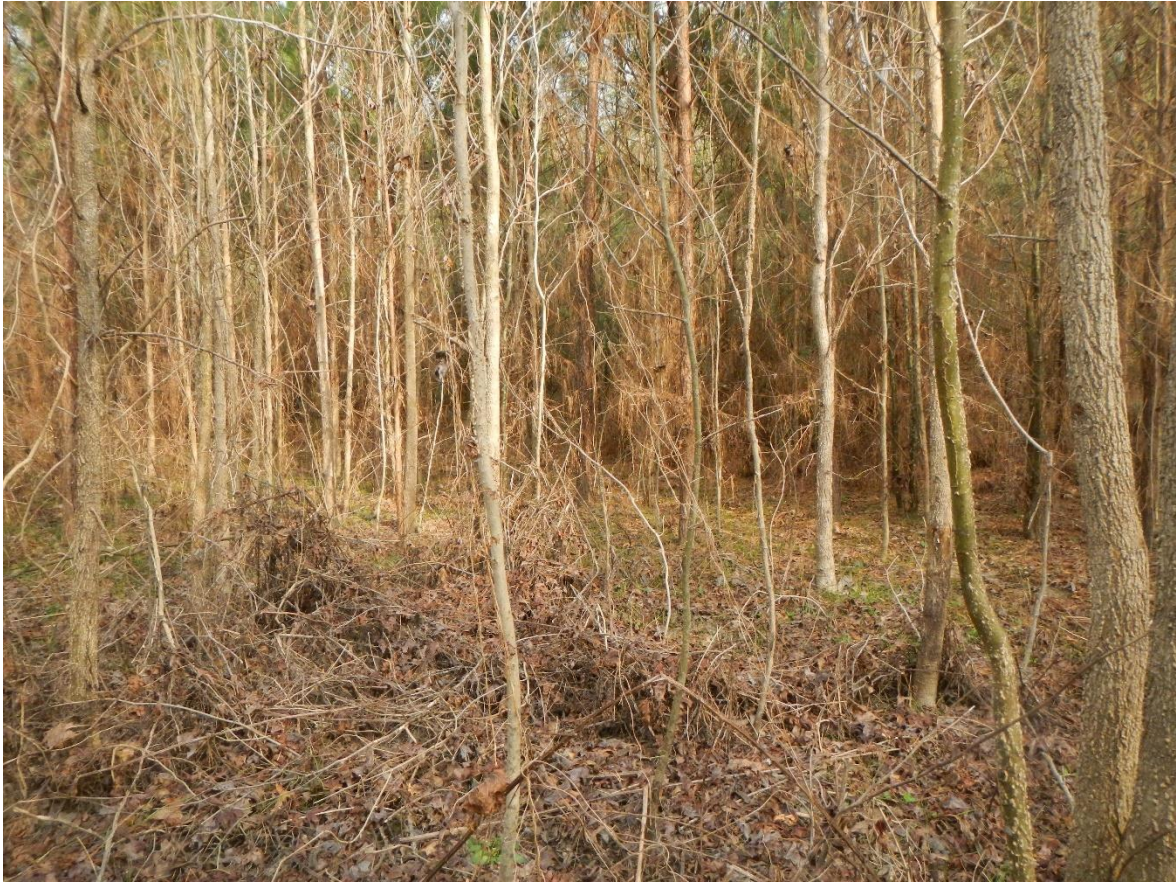
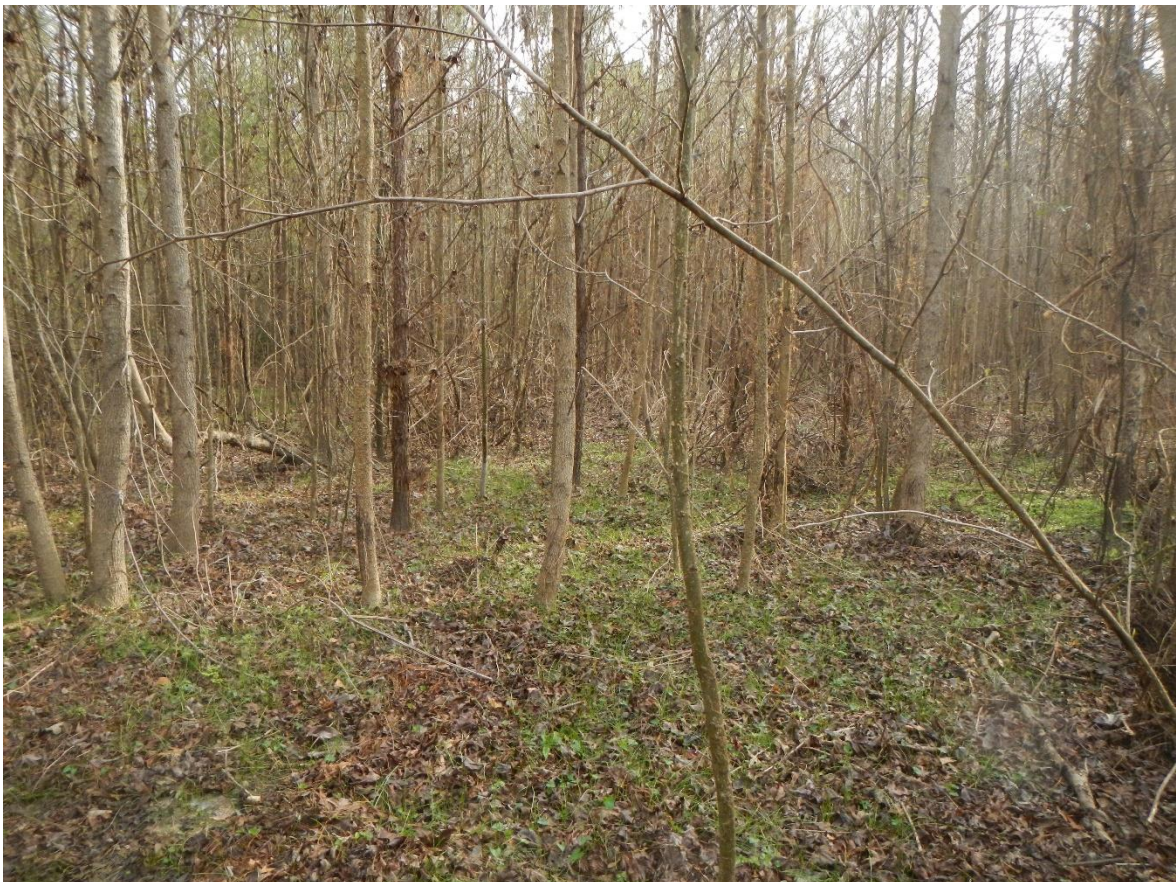
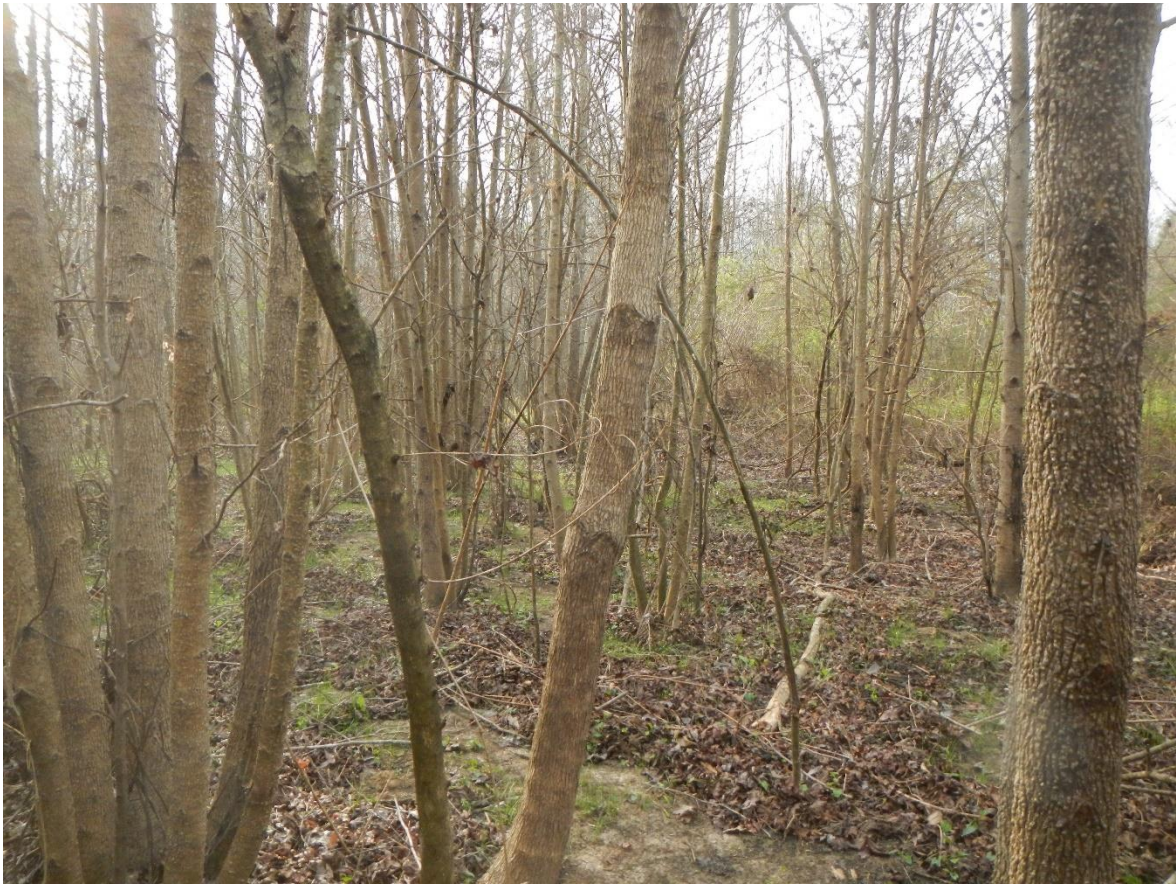
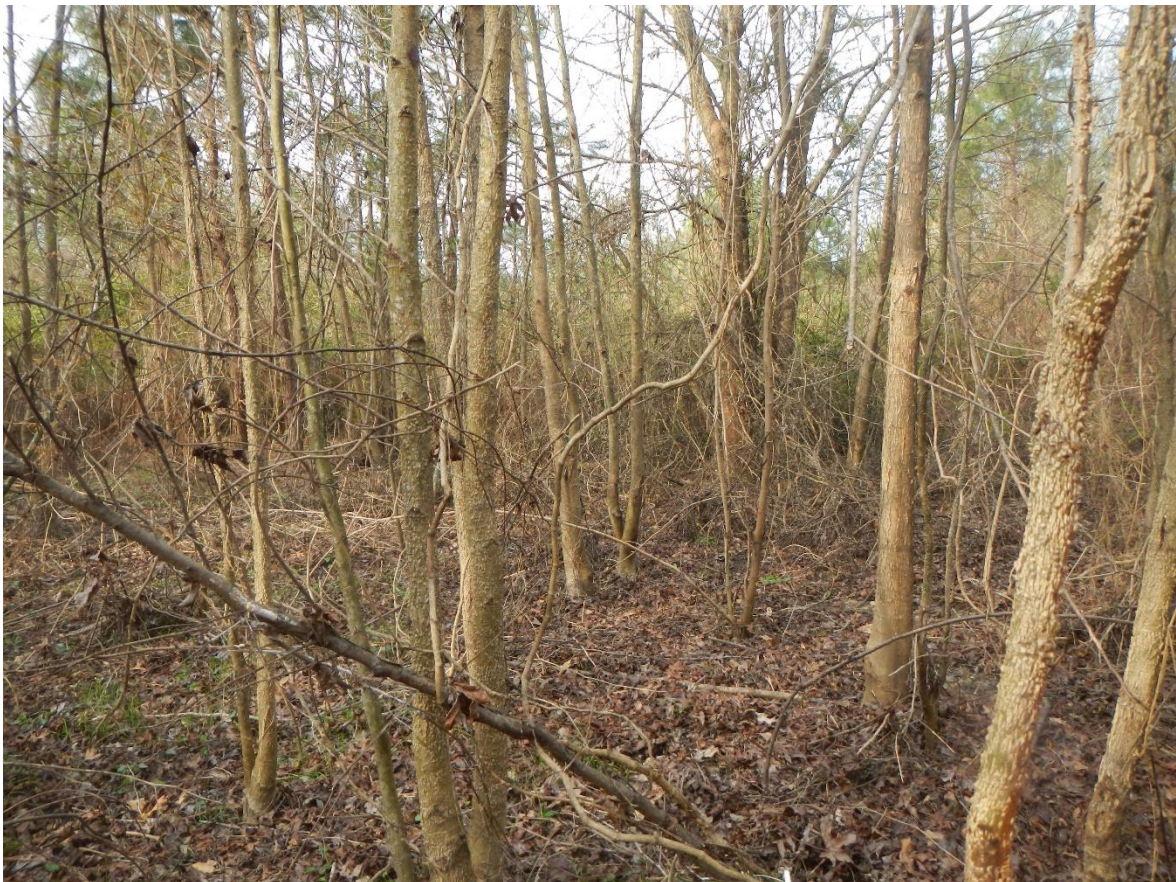
Vegetation at DP5 facing north taken 2/17/2017

Vegetation at DP5 facing east taken 2/17/2017

Vegetation at DP5 facing south taken 2/17/2017

Vegetation at DP5 facing west taken 2/17/2017

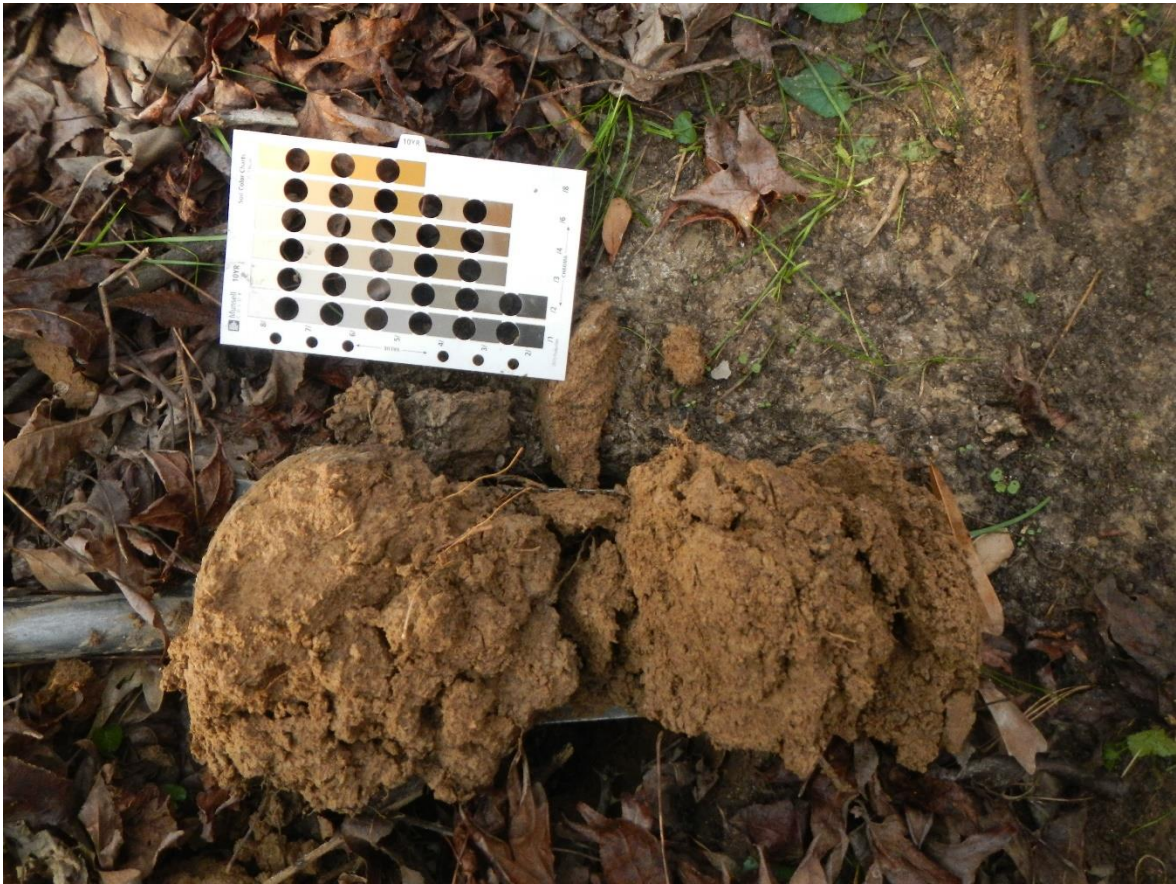
Depth (Inches)	Matrix		Redox Features				Texture	Remarks
	Color (moist)	%	Color (moist)	%	Type*	Loc**		
0-10	10YR 5/4	100					Clay Loam	
10-16	10YR 5/4	90	10YR 3/2	4	C		Clay Loam	
			10YR3/6	6	C

Soil profile at DP5 taken 2/17/2017

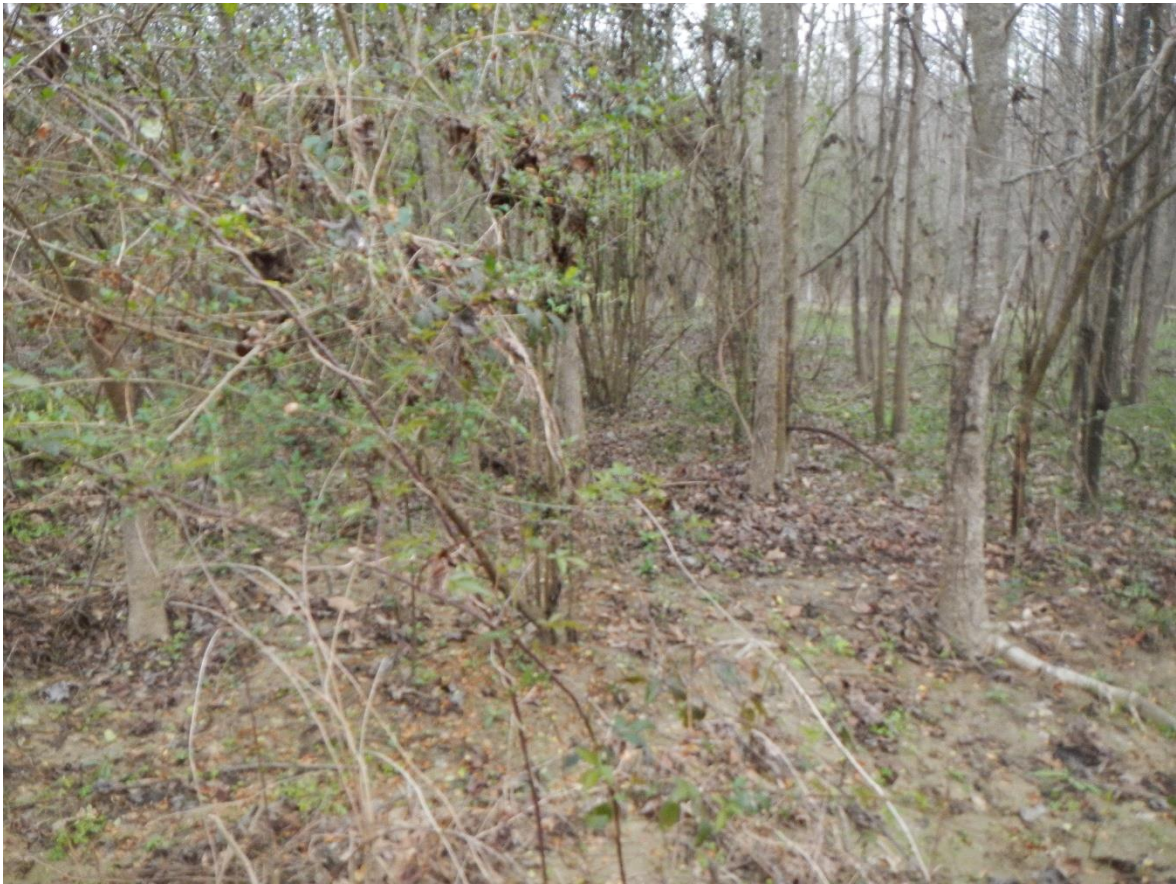
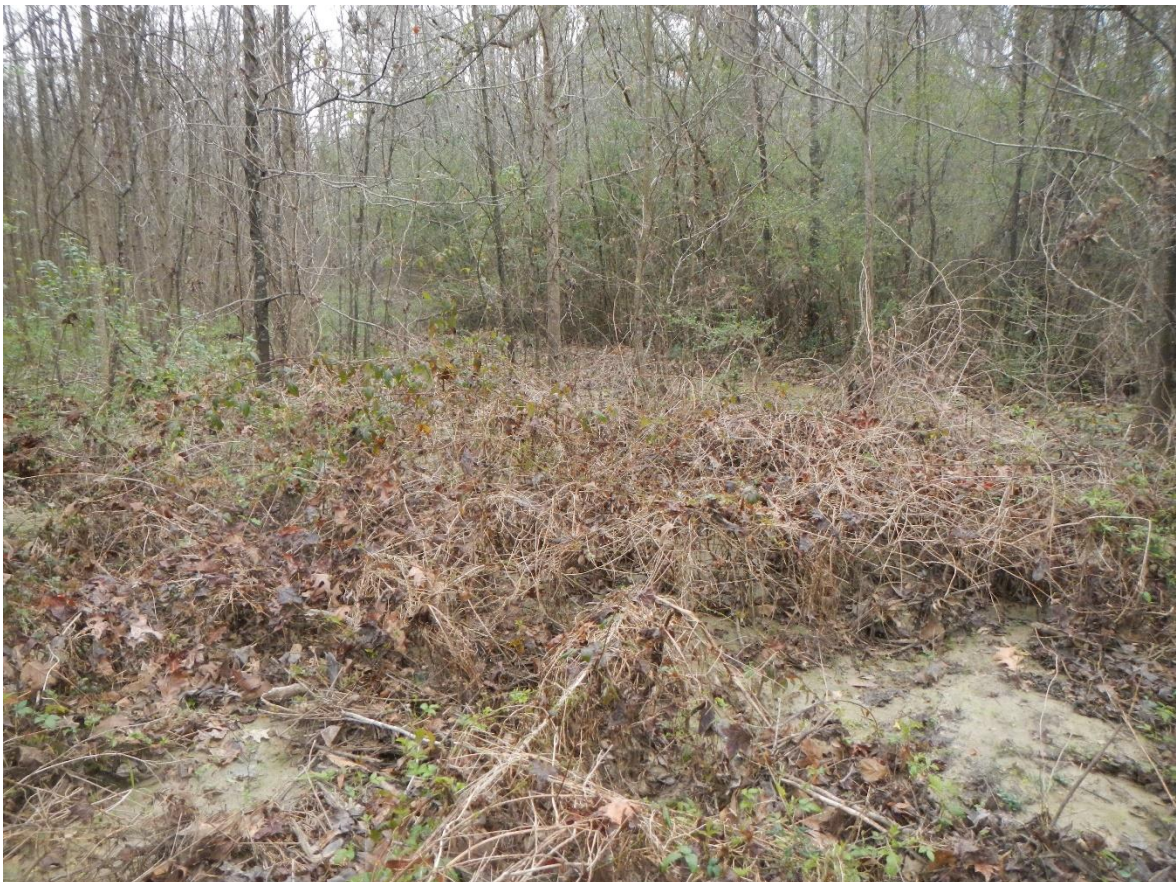
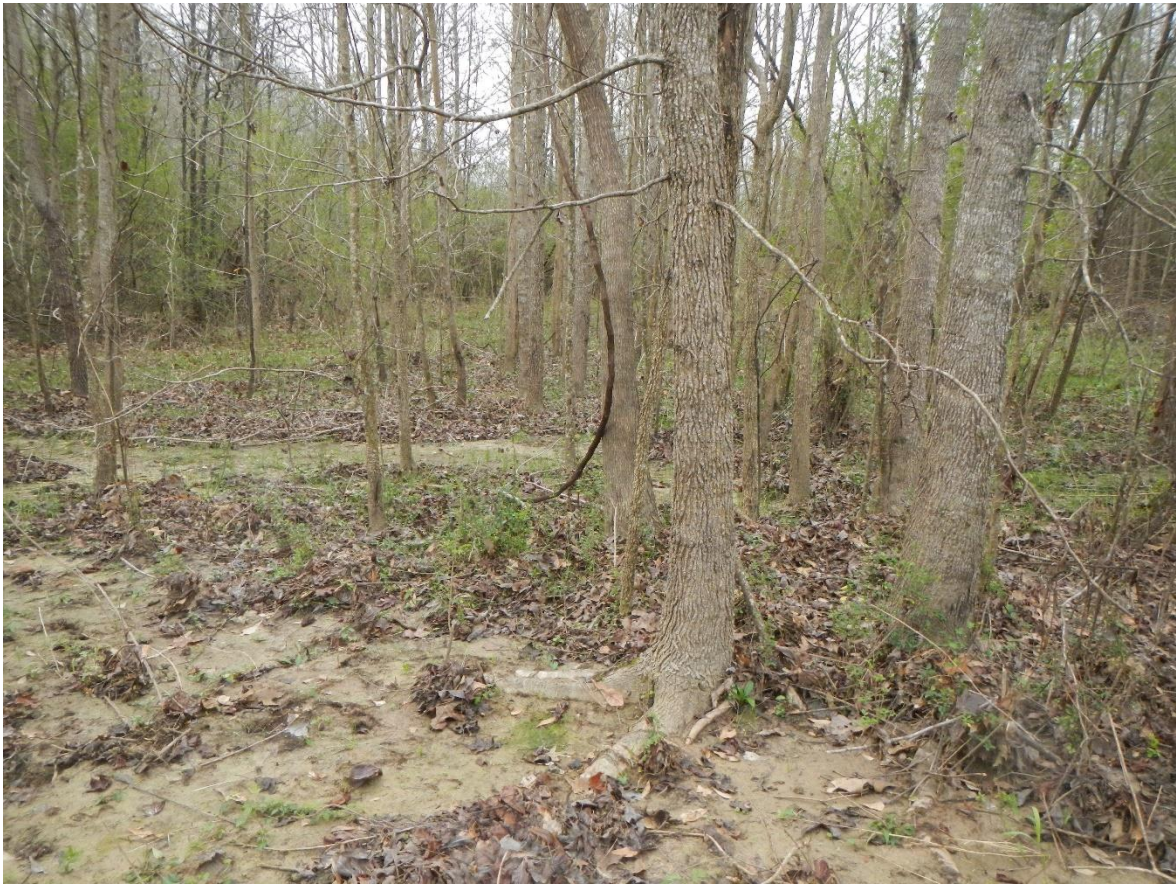
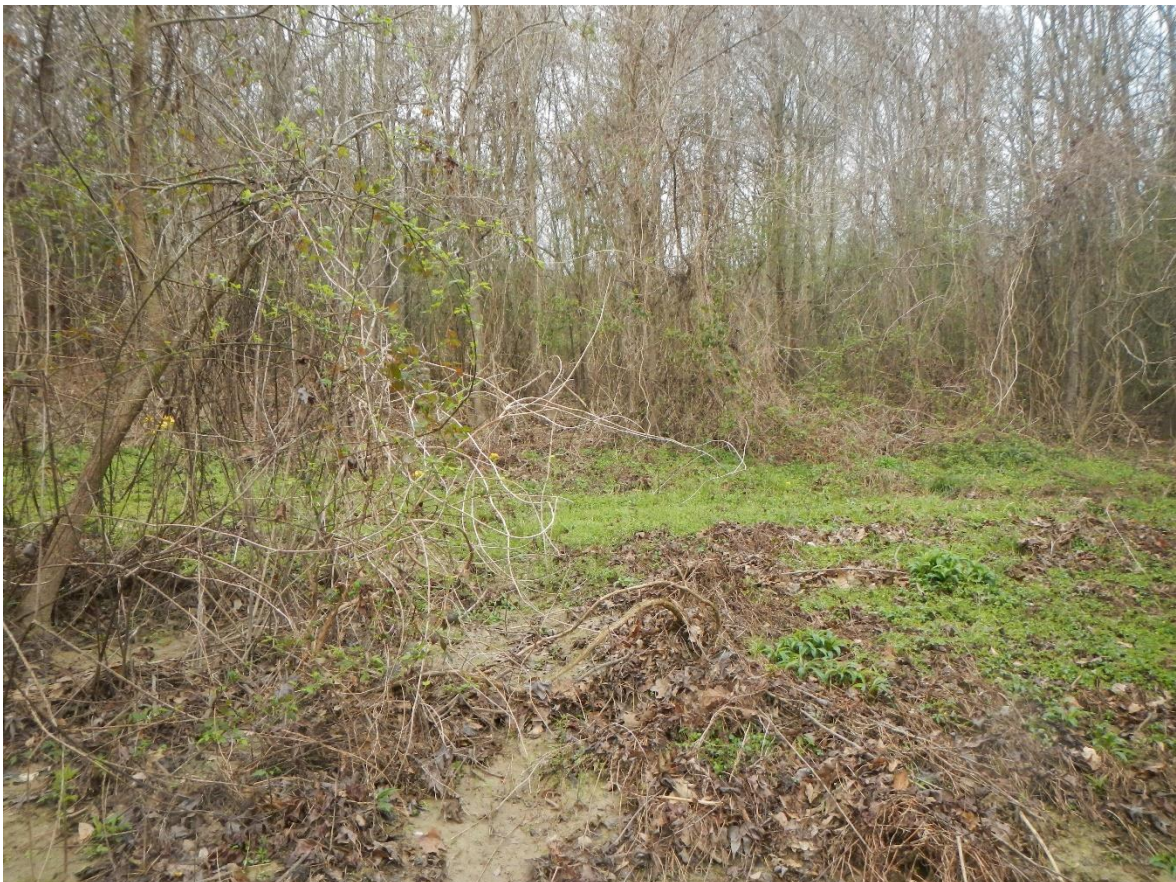
Vegetation at DP6 facing north taken 2/17/2017

Vegetation at DP6 facing east taken 2/17/2017

Vegetation at DP6 facing south taken 2/17/2017

Vegetation at DP6 facing west taken 2/17/2017

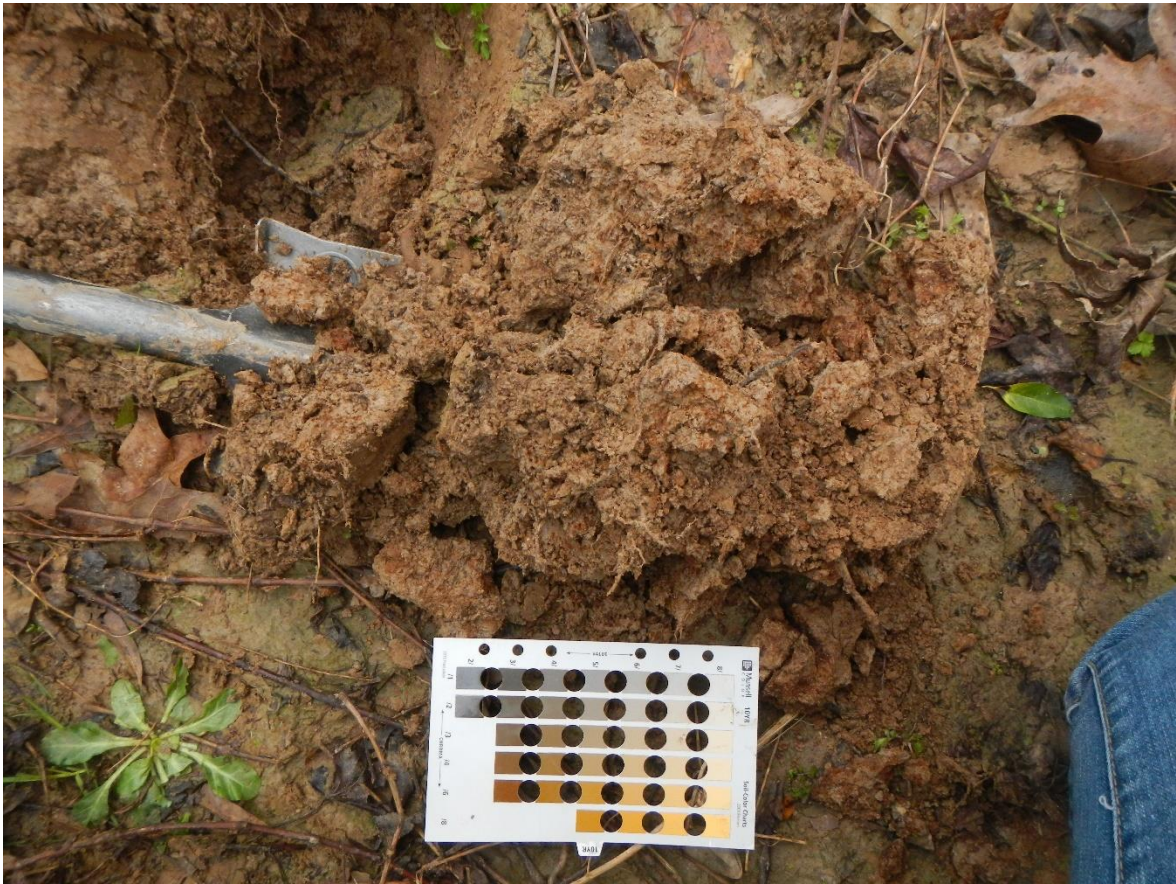
Depth (Inches)	Matrix		Redox Features				Texture	Remarks
	Color (moist)	%	Color (moist)	%	Type*	Loc**		
0-16	10YR 5/2	70	10YR 3/6	30	C	M	Clay Loam

Soil profile at DP6 taken 2/17/2017

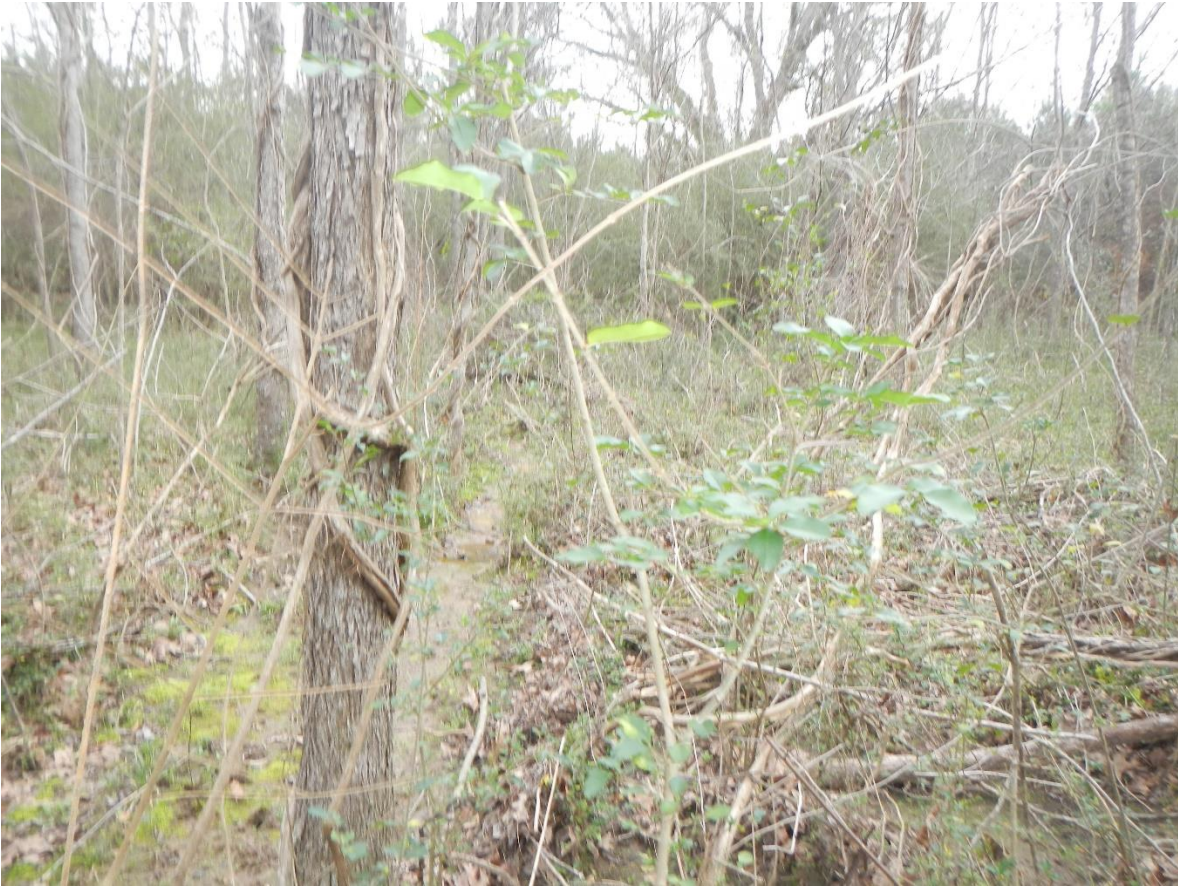
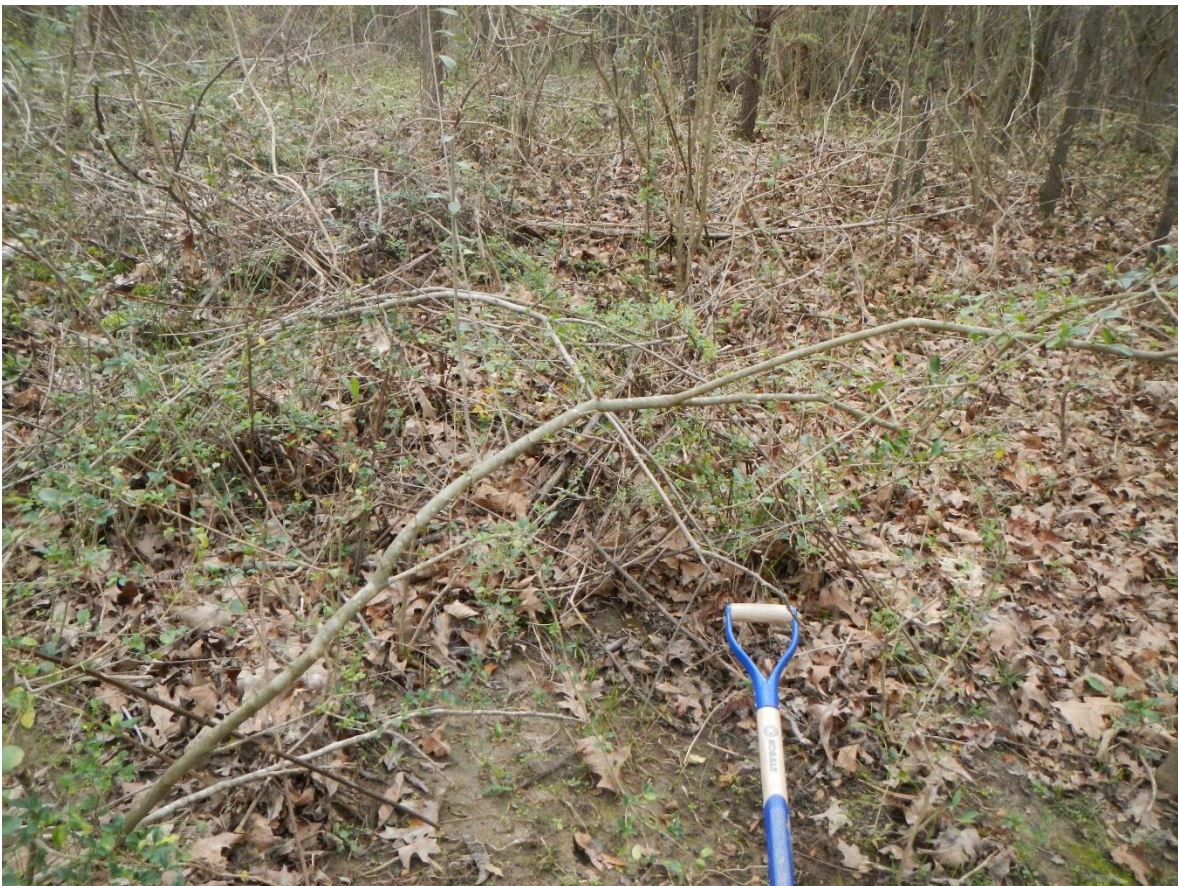
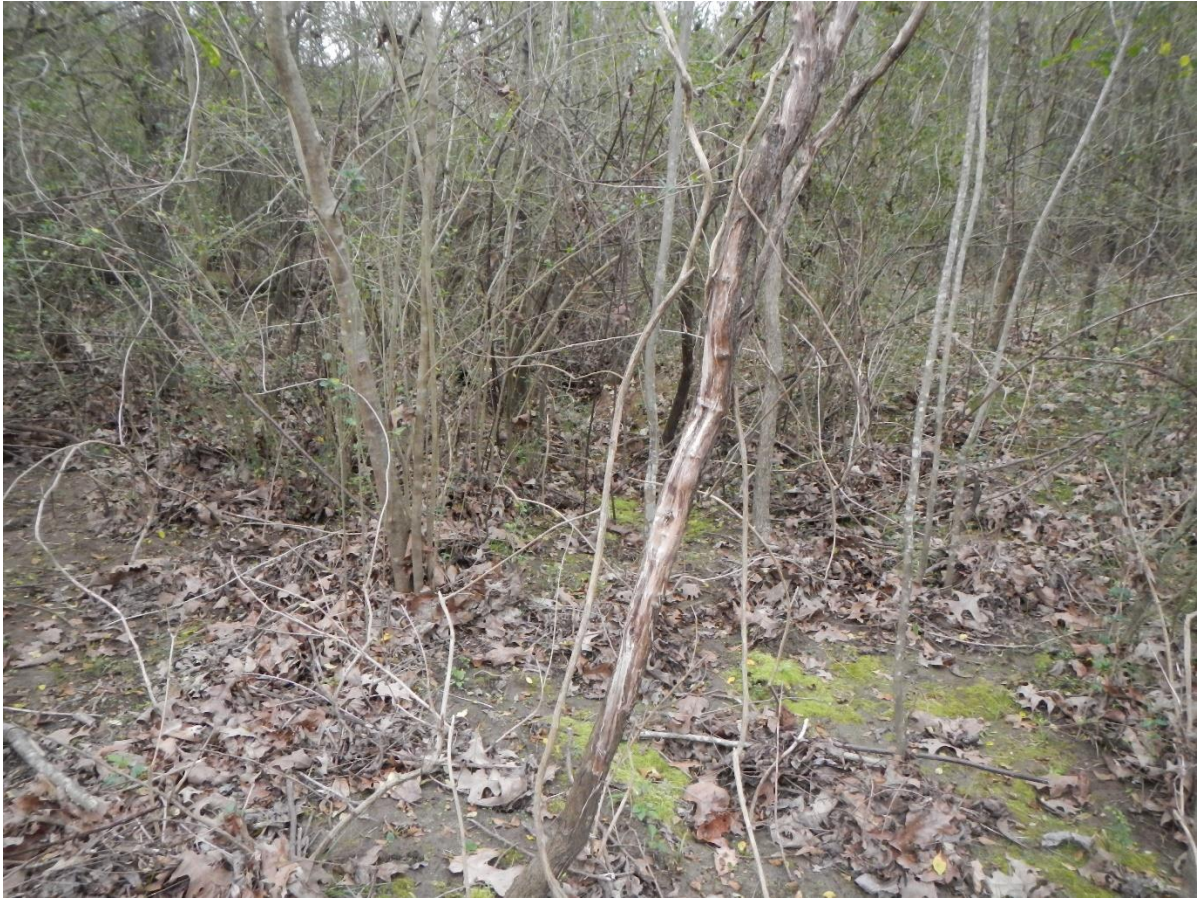
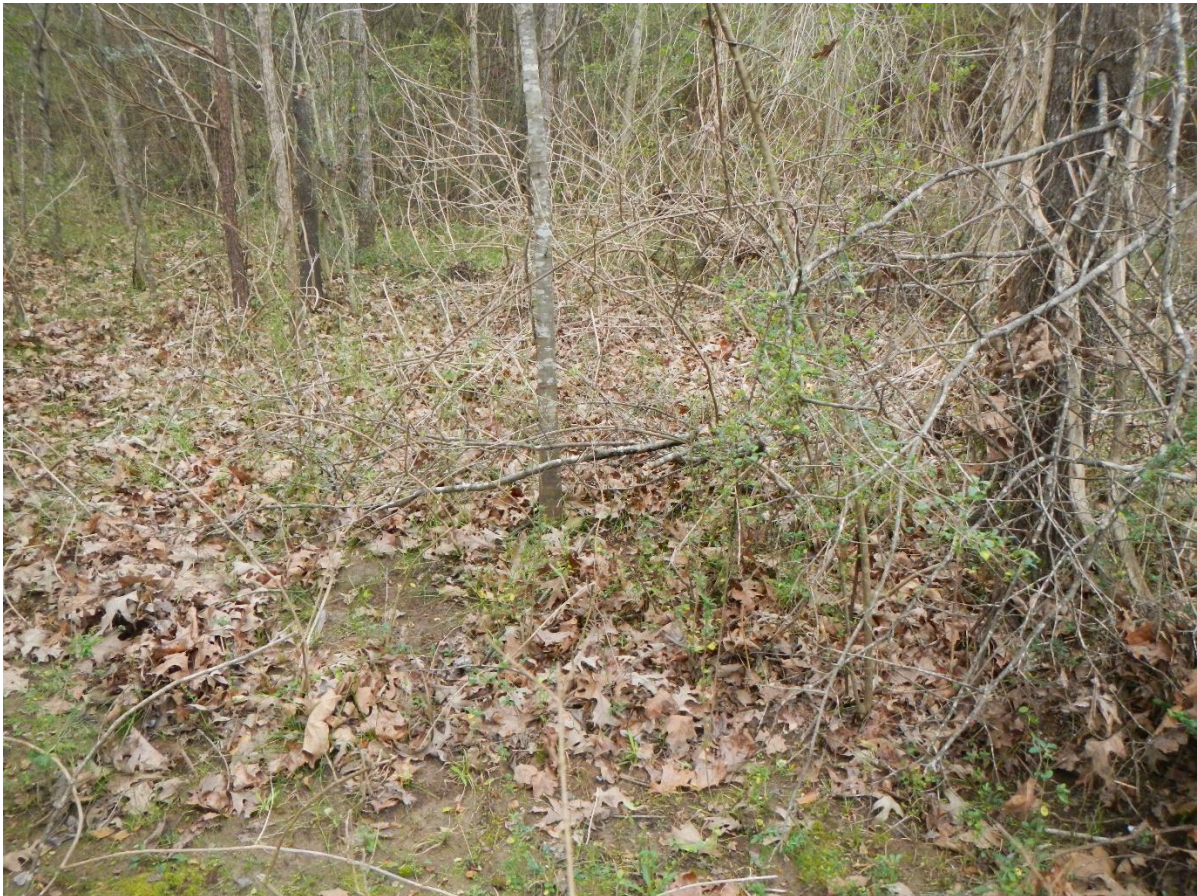
Vegetation at DP7 facing north taken 2/20/2017

Vegetation at DP7 facing east taken 2/20/2017

Vegetation at DP7 facing south taken 2/20/2017

Vegetation at DP7 facing west taken 2/20/2017

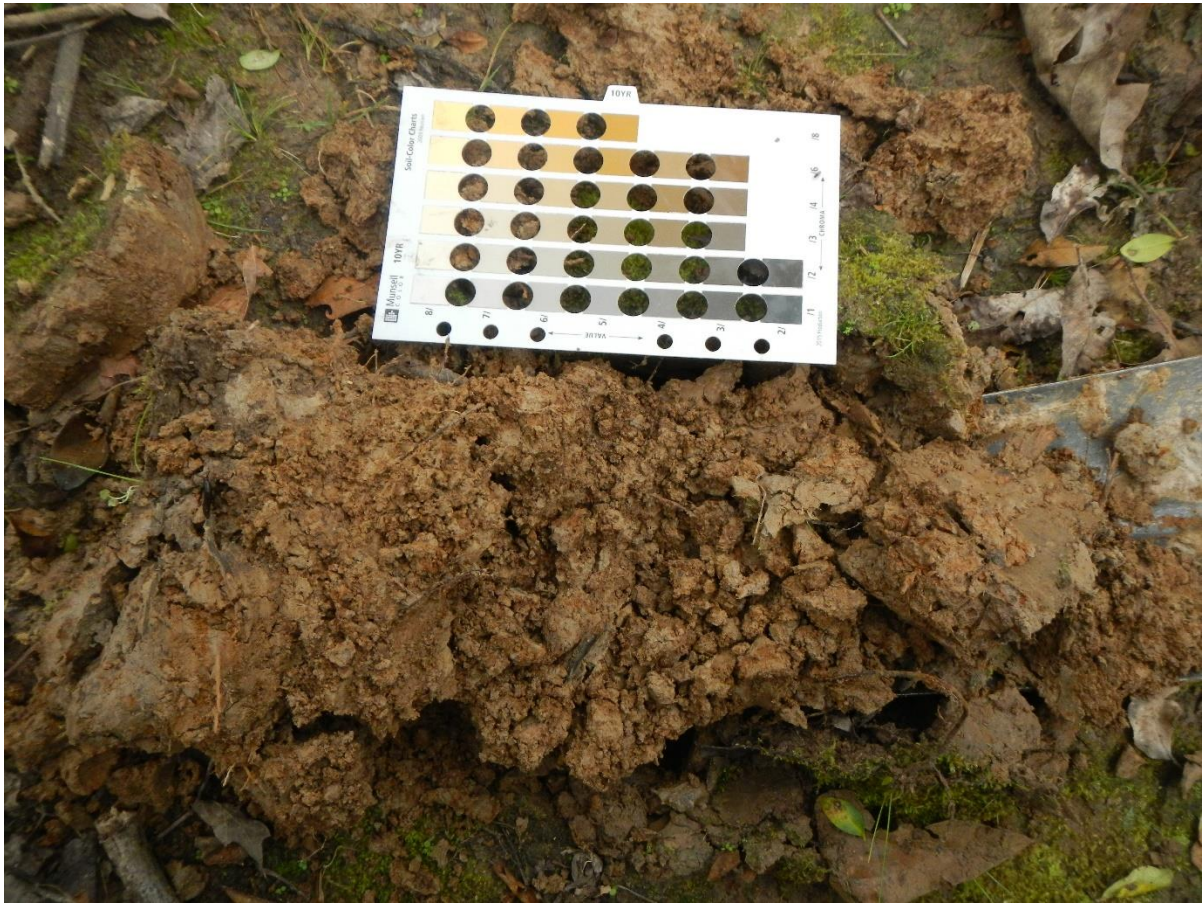
Depth (Inches)	Matrix		Redox Features				Texture	Remarks
	Color (moist)	%	Color (moist)	%	Type*	Loc**		
0-10	10YR 5/2	60	10YR 3/6	20	C	PL		
			10YR 3/4	20	C	M		
10-16	10YR 5/2	70	10YR 3/6	30	C	M

Soil profile at DP7 taken 2/20/2017

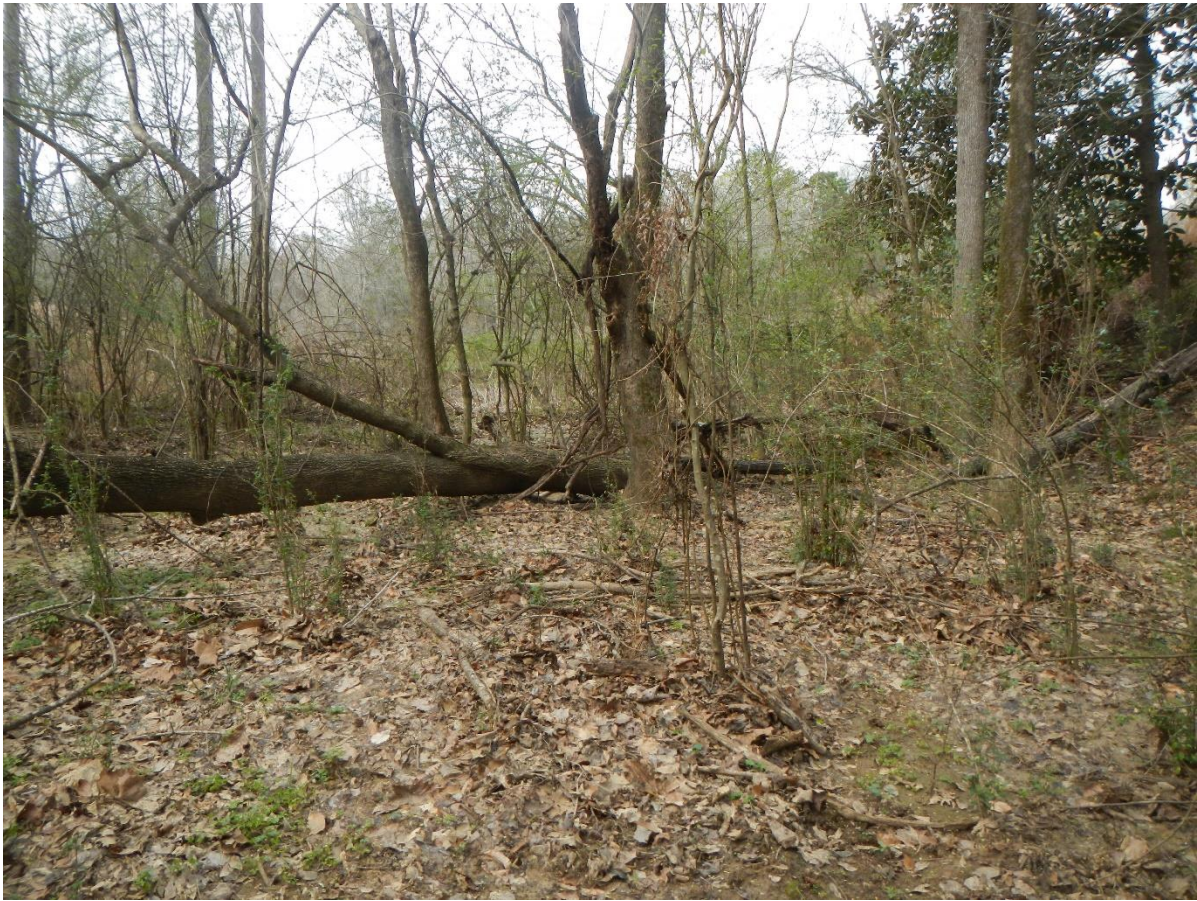
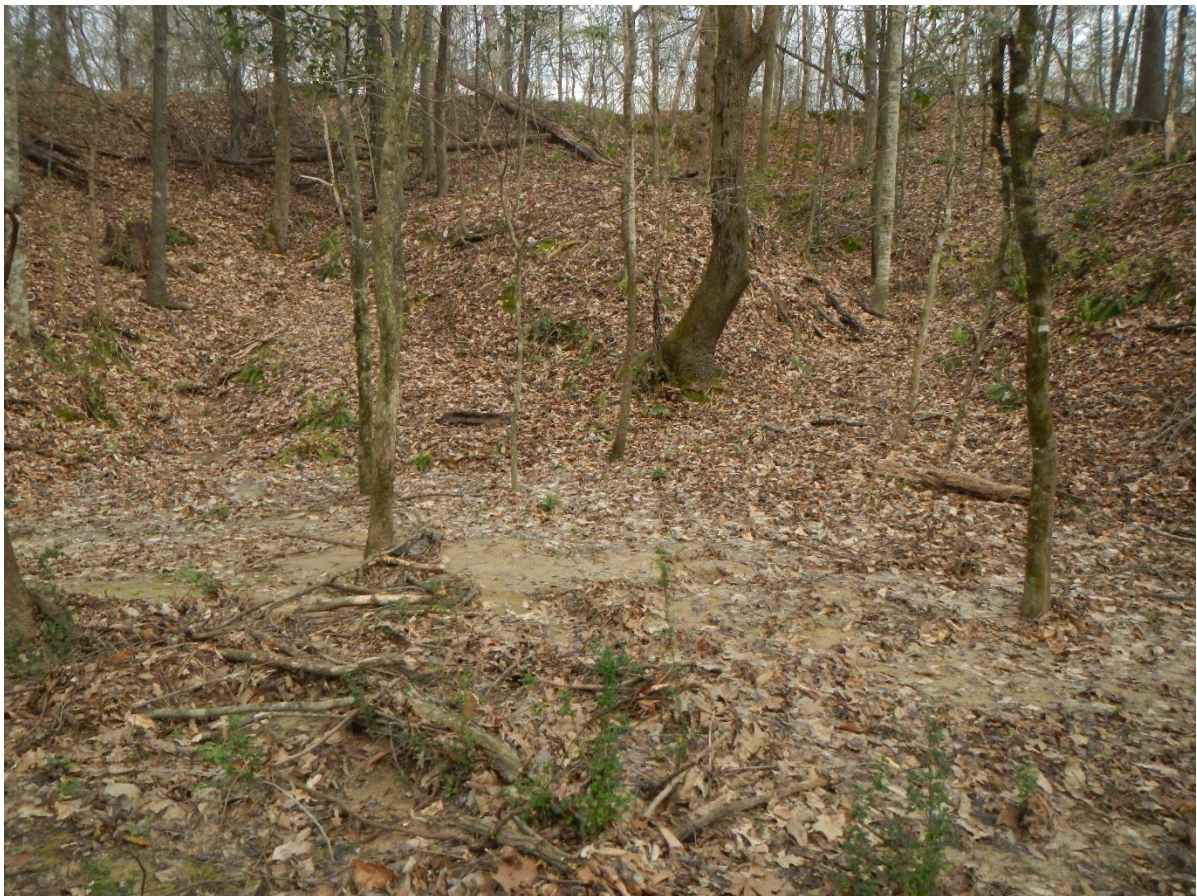
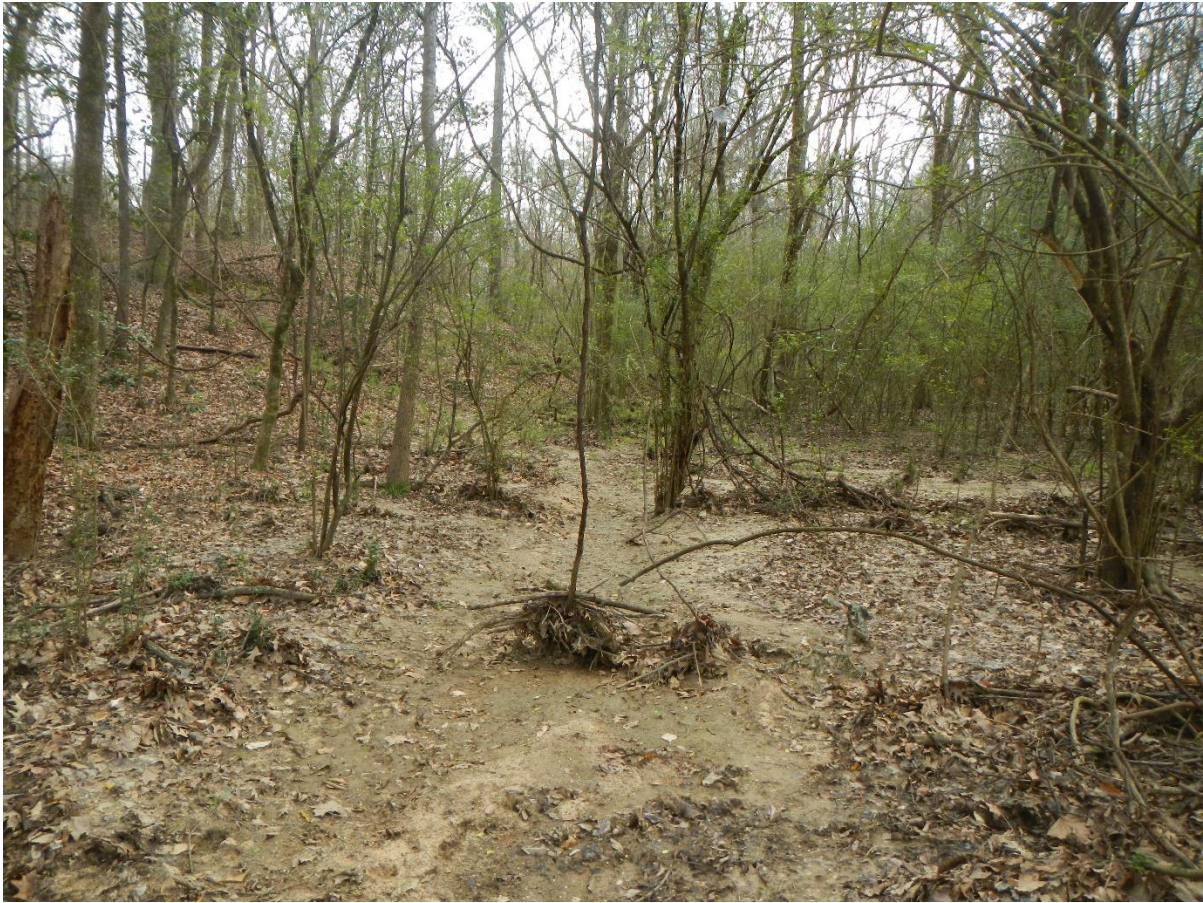
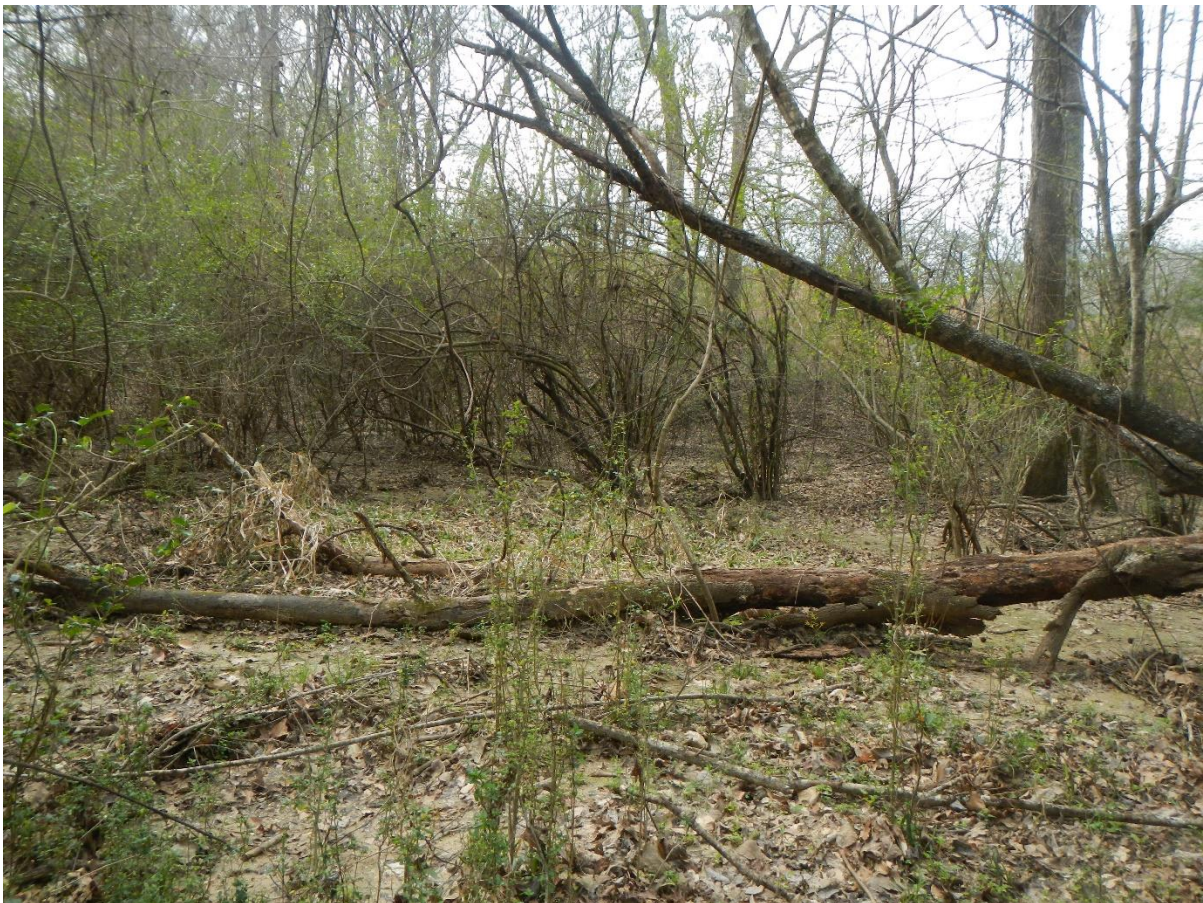
Vegetation at DP8 facing north taken 2/20/2017

Vegetation at DP8 facing east taken 2/20/2017

Vegetation at DP8 facing south taken 2/20/2017

Vegetation at DP8 facing west taken 2/20/2017

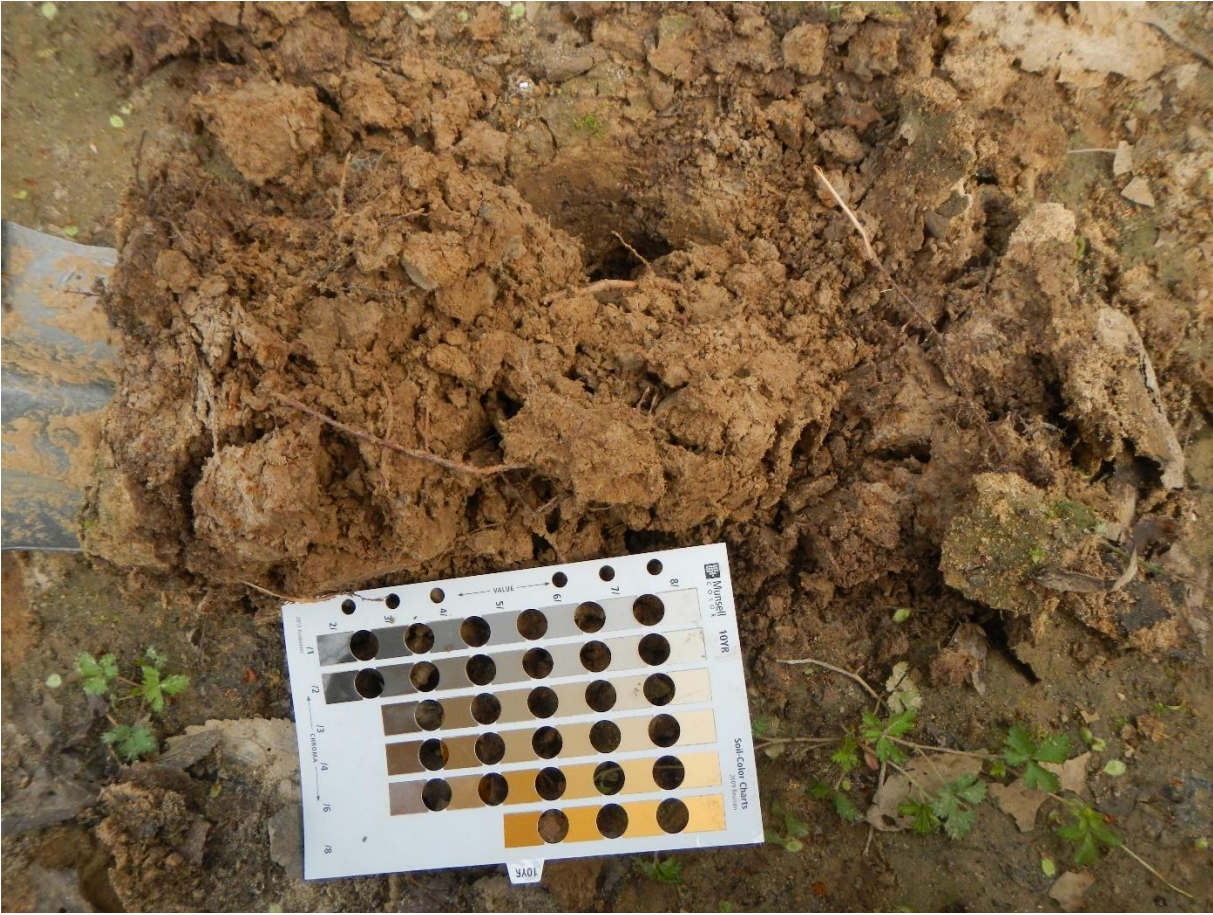
Depth (Inches)	Matrix		Redox Features				Texture	Remarks
	Color (moist)	%	Color (moist)	%	Type*	Loc**		
0-6	10YR 5/2	60	10YR4/4	40	C	M	Silt Clay

Soil profile at DP8 taken 2/20/2017

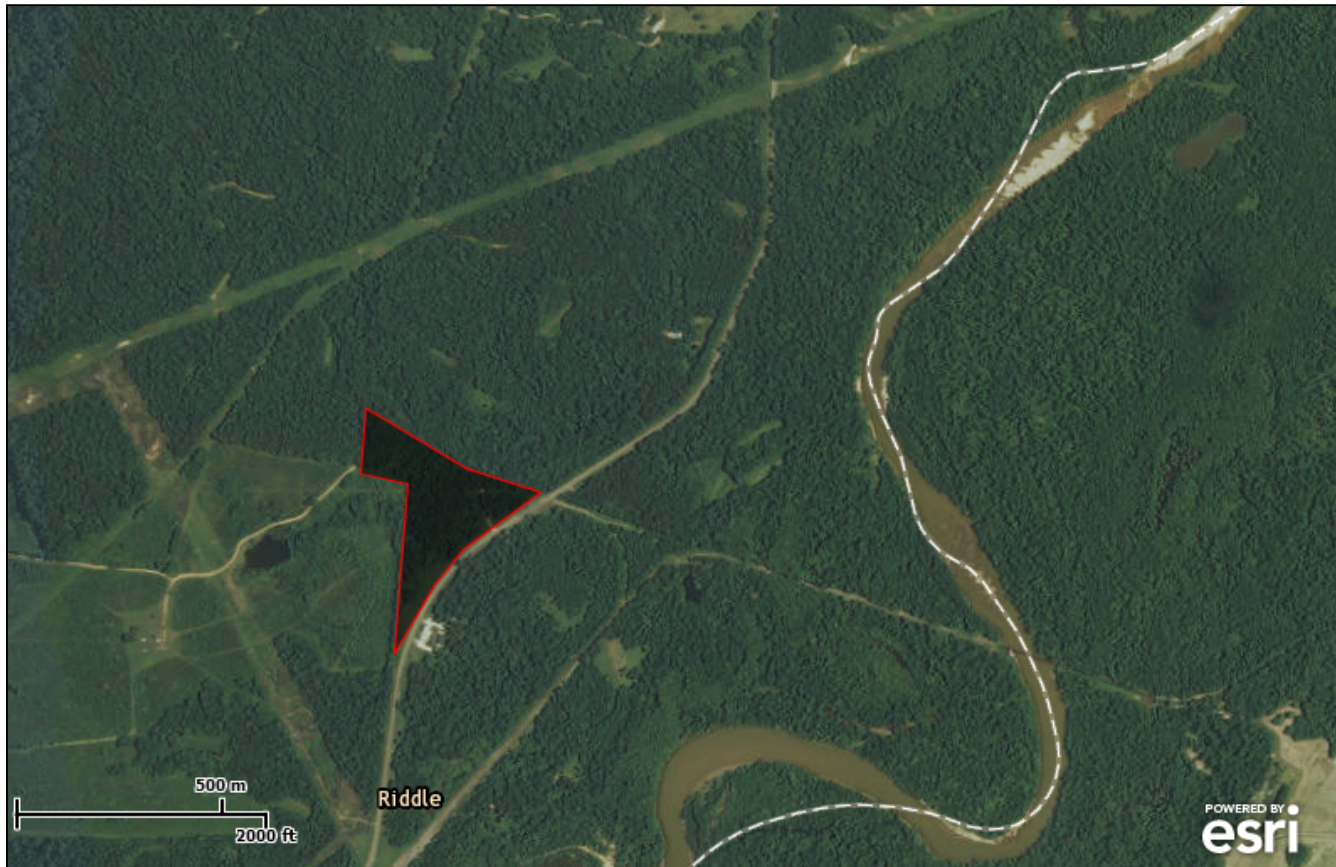
21-Acre Tract

Wetlands

-   Freshwater Emergent
-   Freshwater Forested/Shrub
-   Estuarine and Marine Deepwater
-   Estuarine and Marine
-   Freshwater Pond
-   Lake
-   Riverine
-   Other
