Exhibit FF. West Feliciana Industrial Park Site Wetlands Delineation Report

Wetland Data Report

West Feliciana Industrial Park Site

West Feliciana Parish, Louisiana

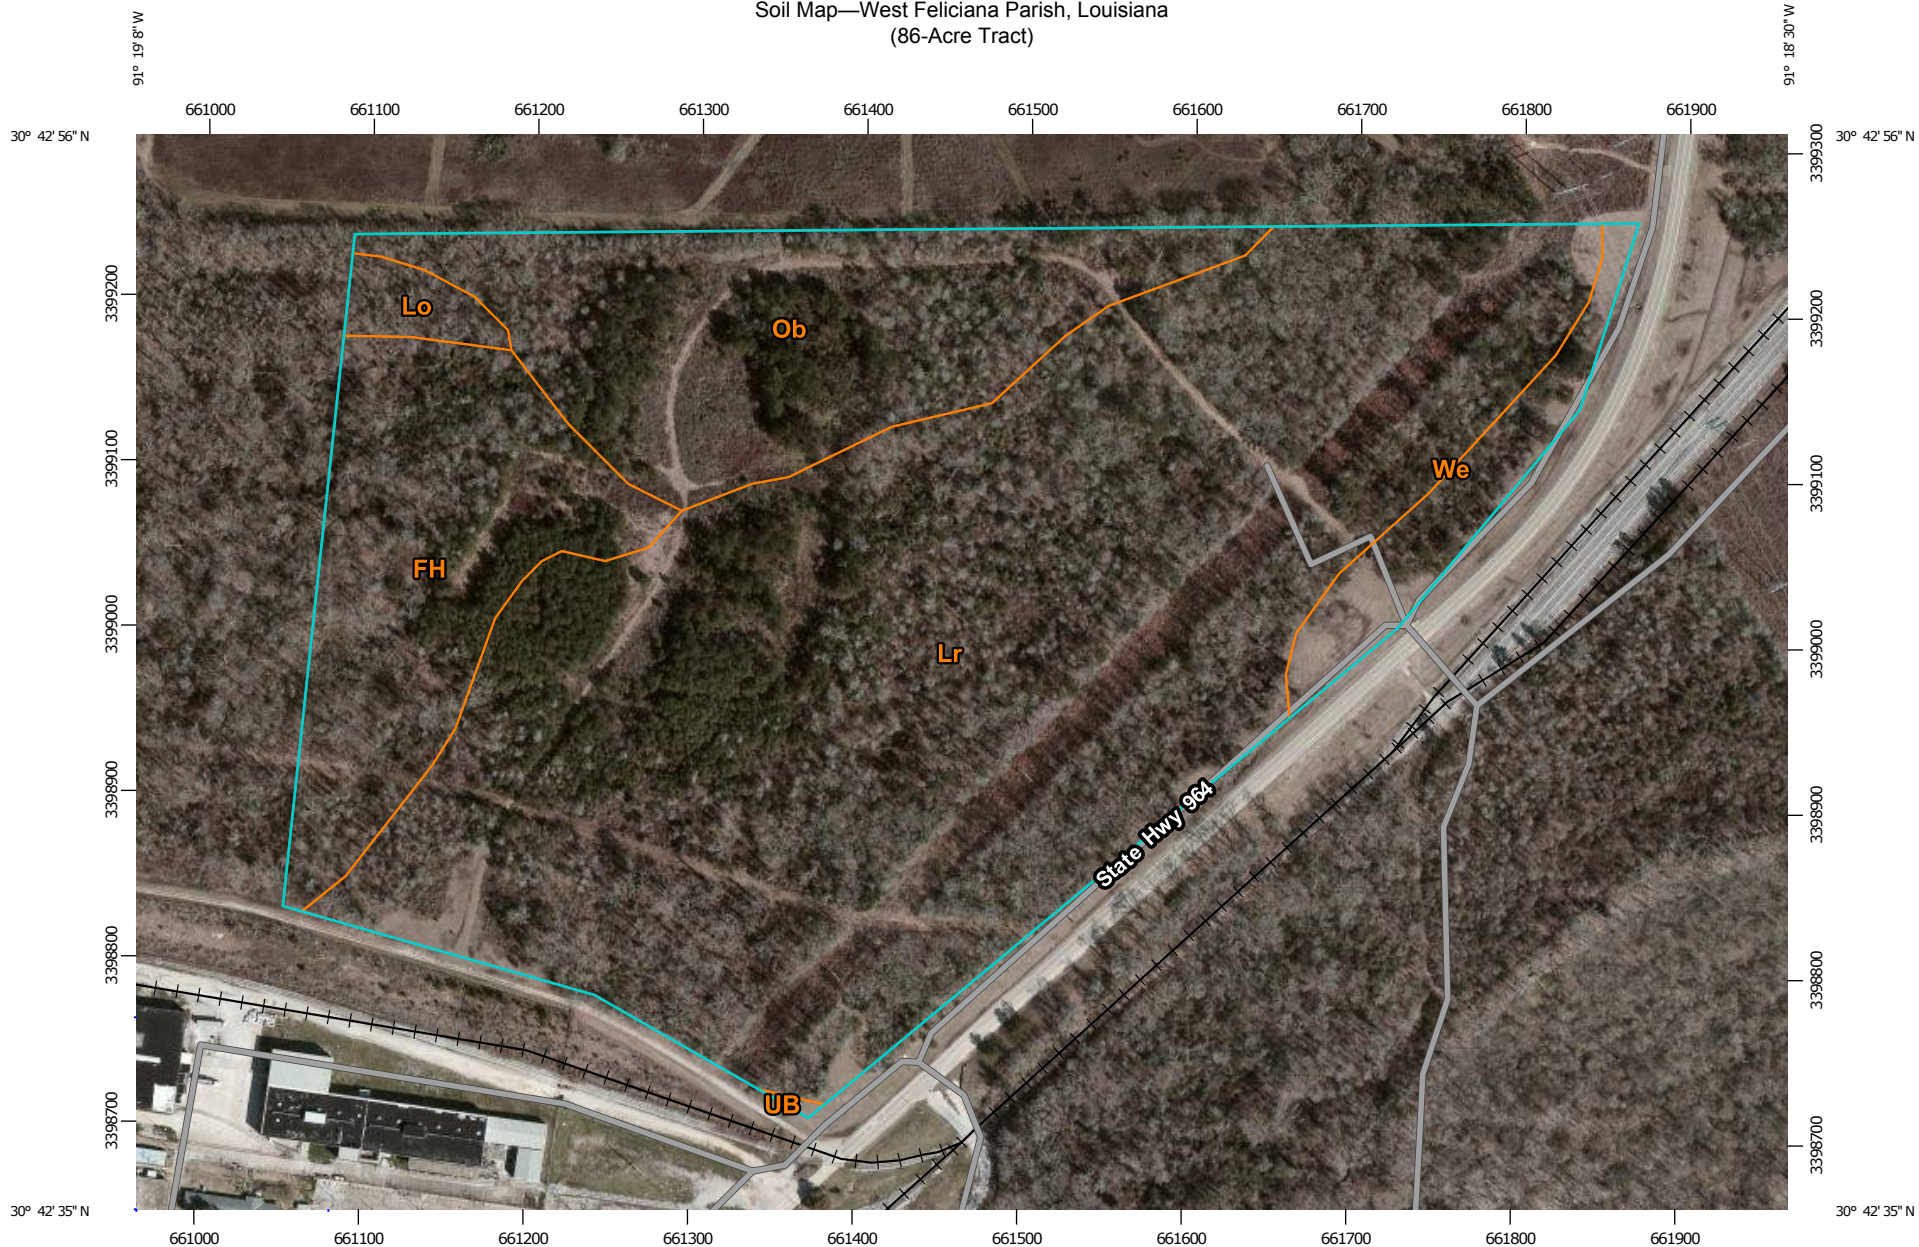
Soil Map—West Feliciana Parish, Louisiana
(86-Acre Tract)

Map Scale: 1:4,590 if printed on A landscape (11" x 8.5") sheet.

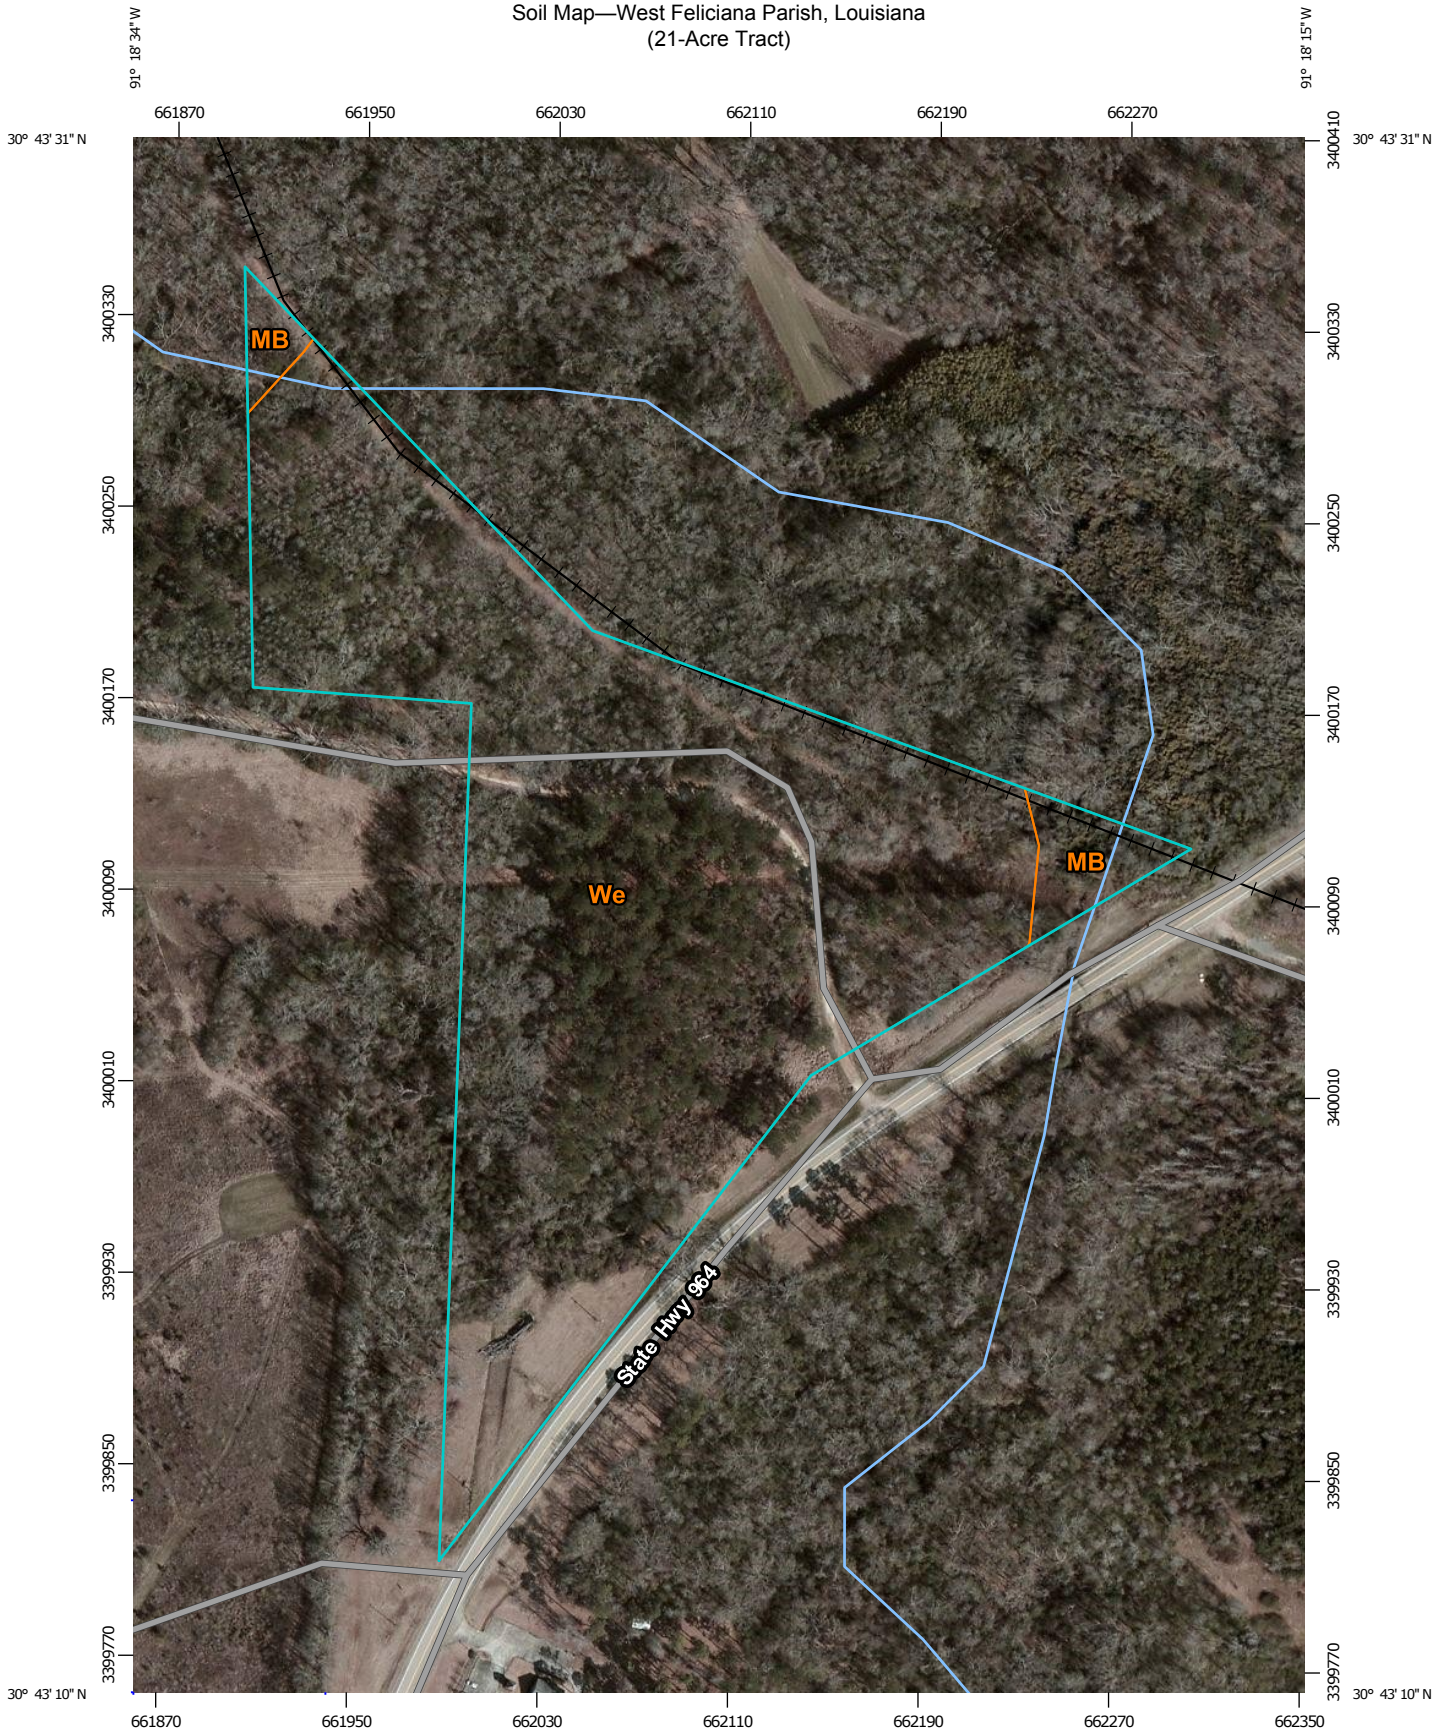
Soil Map—West Feliciana Parish, Louisiana
(21-Acre Tract)

Map Scale: 1:3,170 if printed on A portrait (8.5" x 11") sheet.

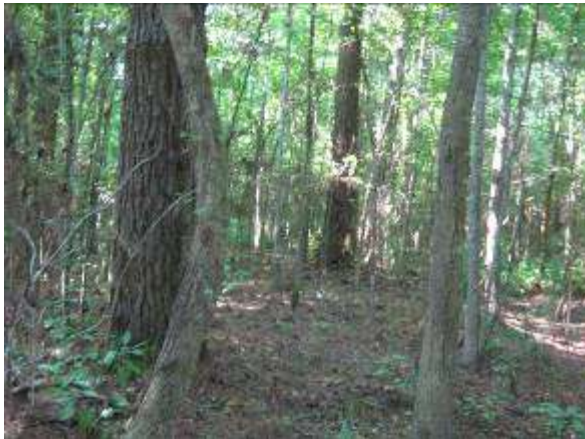
Photo 1 Typical view of mixed pine-hardwood forest.

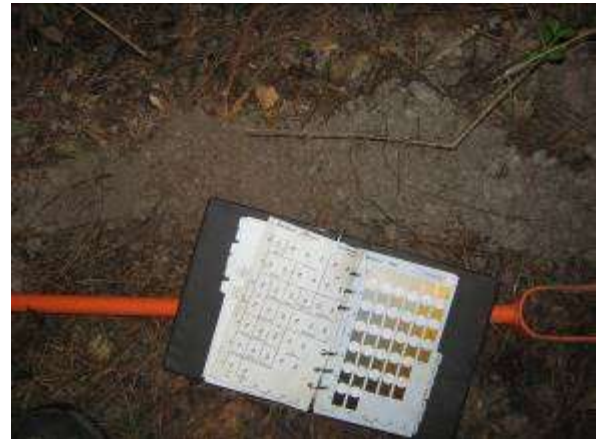
Photo 2 Soil profile from Sampling Point 1.

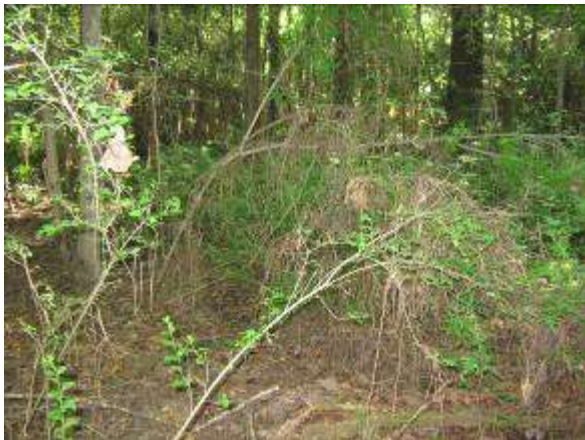
Photo 3 Typical view of understory in wooded area.

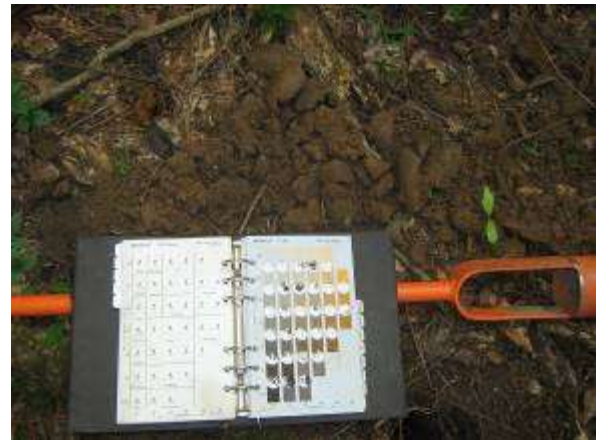
Photo 4 Soil profile from Sampling Point 2.

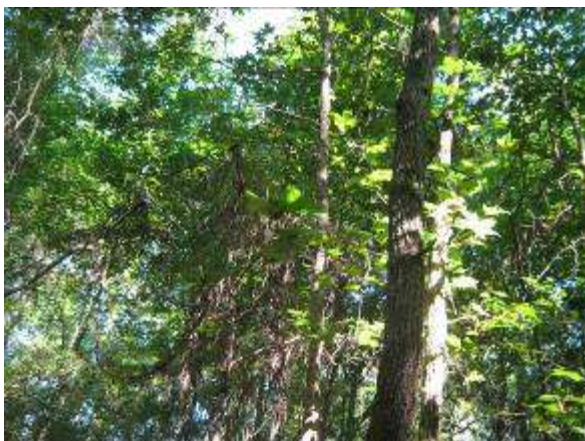
Photo 5 Typical view of hardwood dominant area.

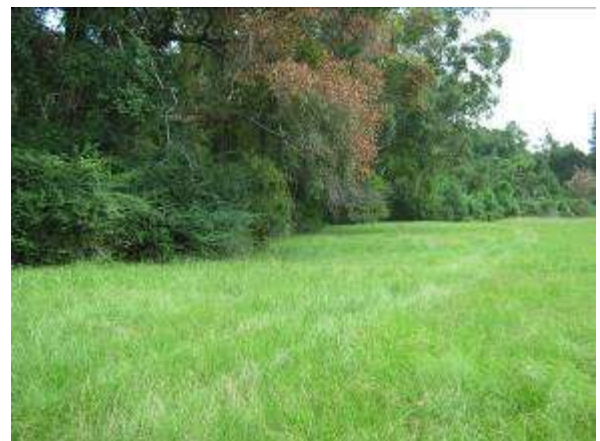
Photo 6 View of landscaped area along Highway 964.

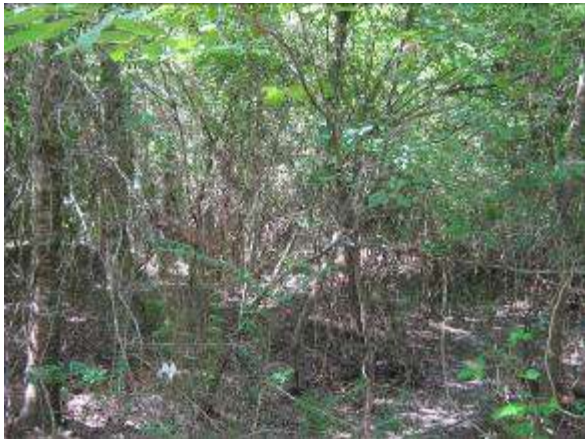
Photo 7 Typical view of forested area.

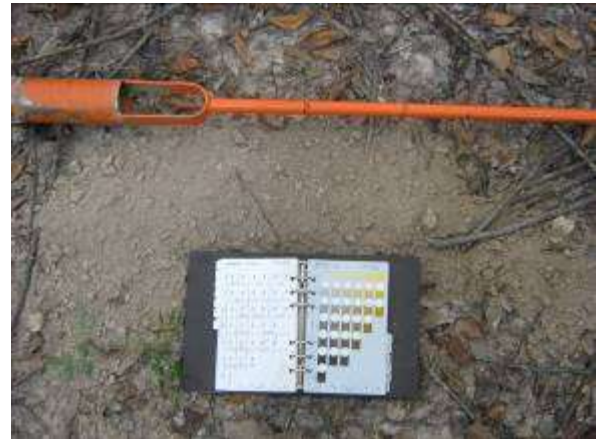
Photo 8 Soil profile from Sampling Point 3.

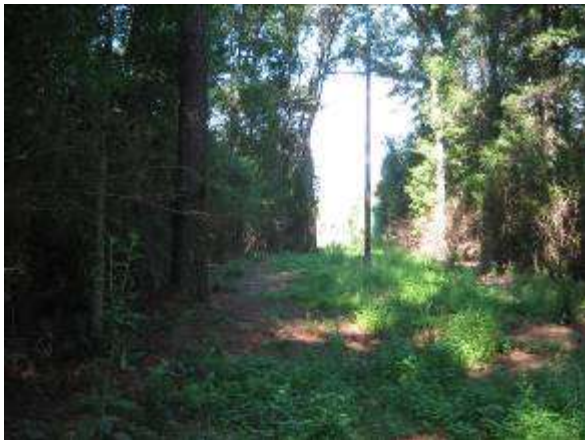
Photo 9 View of maintained transmission right-of-way.
