### WETLANDS AND OTHER WATERS FINDINGS REPORT

### BEE BAYOU HIGHWAY 583 AND I-20 RICHLAND PARISH, LOUISIANA

May 2013

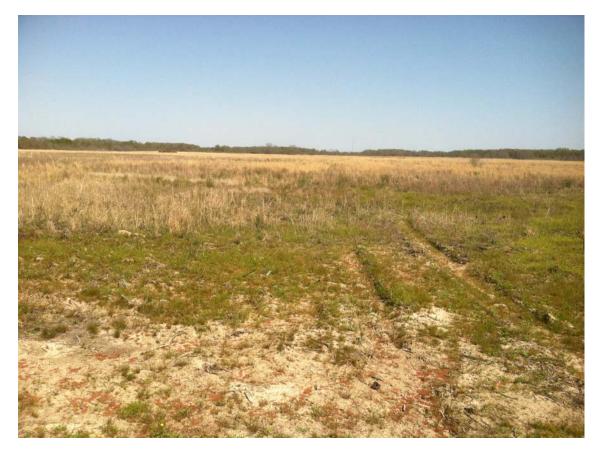
EXHIBIT 2. SUBJECT PROPERTY, FALLOW FIELDS

The property has been actively farmed since at least 1987 according to USDA Soil Conservation Service records; however the fields were not planted at the time of the site visit (Exhibits 2) and along the west and northern fringes the site was planted in trees or has regrown naturally as part of a CRP program (Exhibit 3).

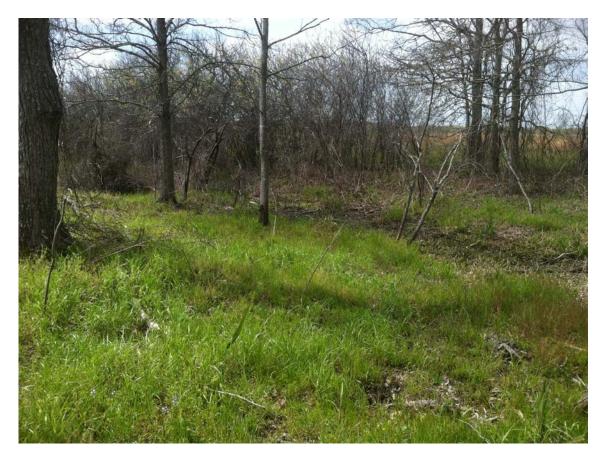
EXHIBIT 4. SUBJECT PROPERTY, WETLAND SWALE

There was a wetland swale that ran north and south through the center of the tract. This swale was dry at the time of the site visit. There were scrub/shrub wetlands along the this wetland swale with a few scattered mature, water oak, sugarberry, honey locust and cherry bark oak (*Quercus pagoda*) trees.

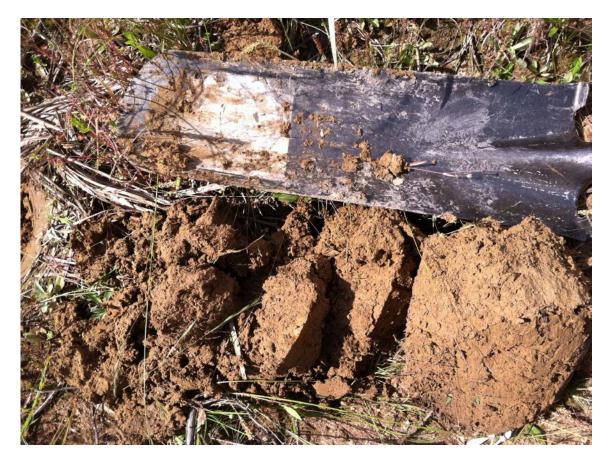
EXHIBIT 5. SUBJECT PROPERTY, TYPICAL UPLAND SOIL

Soil pits were completed in areas within the fields that showed recurring "wet" signatures on historical color infrared and other aerial photography, as well in areas that were suspect of being wet as determined during the site visit. Upland soils were typically dark brownish gray and yellowish brown; some were gleyed although most were not (Exhibit 5). Wetland soils were

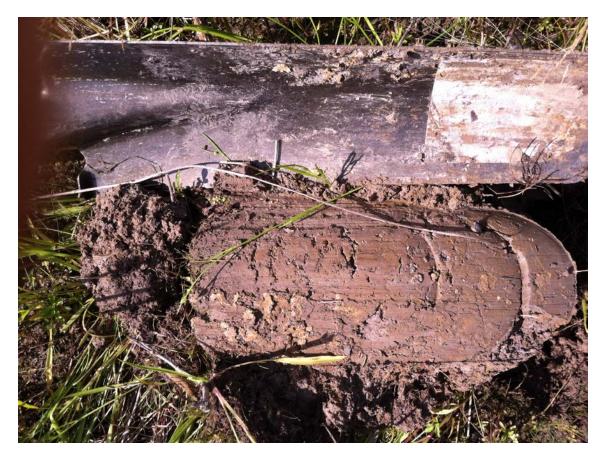
EXHIBIT 6. SUBJECT PROPERTY, TYPICAL HYDRIC SOIL

typically dark gray and dark brownish gray and gleyed (Exhibit 6).

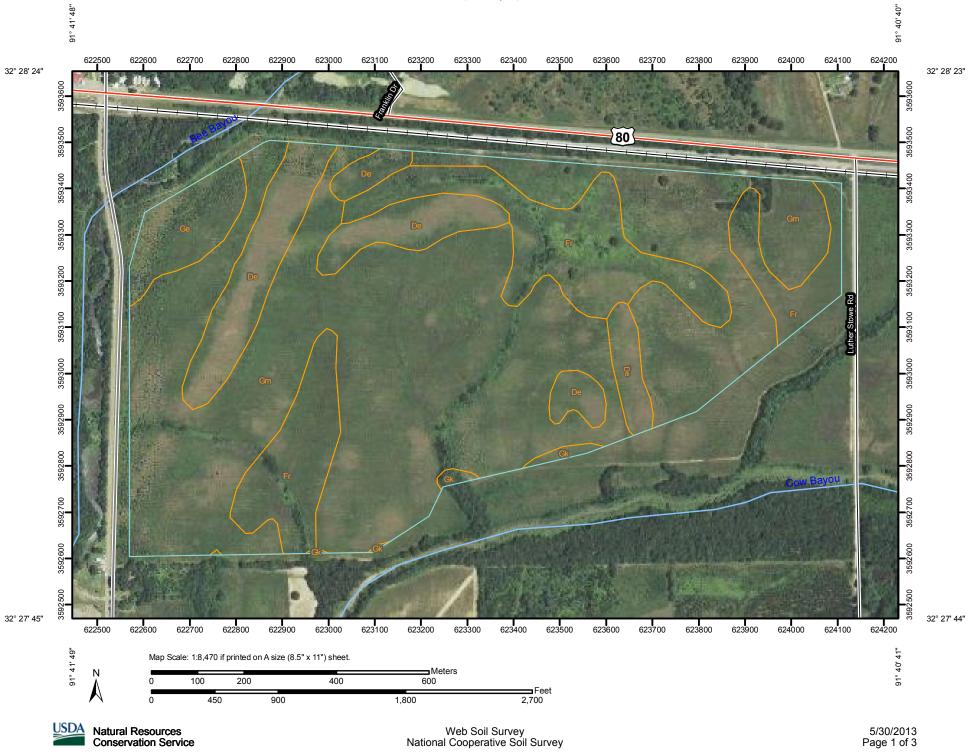
### Soil Map—Richland Parish, Louisiana (bee bayou)

The Richland Parish Soil Survey indicates that **65** percent of soils on the site were Gigger and Gilbert-Egypt Silt Loam, 18 percent Forestdale silty clay loam, 12 percent Dexter silt loam and 4 percent Gigger silt loam (Appendix A).
