Whitehall Industrial Site Wetlands Delineation Report

Subject: Wetland Delineation Report
Whitehall Industrial Site, Concordia Parish
Chenier Project No: 23-236

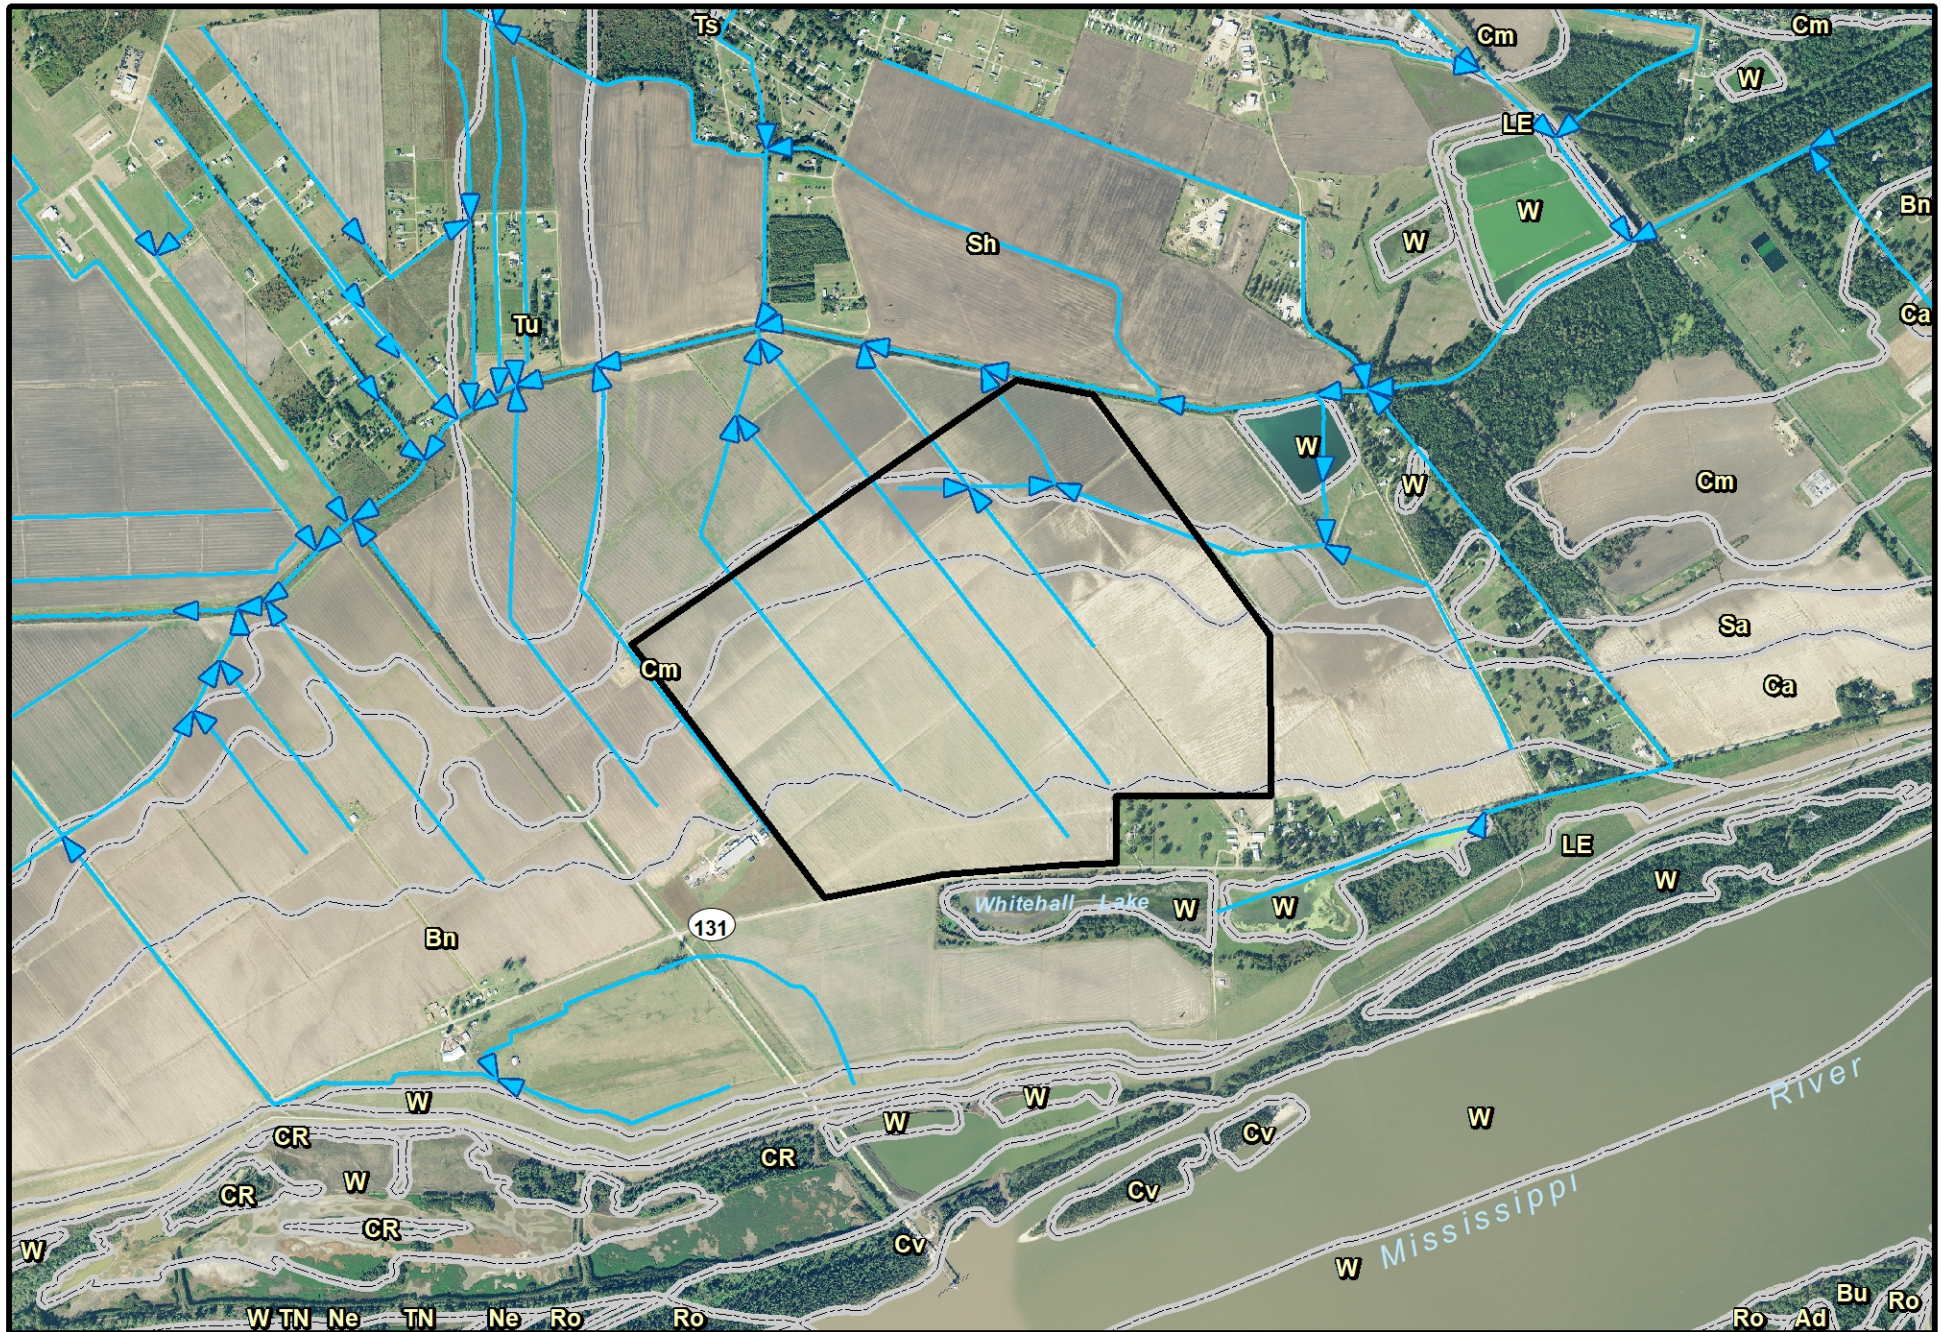
Figure 2 - Existing Conditions Map
Wetland Delineation
Whitehall Industrial Site
Concordia Parish, Louisiana
Louisiana Central

Most of the Site is a well-drained agricultural field. Positive evidence of all three diagnostic characteristics for wetlands was not observed at any of the sample locations established by Chenier. No wetlands were identified on the Site. Seven intermittent agricultural drainage ditches were identified (Figure 2). These appear to be jurisdictional Waters of the U.S.

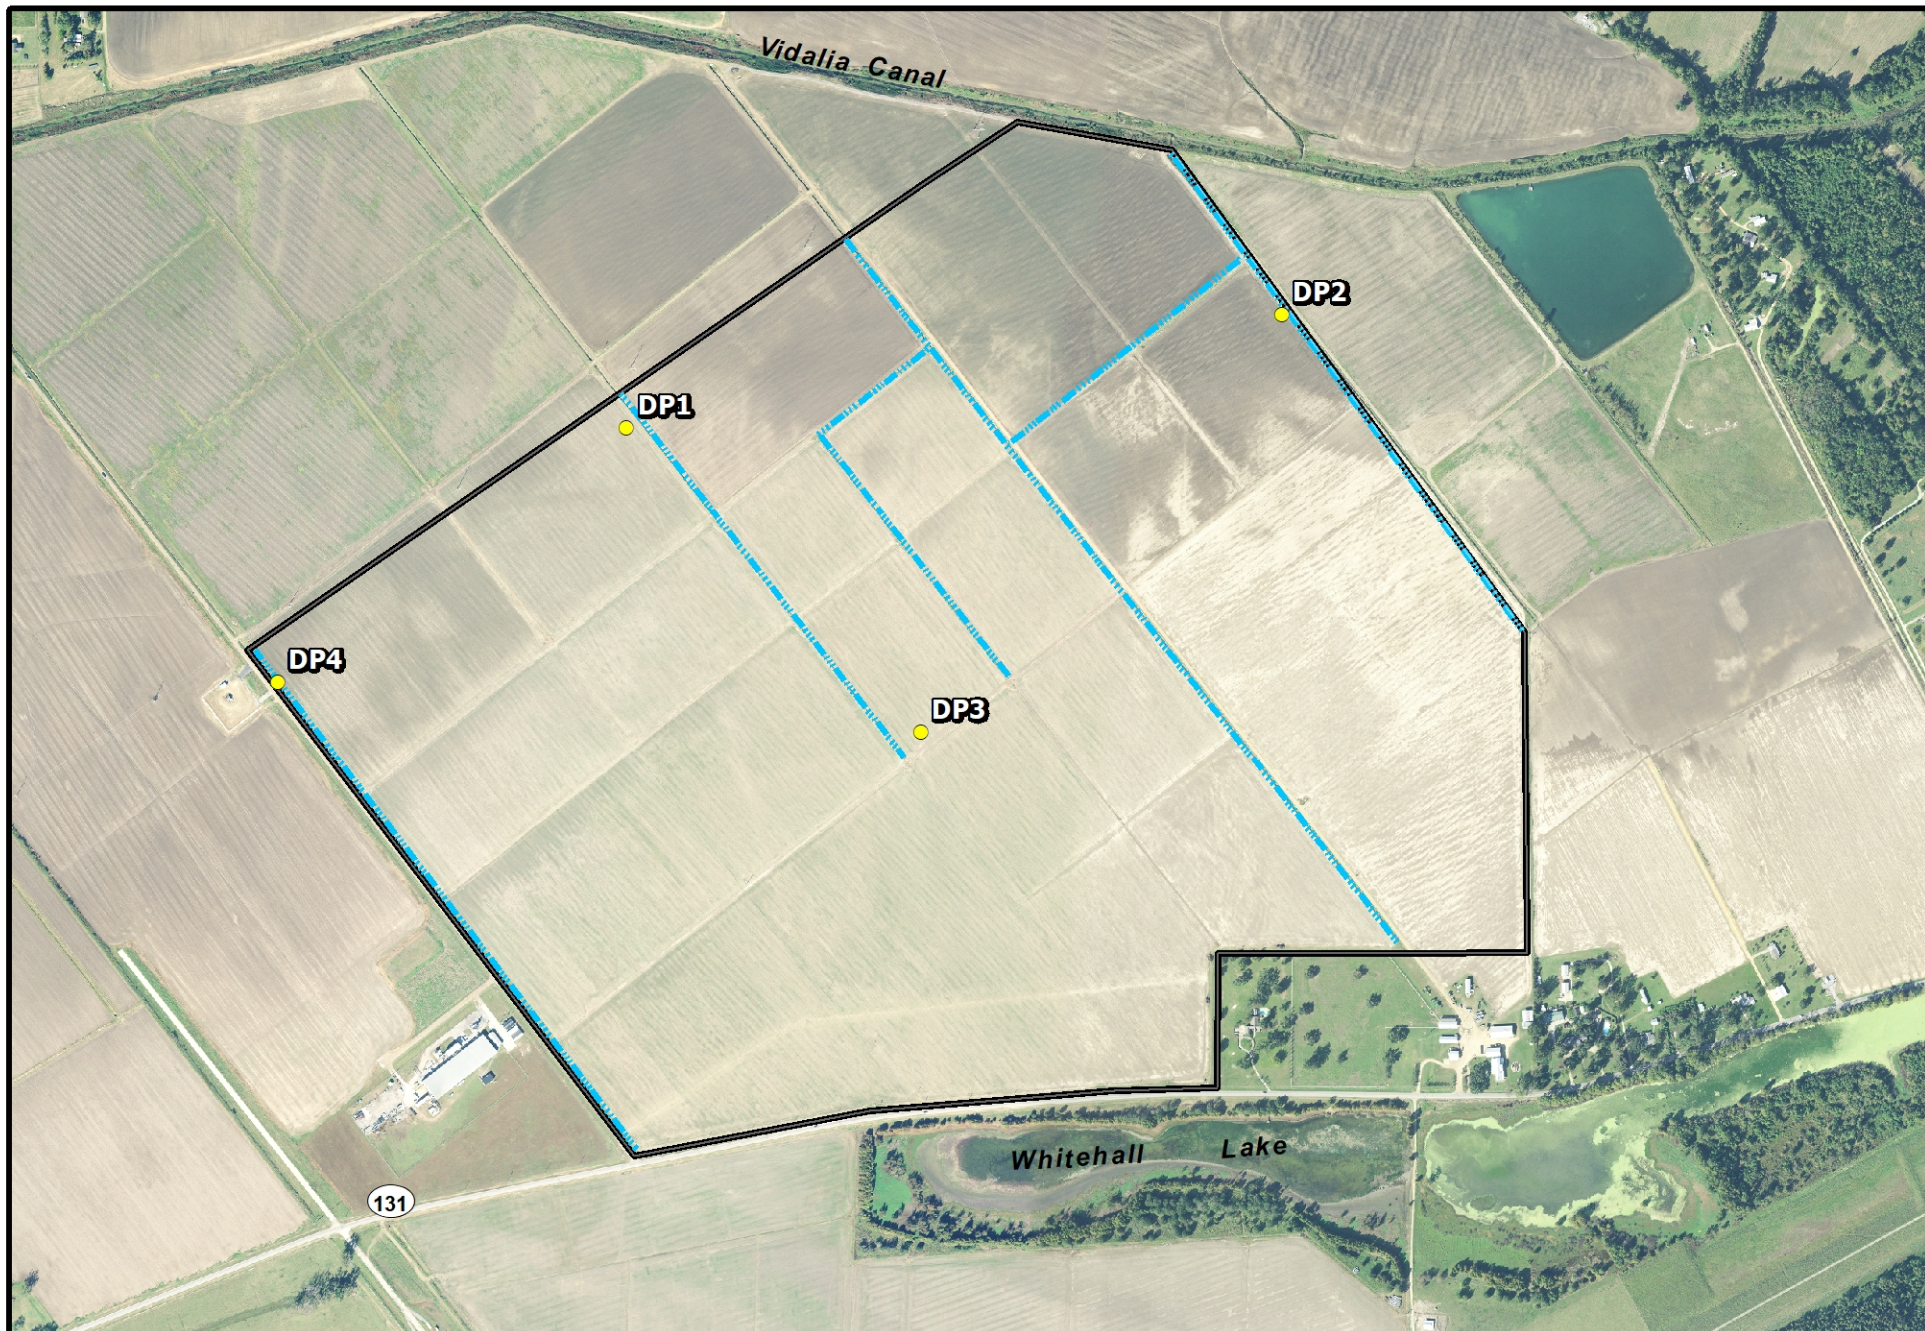
Figure 3 - Wetland Delineation Map

- Project Area
- Data Point
- Wetlands (0.0 ac.)
- Non-Jurisdictional Wetlands (0.0 ac.)
- Jurisdictional Other Waters of the U.S. (3.3 linear miles)
- Other Waters of the U.S. (0.0 linear miles)

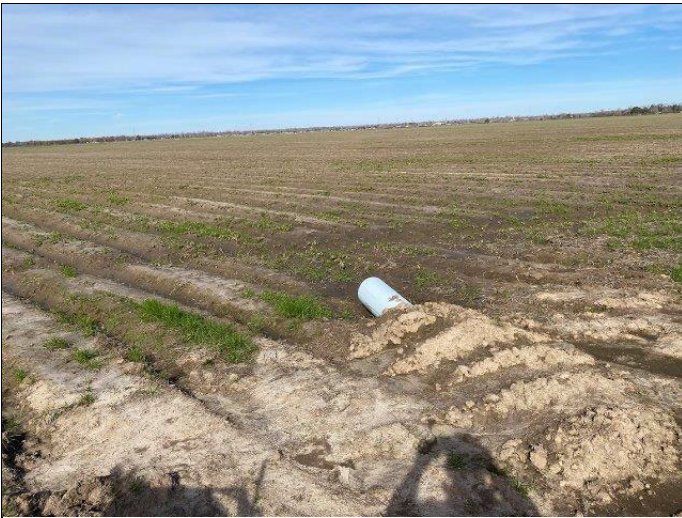
3. Drain pipe along the south side of the site

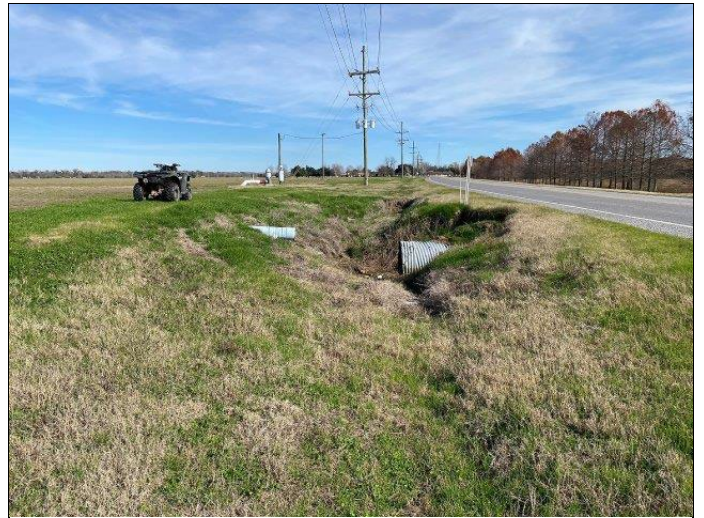
4. Drain pipe and culvert that flows beneath LA 131 to Whitehall Lake

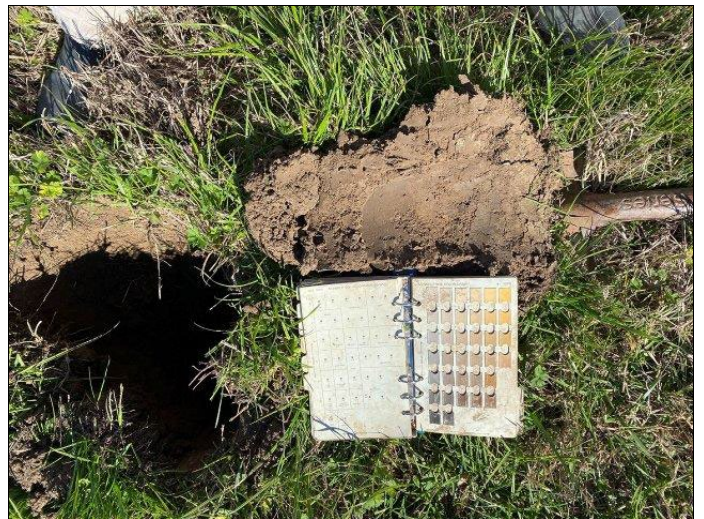
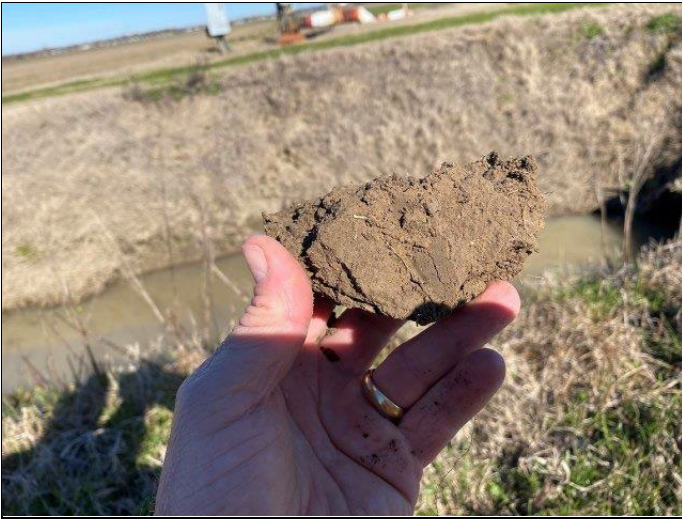
6. DP1 Soils

7. DP1 soil

Depth (inches)	Matrix		Redox Features				Texture	Remarks
	Color (moist)	%	Color (moist)	%	Type ¹	Loc ²		
0-21	10YR 4/3	100					silty	Brown disturbed soil

Yes _____ No **X**

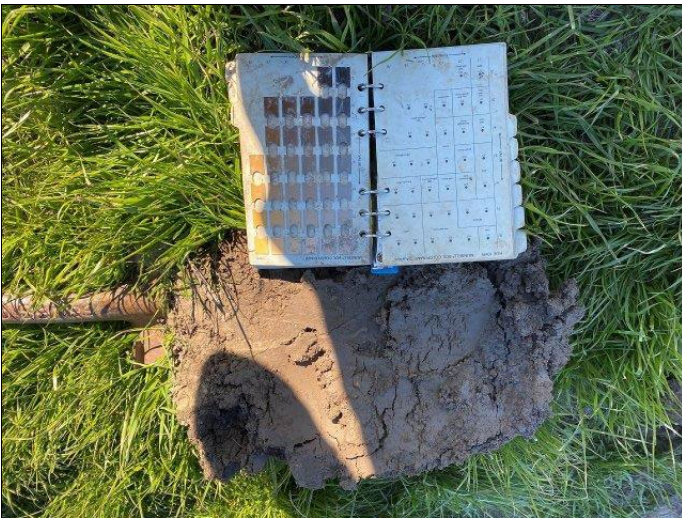
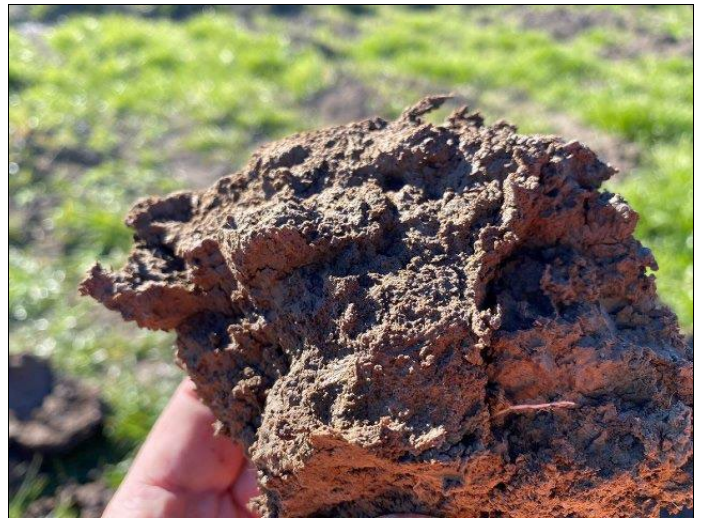
9. DP2 soil

10. DP2 soil

Depth (inches)	Matrix		Redox Features				Texture	Remarks
	Color (moist)	%	Color (moist)	%	Type ¹	Loc ²		
0-3	10YR 4/3	100					silt	Brown disturbed soil
4-21	10YR 3/2	75	10YR 4/6			RM	Silty clay	Reddish mottles

Yes X No

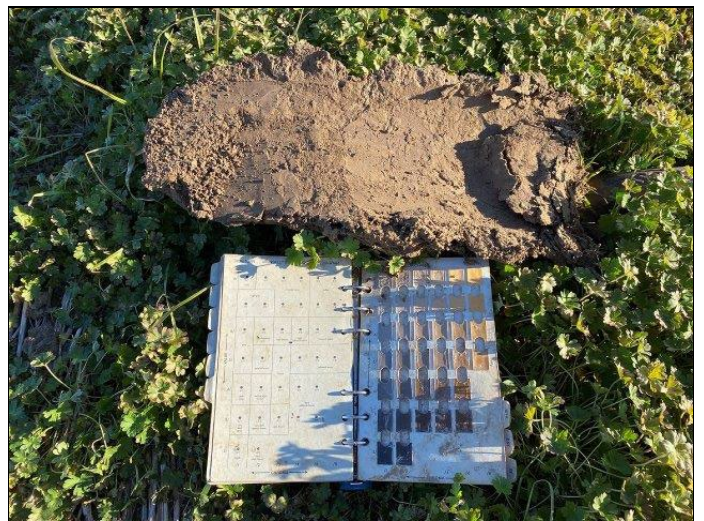
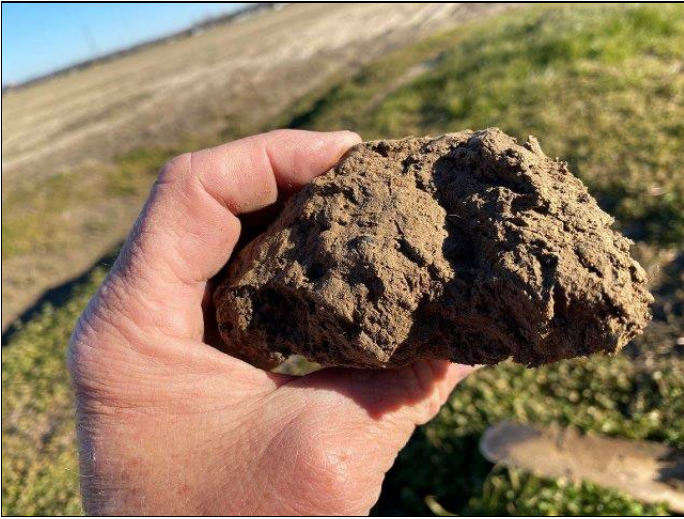
12. DP3 soil

13. DP3 soil

Depth (inches)	Matrix		Redox Features				Texture	Remarks
	Color (moist)	%	Color (moist)	%	Type ¹	Loc ²		
0-6	10YR 4/3	100					silt	brown
6-21	10YR 4/3	75	10YR 4/6	25	D	M	Silty clay	Reddish mottles

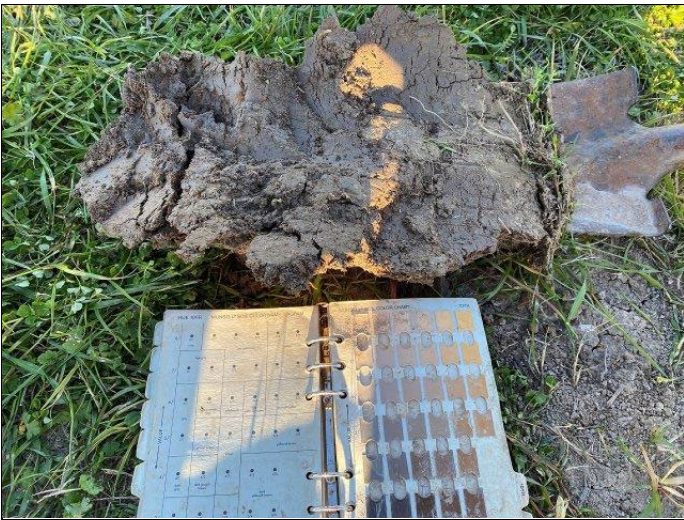
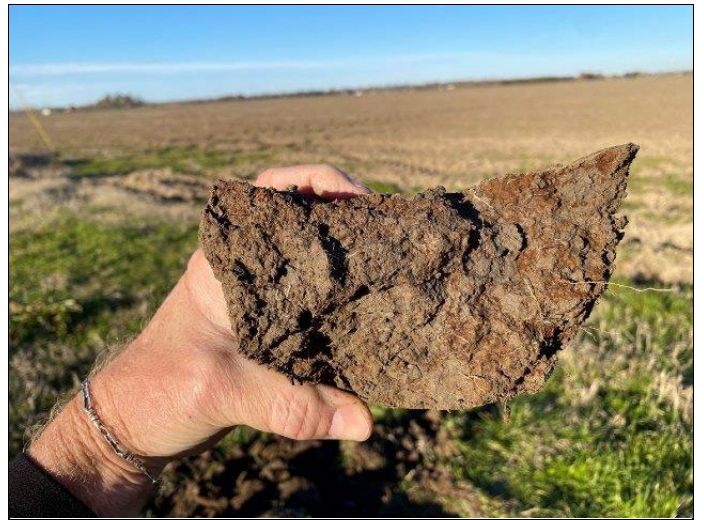
15. DP4 soil

16. DP4 soil

Depth (inches)	Matrix		Redox Features				Texture	Remarks
	Color (moist)	%	Color (moist)	%	Type ¹	Loc ²		
0-2	10YR 4/3						silty	Some roots
3-6	10YR 4/3						silty	brown
7-21	10YR 3/2	75	10YR 3/6	25	RM	M		Dark red mottles

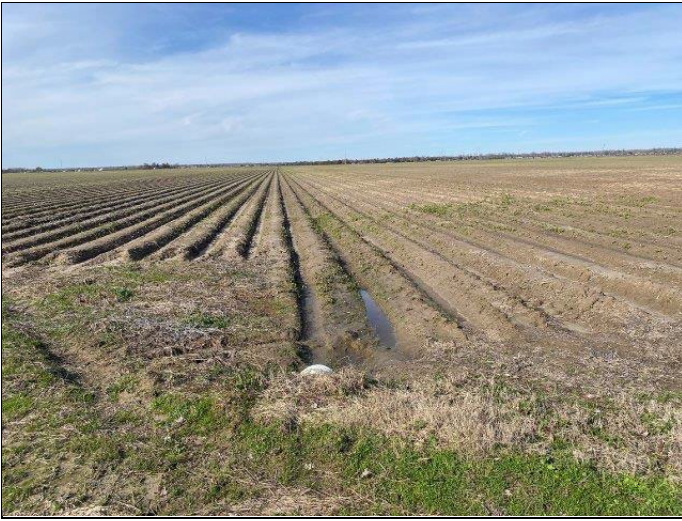
19. Typical field drain pipe

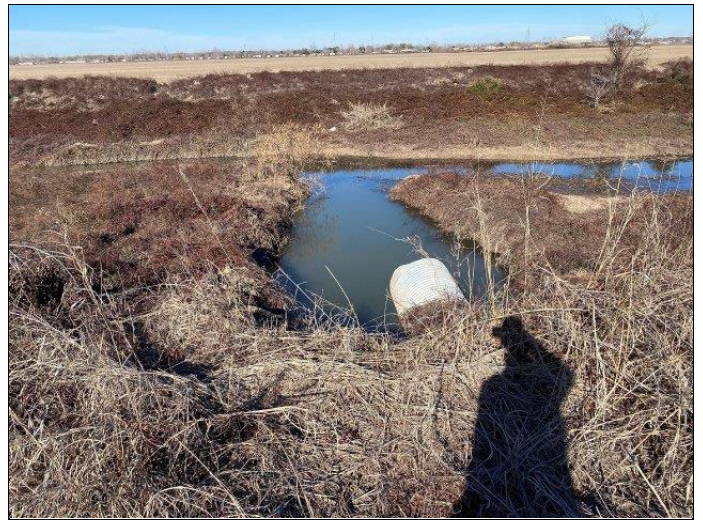
22. S5 outfall into Vidalia Canal
