# **North Schaefer Site Wetlands Delineation Report**

## **WETLAND DELINEATION FOR NORTH SCHAFFER PROPERTY**

**+/-30-Acre Tract  
Section 23, Township-11-South, Range-5-East  
St. Martin Parish, Louisiana**

**November 2023  
(CEI No. 223094)**

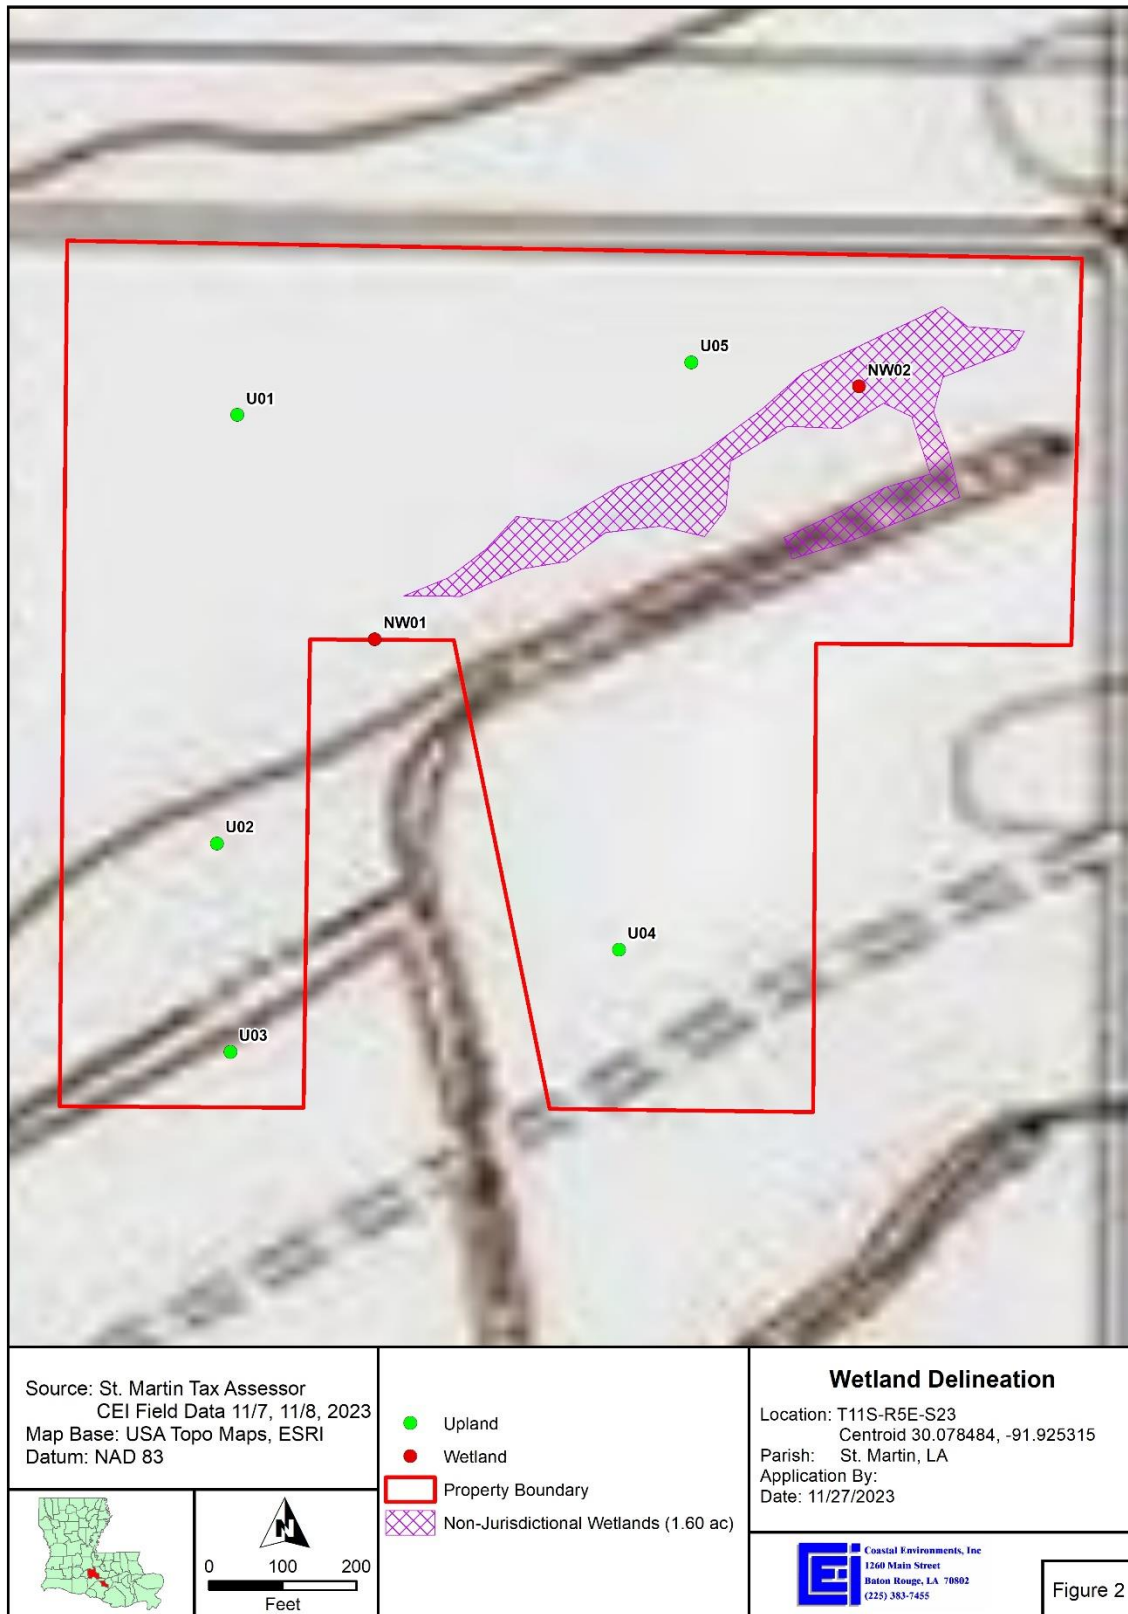
**Figure 2: Potential Non-Jurisdictional Wetlands and Property Boundaries on USGS Quad sheet.**

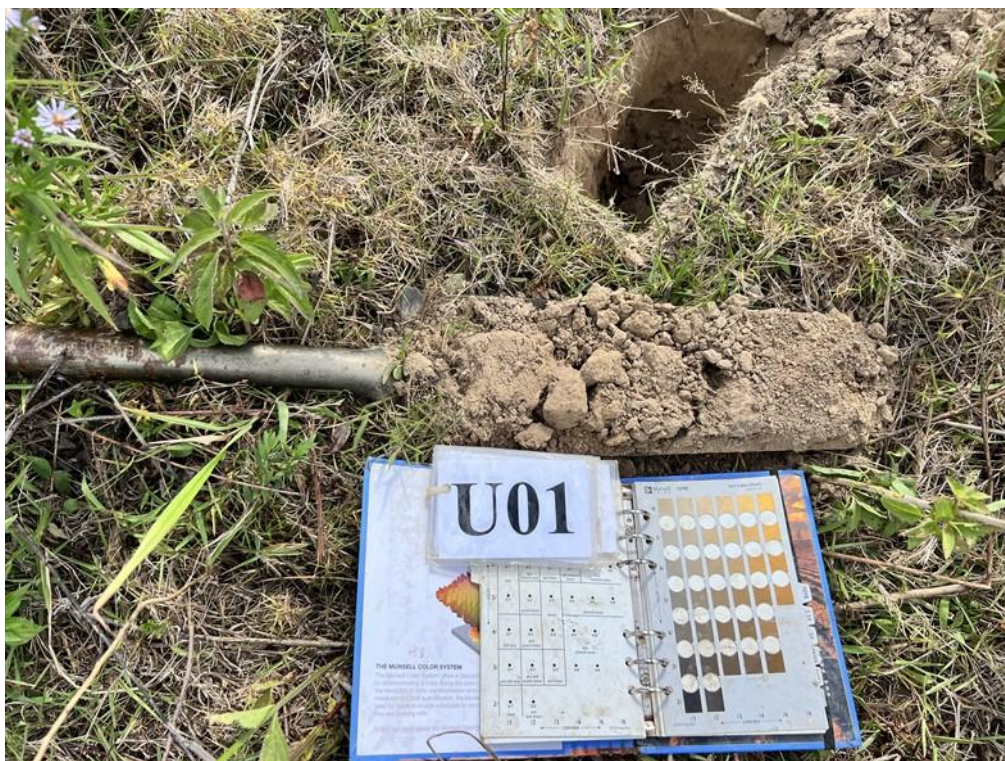
**Figure B.1** Photograph of soil sample from Sample Site U01- (CEI 11-07-23)- Upland areas on northwest property corner.

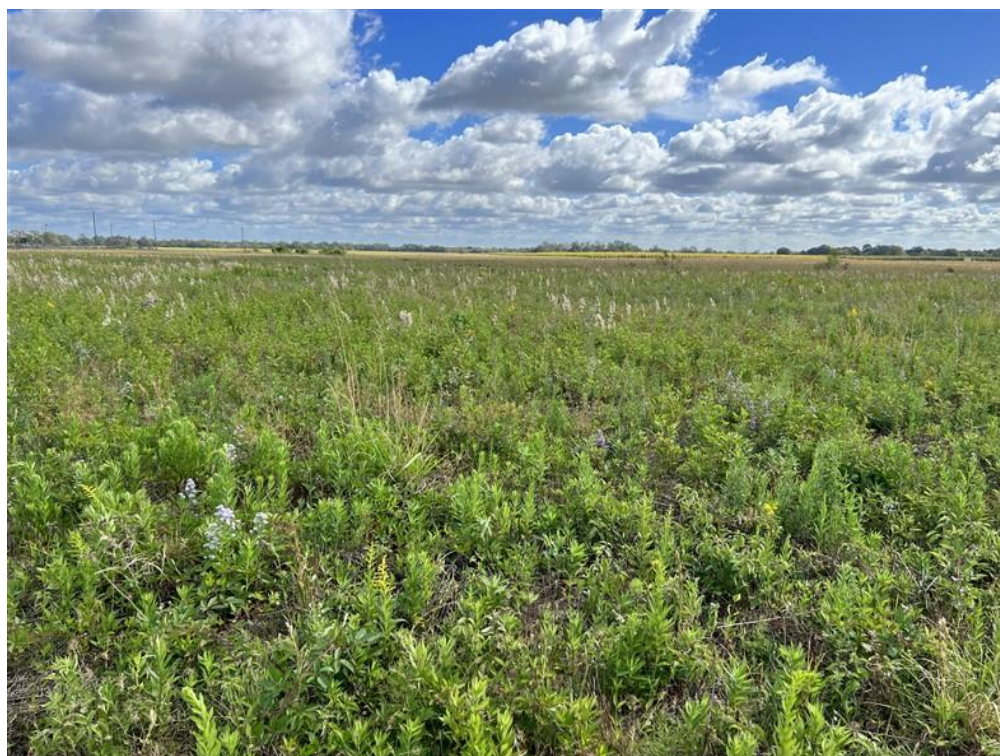
**Figure B.2** Photograph looking to the west of open field areas at Sample Site U01- (CEI 11-07-23)- Upland areas on northwest property corner.

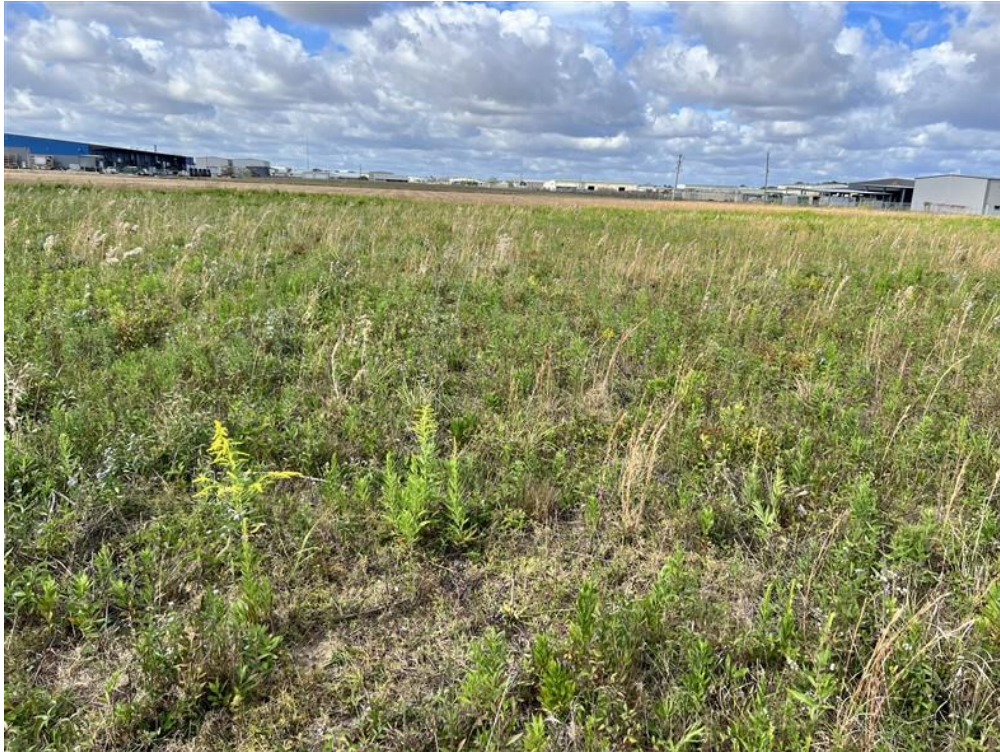
**Figure B.** Photograph looking to the east of open field areas at Sample Site U01- (CEI 11-07-23)- Upland areas on northwest property corner.

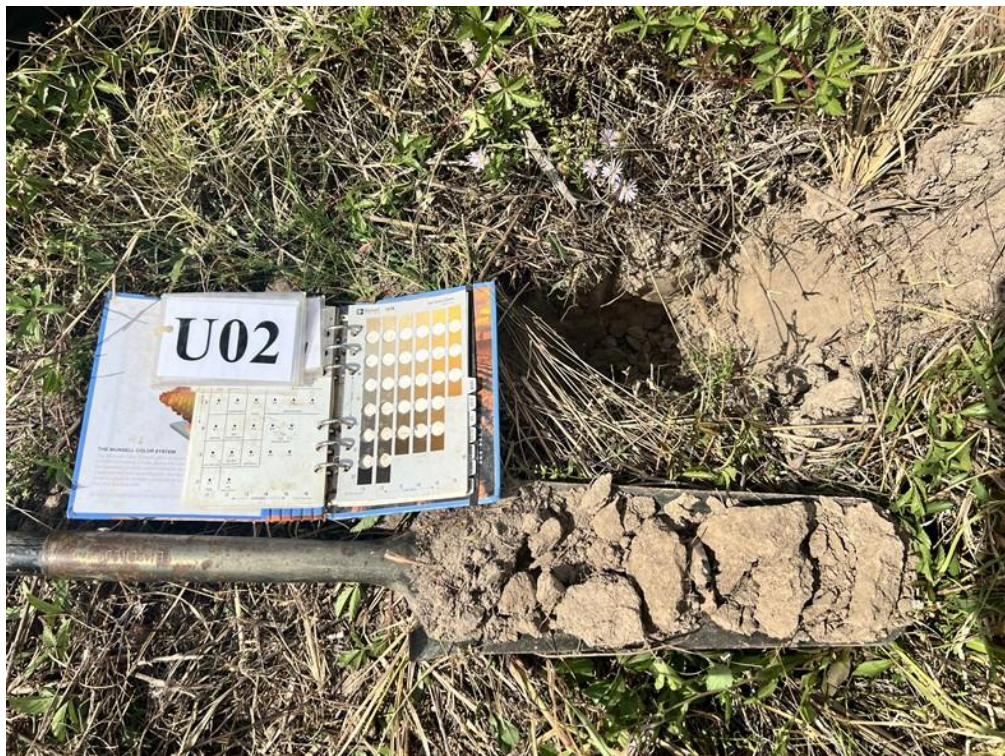
**Figure B.4** Photograph of soil sample from Sample Site U02- (CEI 11-07-23)- Upland areas on southwest property corner.

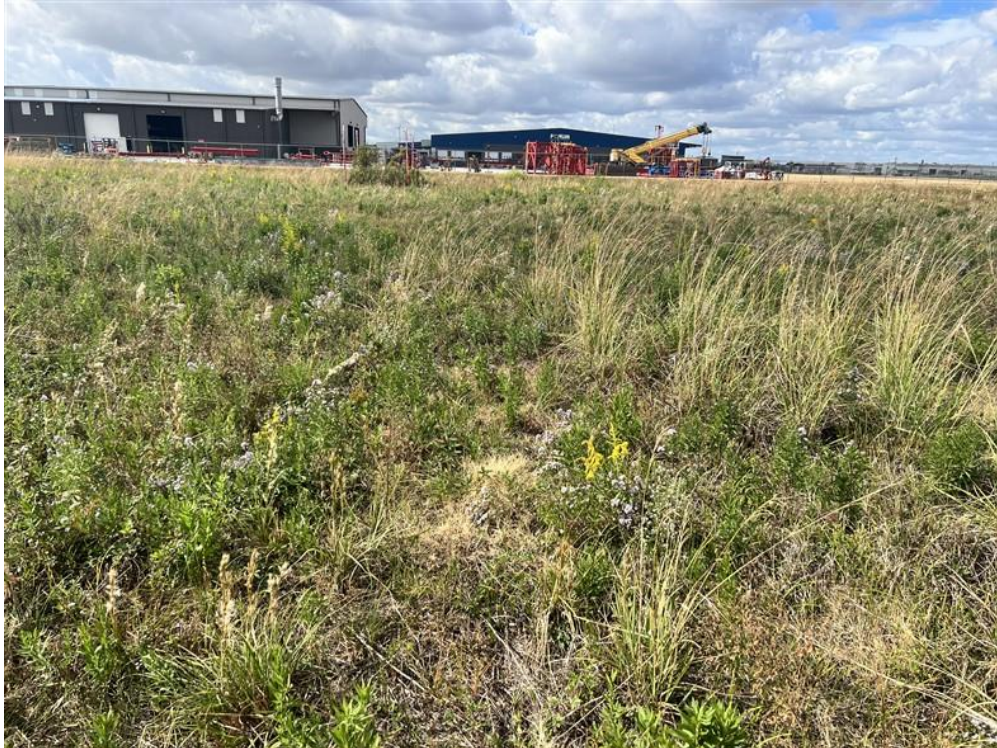
**Figure B.5** Photograph looking to the west of open field areas at Sample Site U02- (CEI 11-07-23)- Upland areas on southwest property corner.

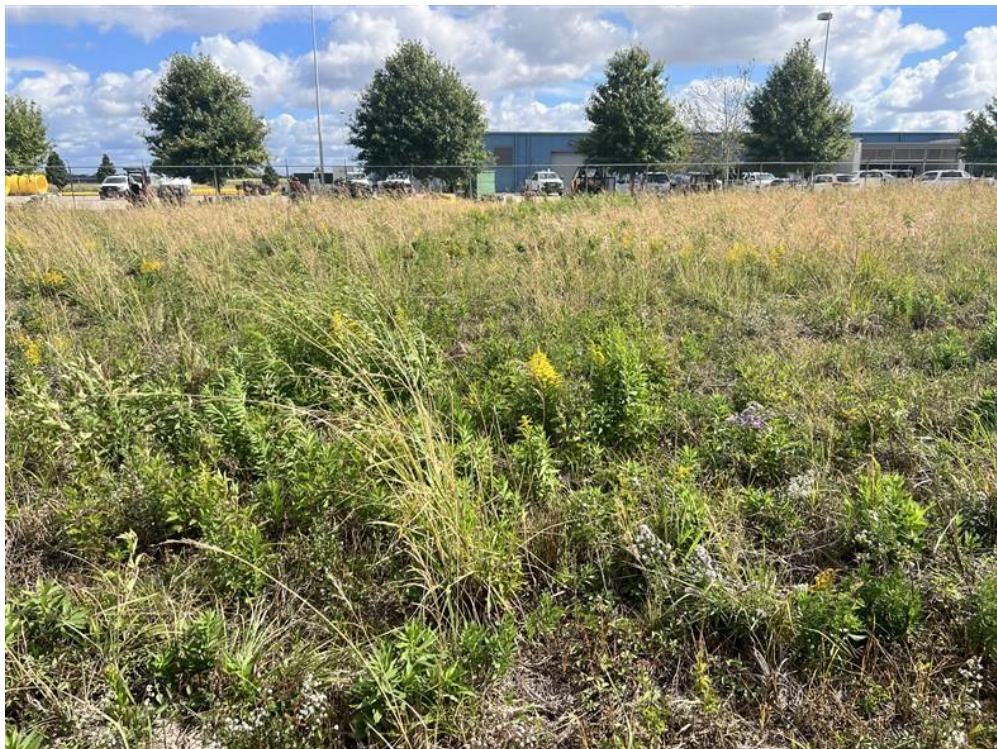
**Figure B.6** Photograph looking to the east of open field areas at Sample Site U02- (CEI 11-07-23)- Upland areas on southwest property corner.

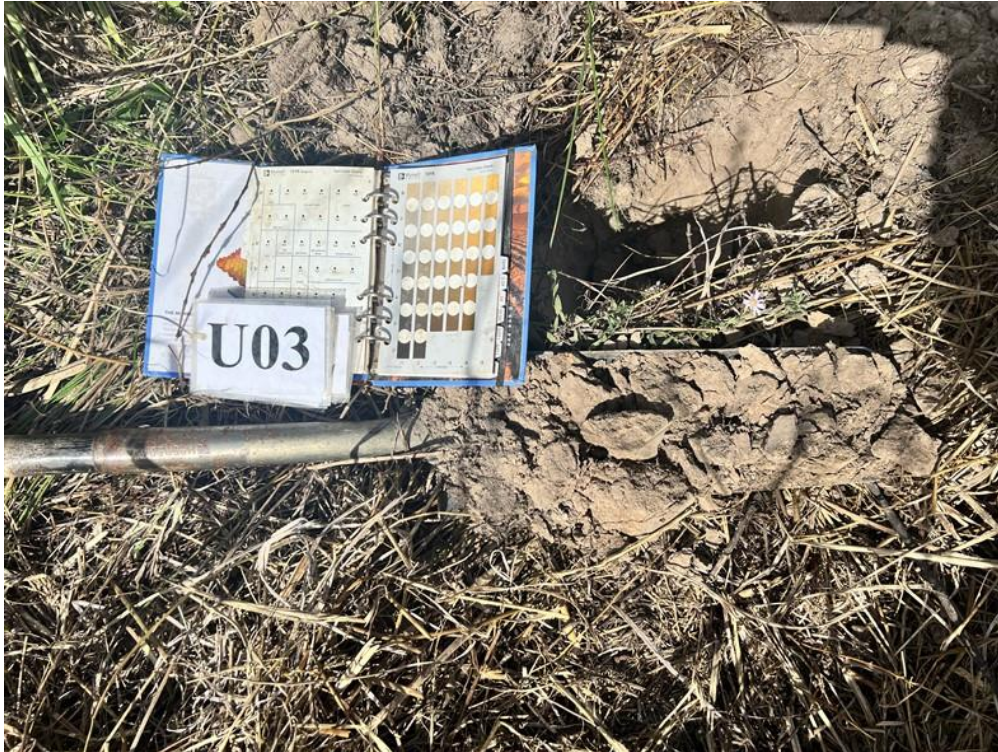
**Figure B.7** Photograph of soil sample from Sample Site U03- (CEI 11-07-23)- Upland areas on center-west property area.

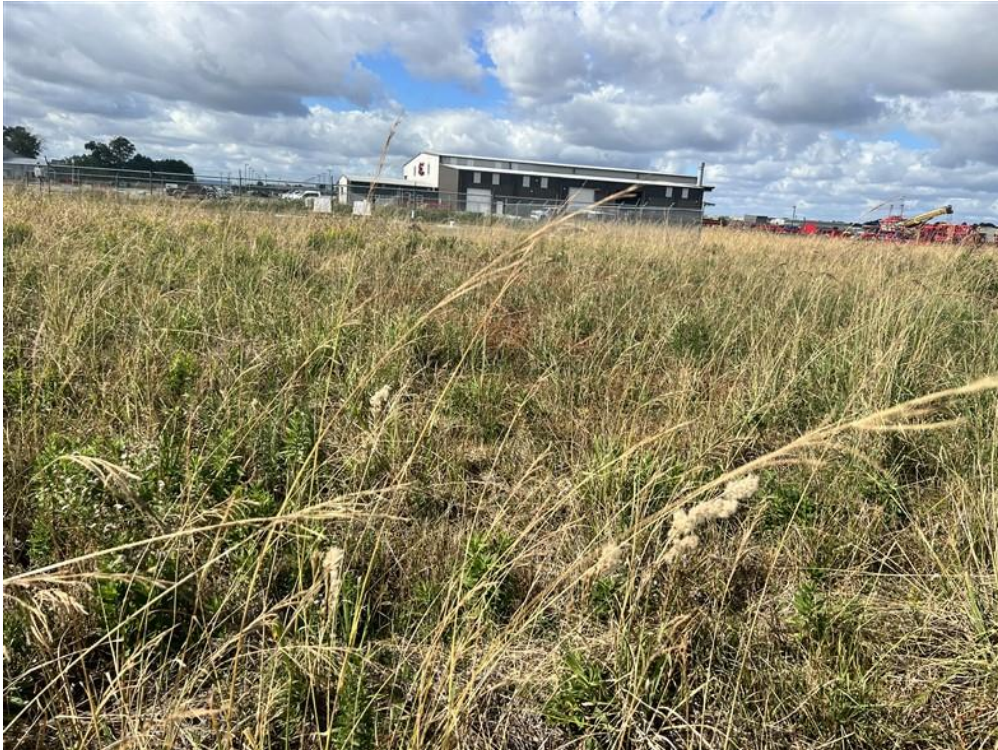
**Figure B.8** Photograph looking to the west of open field areas at Sample Site U03- (CEI 11-07-23)- Upland areas on center-west property area.

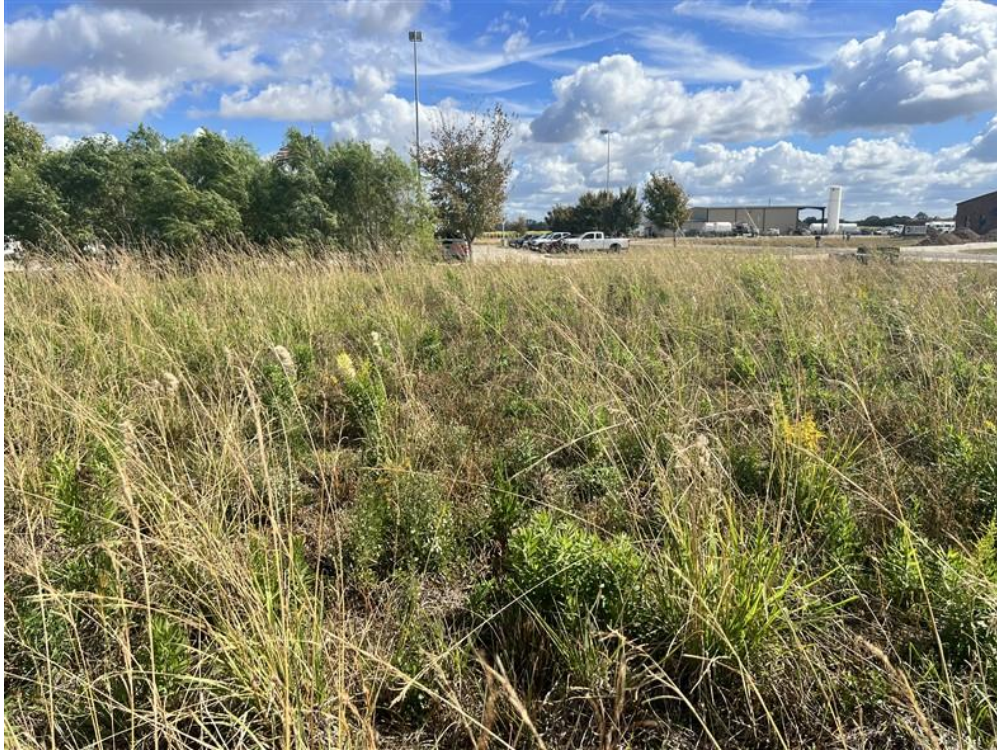
**Figure B.9** Photograph looking to the east of open field areas at Sample Site U03- (CEI 11-07-23)- Upland areas on center-west property area.

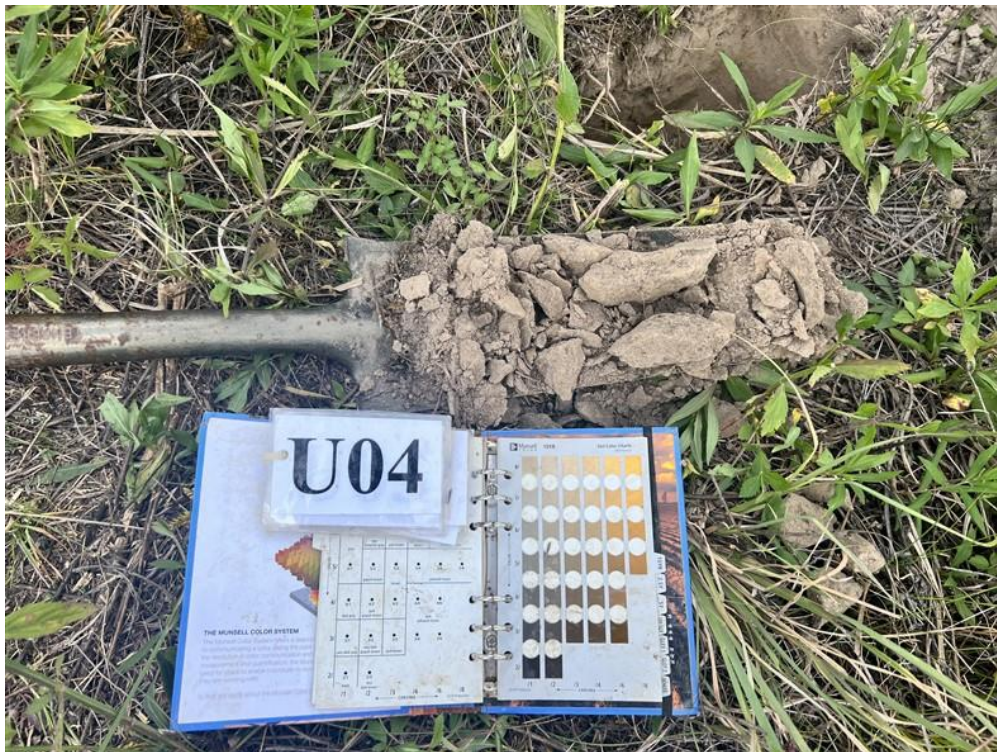
**Figure B.10** Photograph of soil sample from Sample Site U04- (CEI 11-07-23)- Upland areas on southeast corner of property.

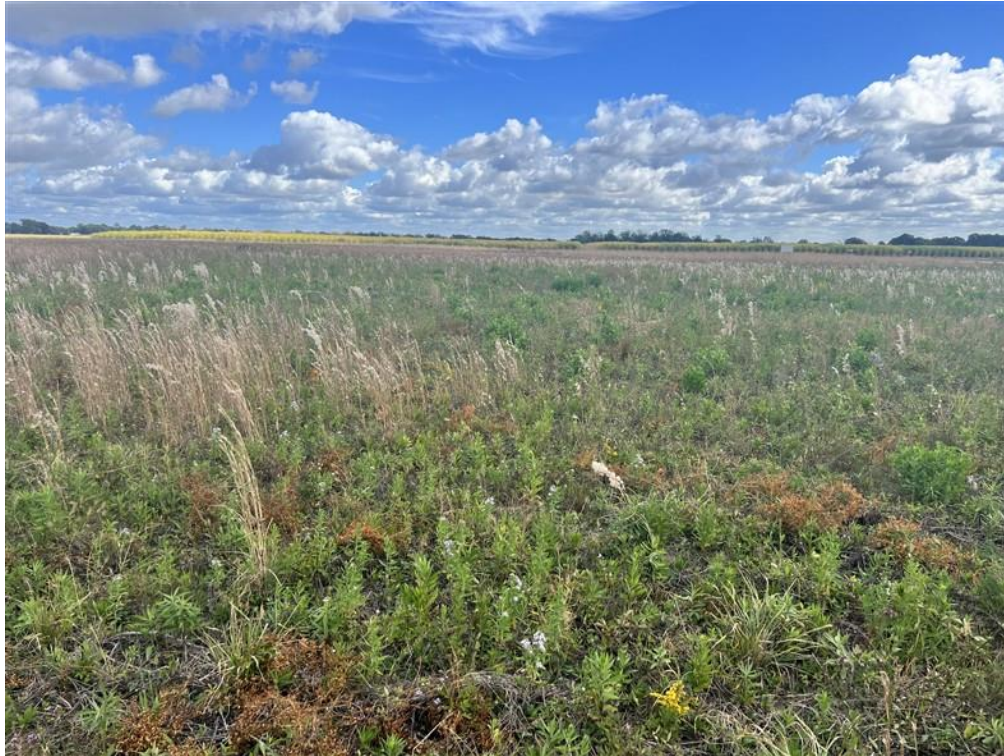
**Figure B.11** Photograph looking west of vegetated areas at Sample Site U04- (CEI 11-07-23)-  
Upland areas on southeast corner of property.

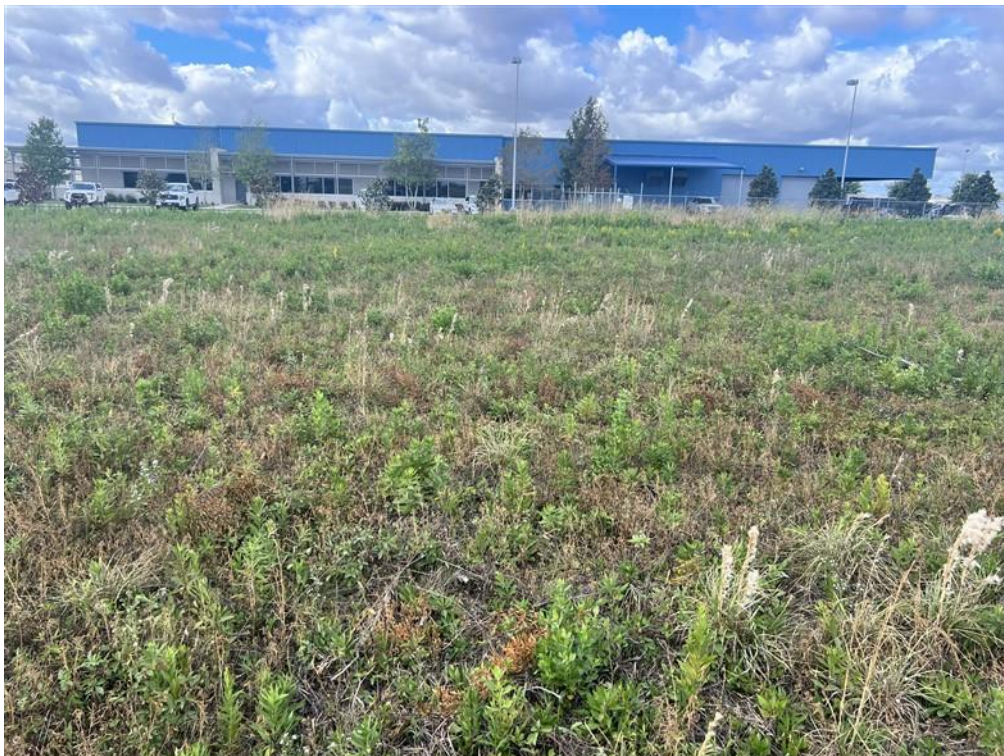
**Figure B.12** Photograph looking east of vegetated areas at Sample Site U04- (CEI 11-07-23)-  
Upland areas on southeast corner of property.

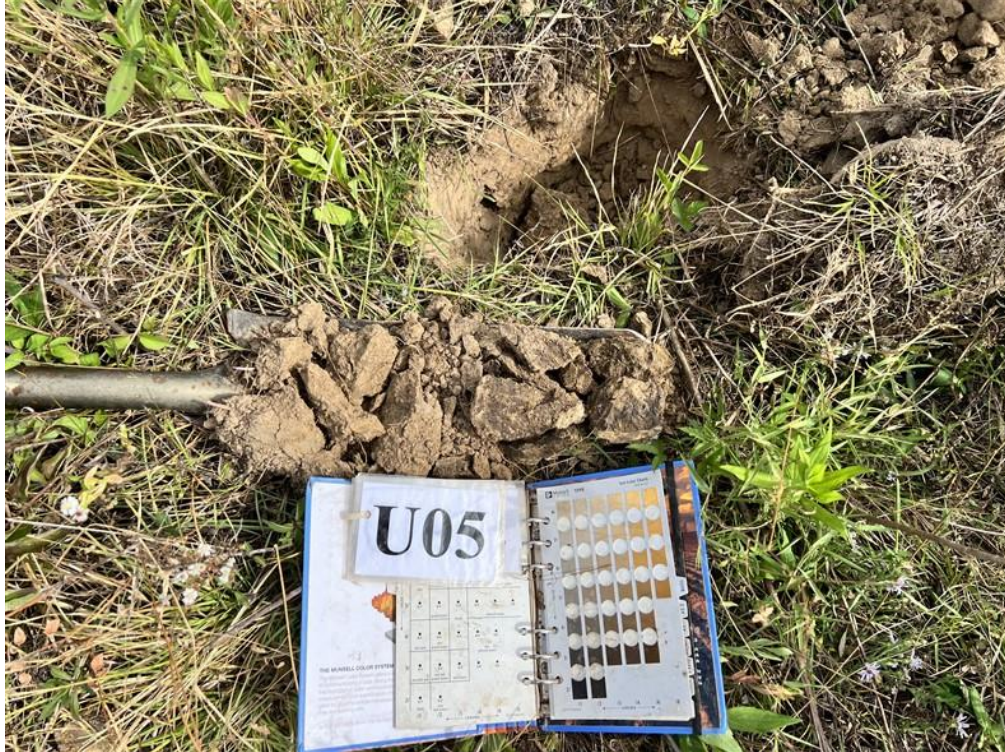
**Figure B.13** Photograph of soil sample from Sample Site U05- (CEI 11-07-23)- Upland areas on northeast area of property.

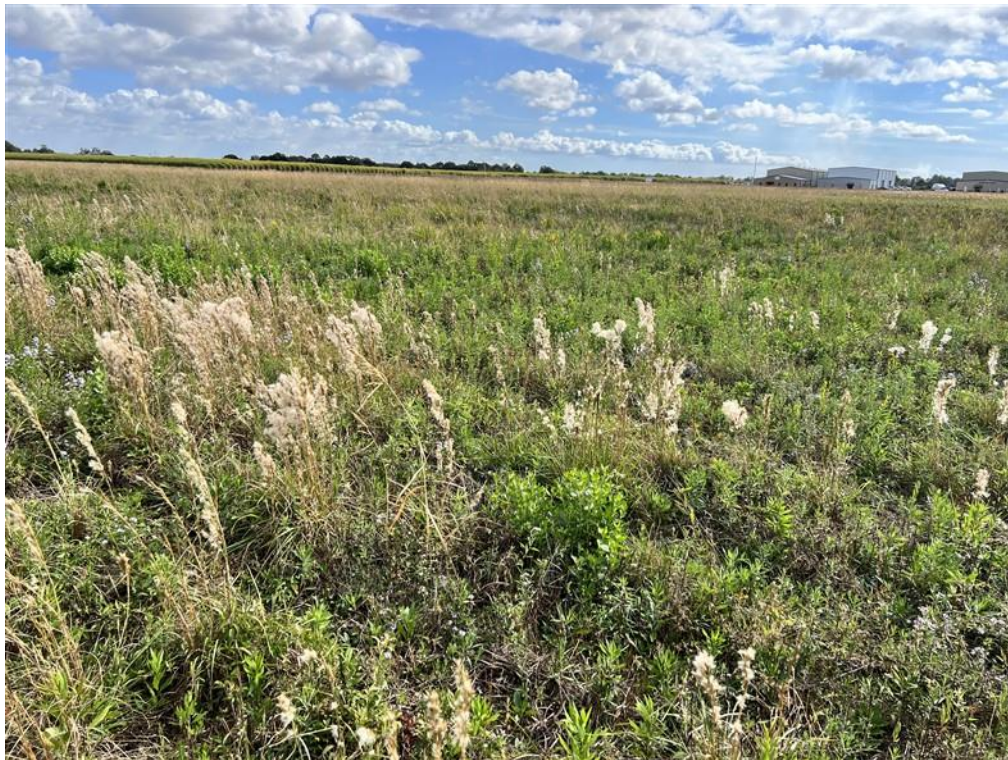
**Figure B.14** Photograph looking west of vegetated areas at Sample Site U05- (CEI 11-07-23)- Upland areas on northeast area of property.

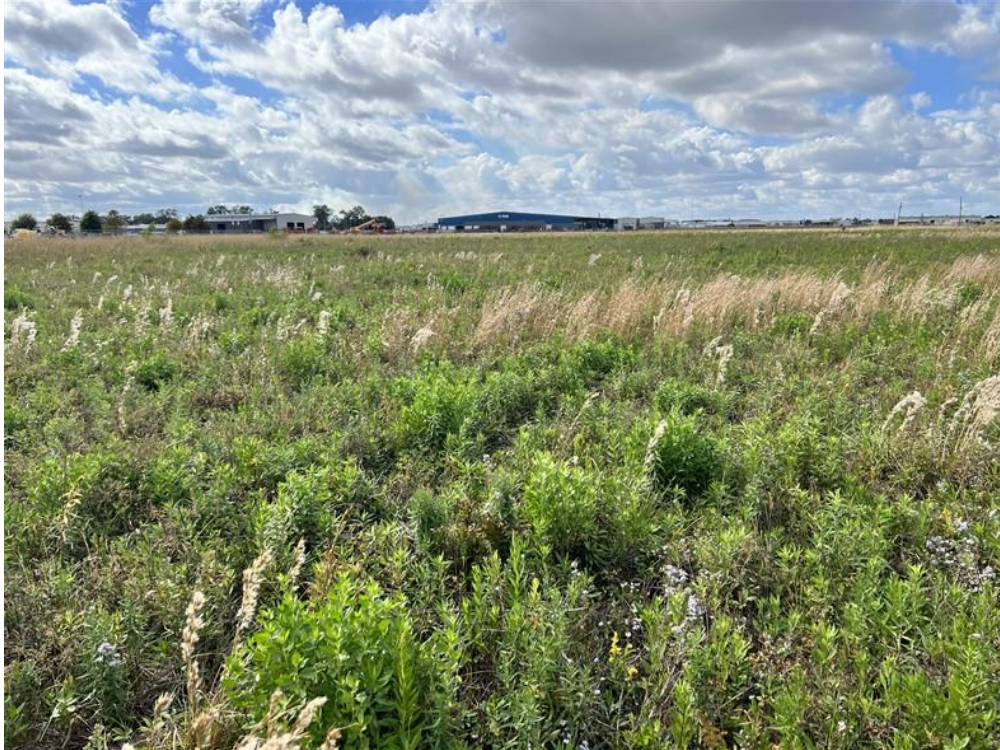
**Figure B.15** Photograph looking east of vegetated areas at Sample Site U05- (CEI 11-07-23)- Upland areas on southeast area of property.

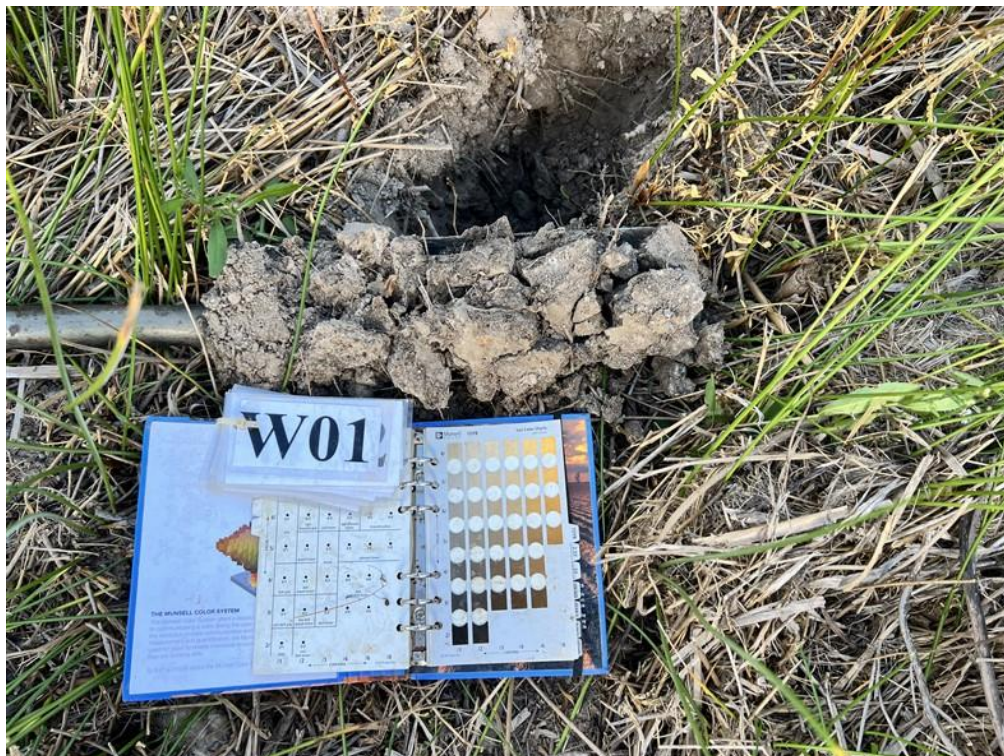
**Figure B.16** Photograph of soil sample from Sample Site NW01- (CEI 11-07-23)- Lower ditch at center/west side of property. Ditch was created by past grubbing activities from agricultural land conversion and should be non-jurisdictional wetlands.

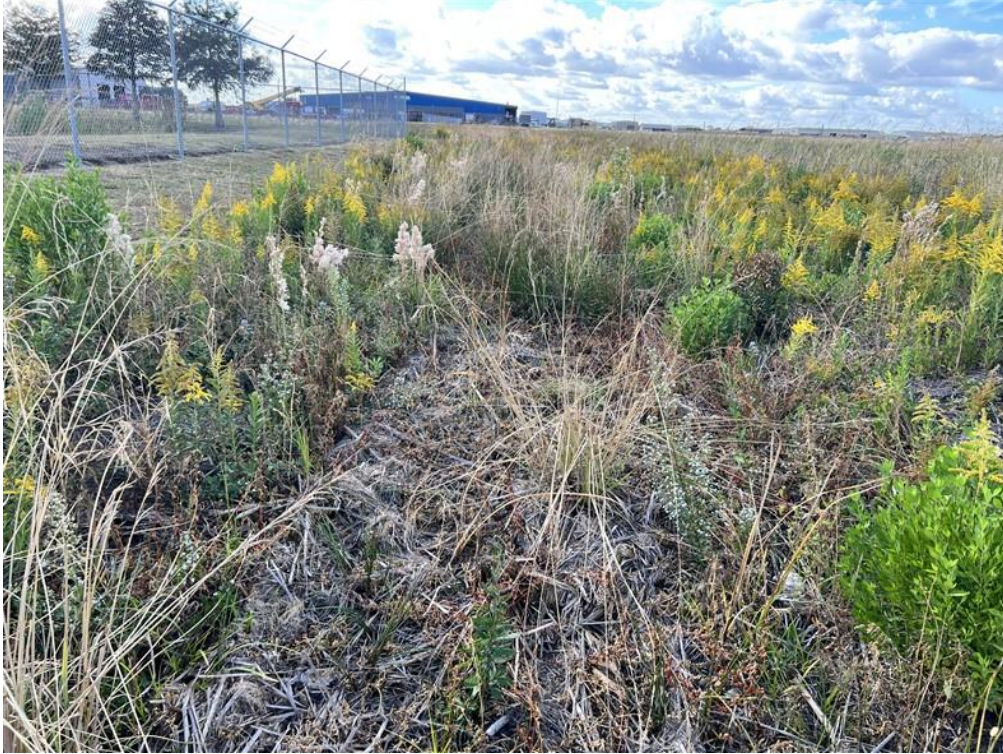
**Figure B.17** Photograph looking to the east along ditch showing vegetated areas (ditch) at Sample Site NW01- (11-07-23)- Lower ditch at center/west side of property. Ditch was created by past grubbing activities from agricultural land conversion and should be non-jurisdictional wetlands.

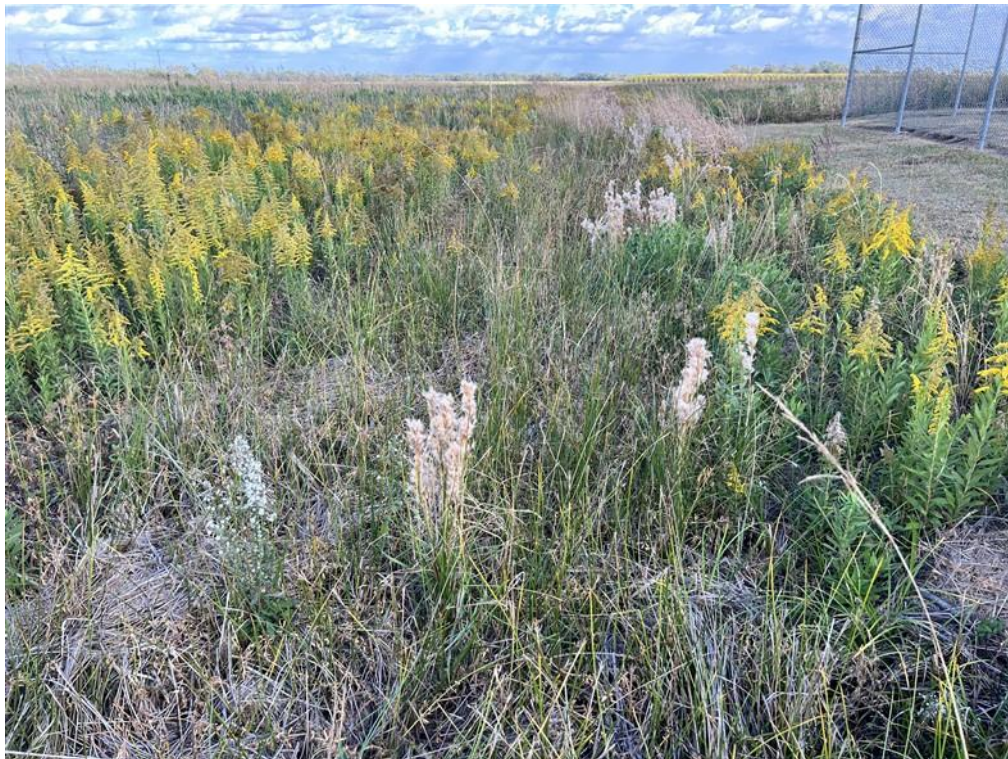
**Figure B.18** Photograph looking to the east along ditch showing vegetated areas (ditch) at Sample Site NW01- (11-07-23)- Lower ditch at center/west side of property. Ditch was created by past grubbing activities from agricultural land conversion and should be non-jurisdictional wetlands.

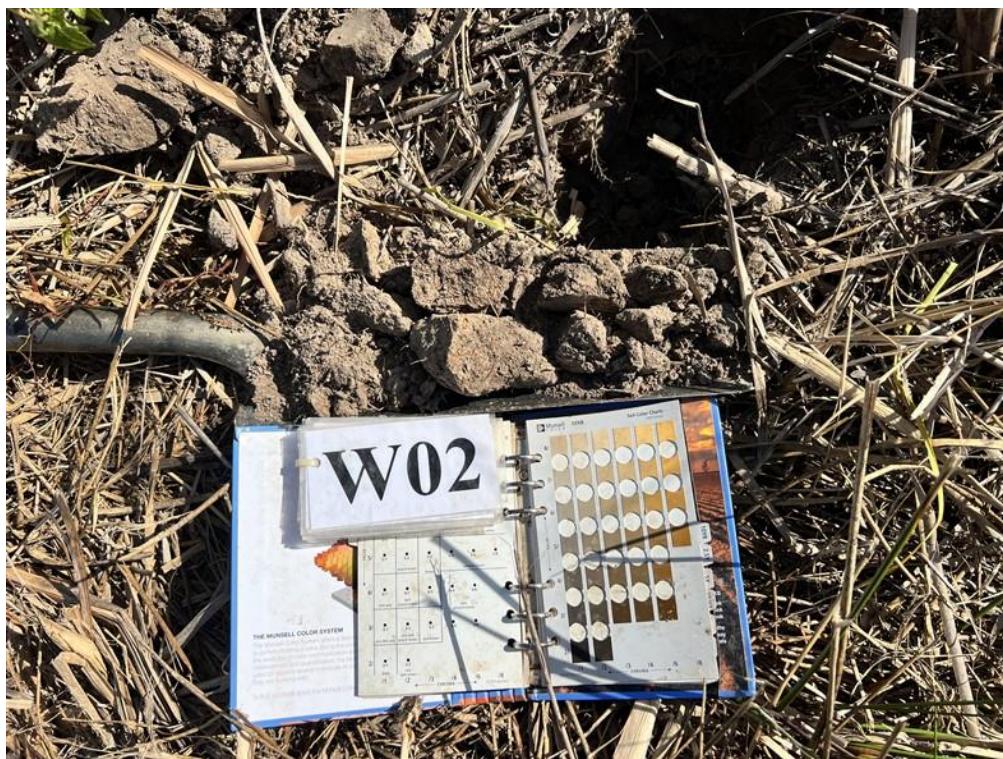
**Figure B.19** Photograph of soil sample from Sample Site NW02- (CEI 11-07-23)- Lower field area at center/northeast property corner. Lower areas were created by past grubbing activities from agricultural land conversion and should be non-jurisdictional wetlands.

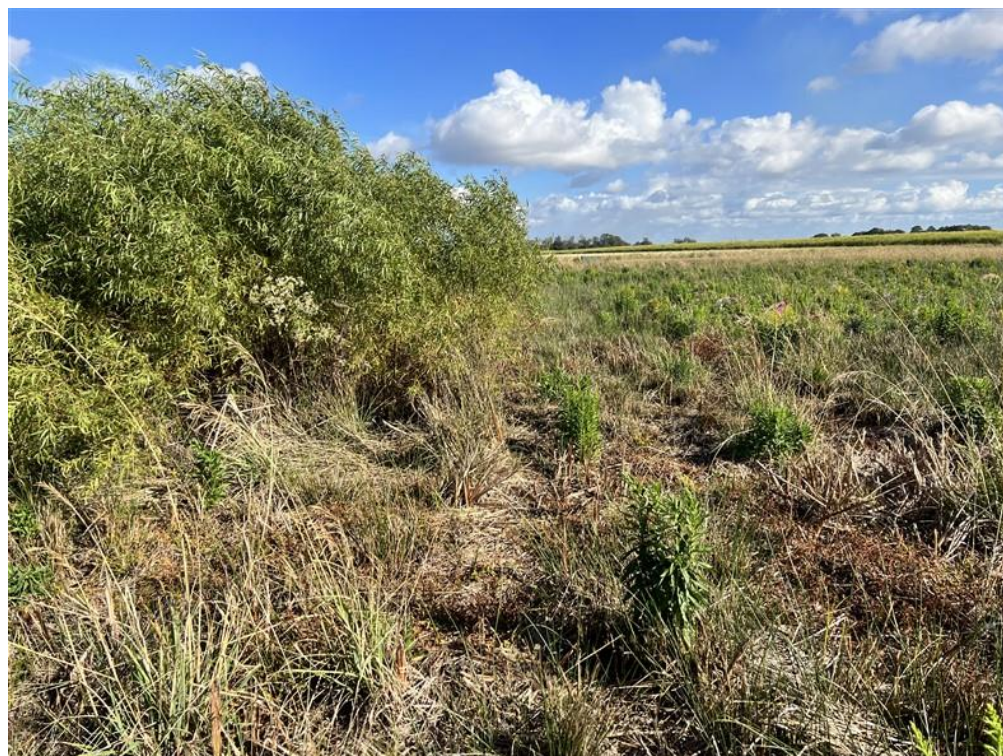
**Figure B.20** Photograph looking to the east showing vegetated areas (scrub/shrub and fields) at Sample Site NW02- (11-07-23)- Lower field area at center/northeast property corner. Lower areas were created by past grubbing activities from agricultural land conversion and should be non-jurisdictional wetlands.

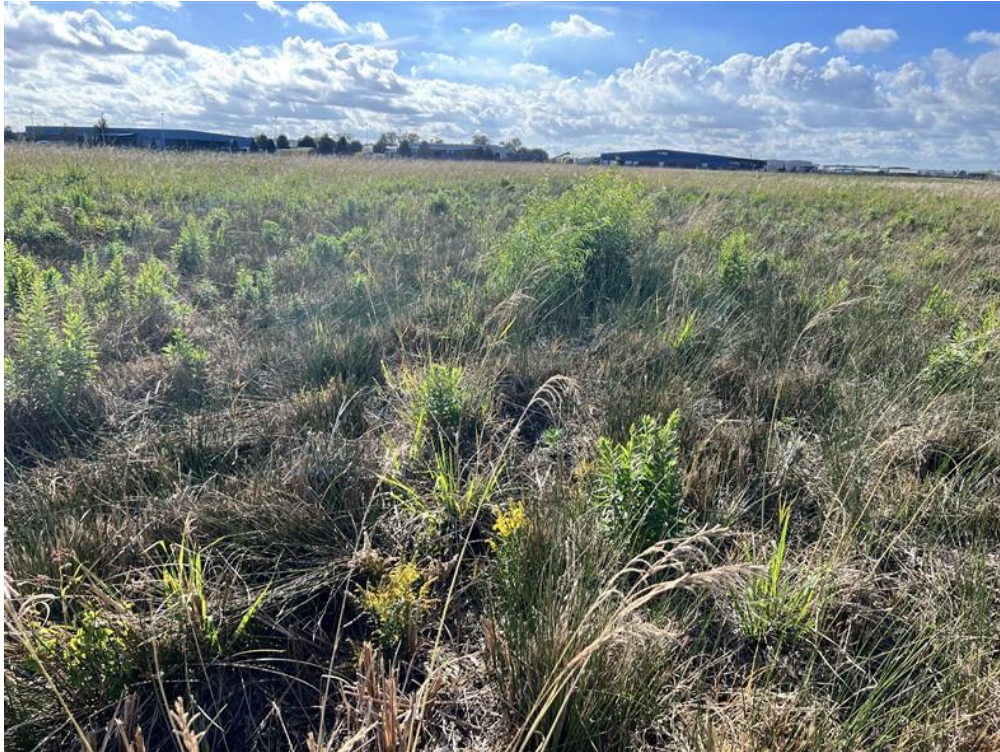
**Figure B.21** Photograph looking to the west showing vegetated areas in lower field at Sample Site NW02- (11-07-23)- Lower field area at center/northeast property corner. Lower areas were created by past grubbing activities from agricultural land conversion and should be non-jurisdictional wetlands.

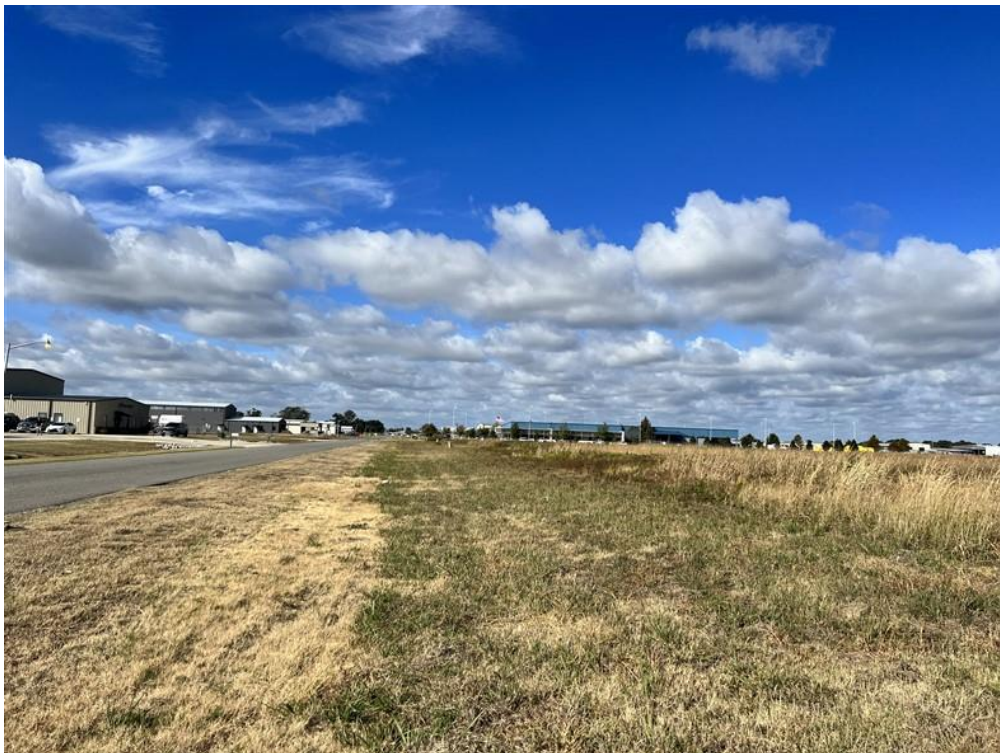
**Figure B.22** View looking to the west along the front part portion of property - (CEI 11-07-23).

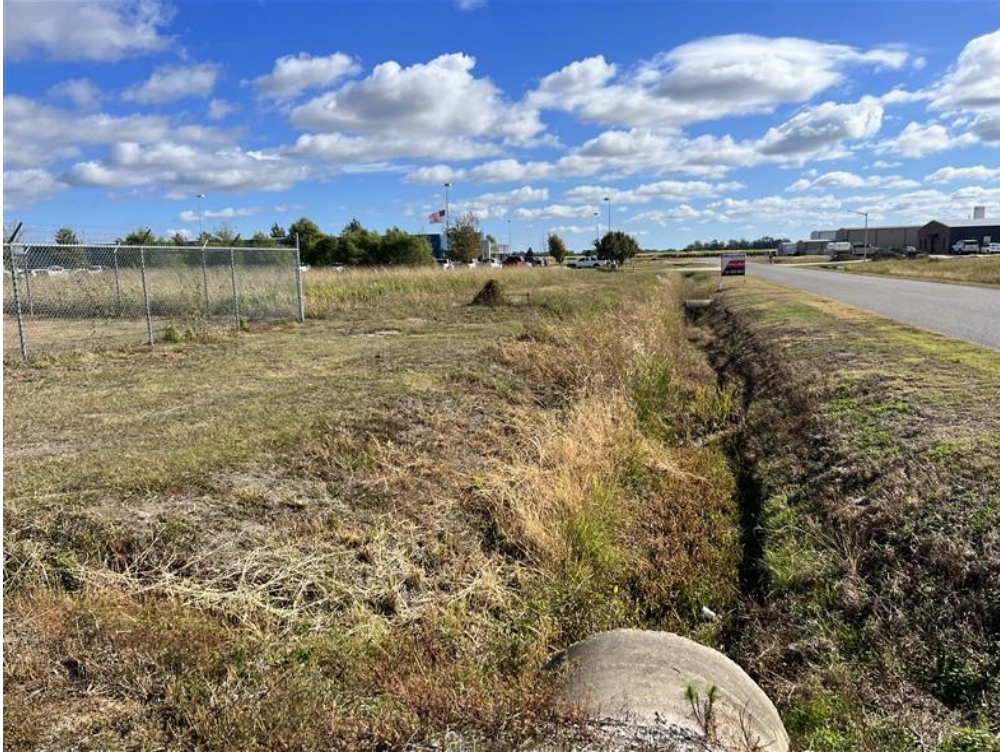
**Figure B.23** View looking to the east from southwest property corner showing the roadside drainage ditch along southern boundary - (CEI 11-07-23).

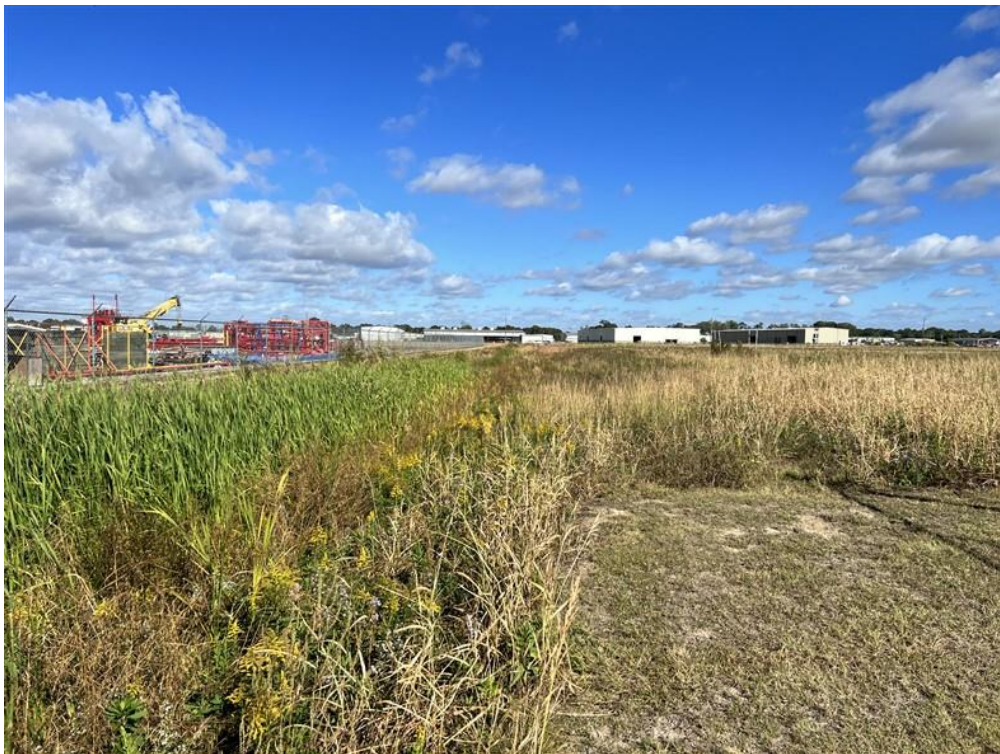
**Figure B.24** View looking to the north from southwest property corner showing the drainage ditch along western boundary - (CEI 11-07-23).

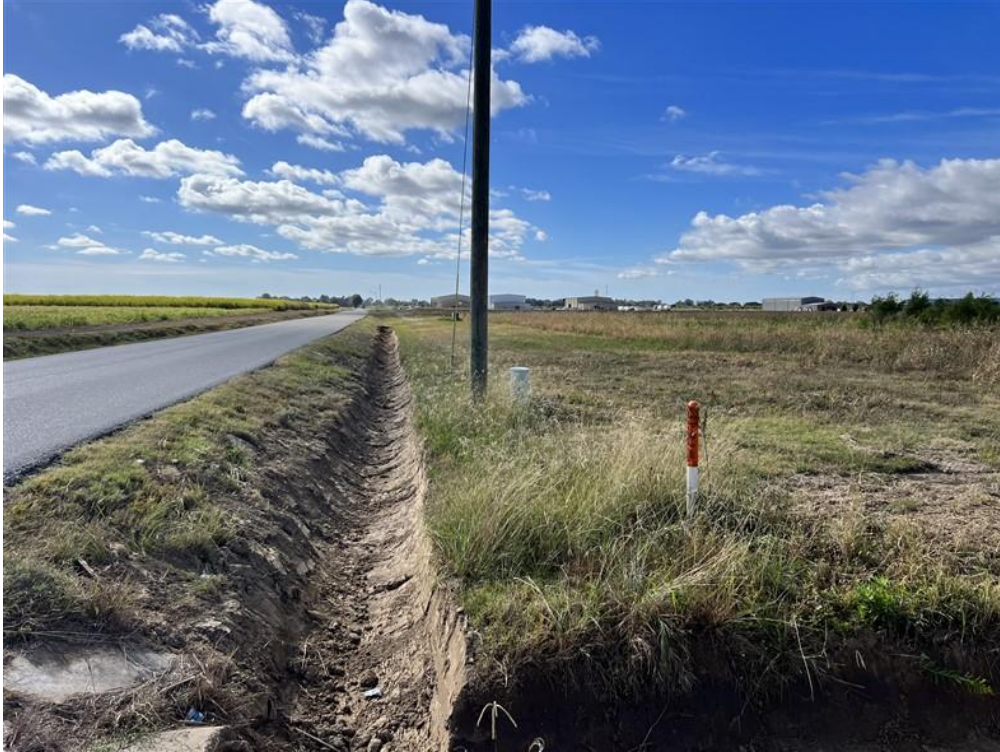
**Figure B.25** View looking to the south from northwest property corner showing the roadside drainage ditch along the eastern boundary - (CEI 11-07-23).

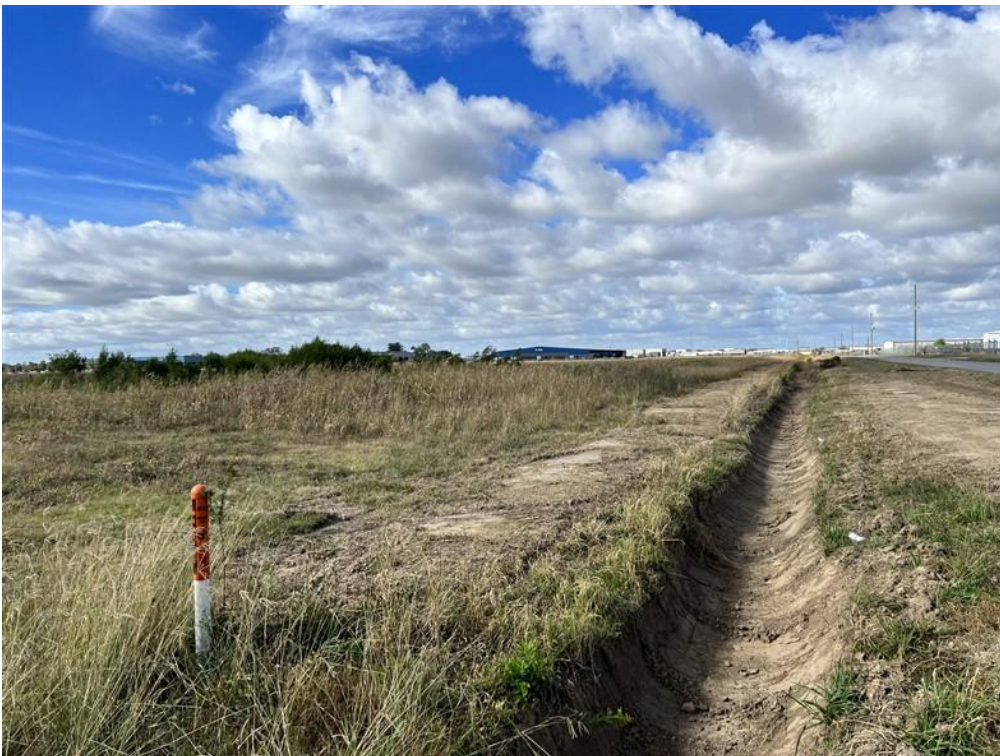
**Figure B.26** View looking to the west from northwest property corner showing the roadside drainage ditch along northern boundary - (CEI 11-07-23).
