RE: WETLAND DELINEATION REPORT 514.6-ACRE GRACE FARMS WEST IBERVILLE PARISH, LOUISIANA

514.6-ACRE GRACE FARMS WEST IBERVILLE PARISH, LOUISIANA

WETLAND DELINEATION REPORT

GEC Project No. 0013.2122013.001

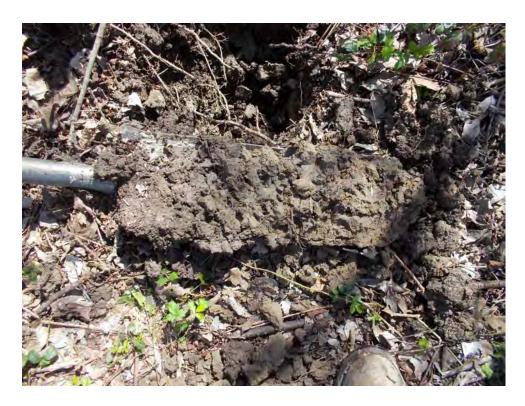
Photograph 1. Soil Profile Observed at Plot 1

The soil series mapped by the NRCS at Plot 1 as Schriever clay; field investigations confirm this soil type. No wetland hydrology indicators were noted. It is GEC's opinion that this feature <u>does not meet</u> the criteria for a wetland based on all three parameters not being met. Photographs 1 and 2 depict the soil profile and an overview of the plot location.

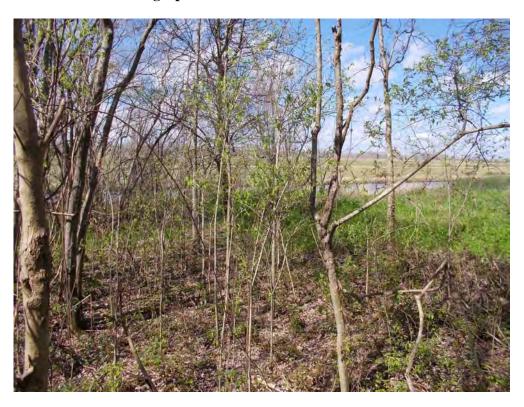
Photograph 2. Overview of Plot 1

Sample Plot 1 consists of a ridge between a canal and a hardwood forest. This plot is located at 30.4059 N and 91.5163 W. The location of this plot is presented in Figure 4.

The tree stratum was dominated by sugarberry (*Celtis laevigata*), roughleaf dogwood (*Cornus drummondii*), and sweet gum (*Liquidambar styraciflu*). Shrub/sapling stratum was dominated by roughleaf dogwood (*Cornus drummondii*). Southern dewberry (*Rubus trivialis*) dominated the herbaceous stratum, while the woody vines noted at the site included balloon vine (*Cardiospermum halicacabum*) and poison ivy (*Toxicodendron radicans*). The hydrophytic vegetation criteria were met at this site.

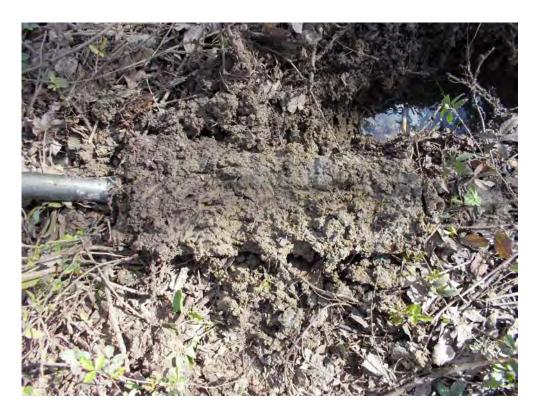
Photograph 3. Soil Profile Observed at Plot ${\bf 2}$

The soil series mapped by the NRCS at Plot 2 as Schriever clay; field investigations confirm this soil type. The primary wetland hydrology indicator was high water table and saturation. It is GEC's opinion that this feature <u>does meet</u> the criteria for a wetland based on all three parameters being met. Photographs 3 and 4 depict the soil profile and an overview of the plot location.

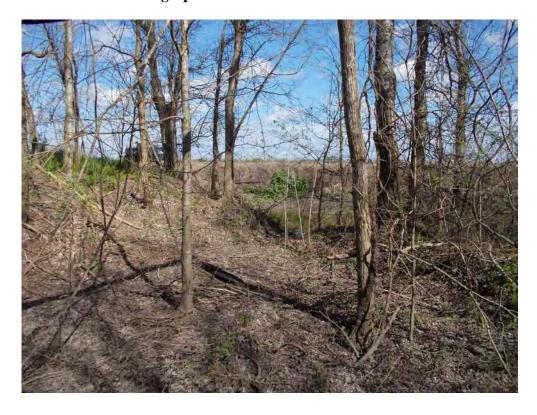
Photograph 4. Overview of Plot 2

Sample Plot 2 consists of a depression adjacent to a canal. This plot is located at 30.4059 N and 91.5162 W. The location of this plot is presented in Figure 4.

The tree stratum was dominated by sugarberry (*Celtis laevigata*) and boxelder (*Acer negundo*). Shrub/sapling stratum was dominated by roughleaf dogwood (*Cornus drummondii*). Southern dewberry (*Rubus trivialis*) dominated the herbaceous stratum, while the only woody vine noted at the site was saw greenbrier (*Smilax bona-nox*). The hydrophytic vegetation criteria were met at this site.

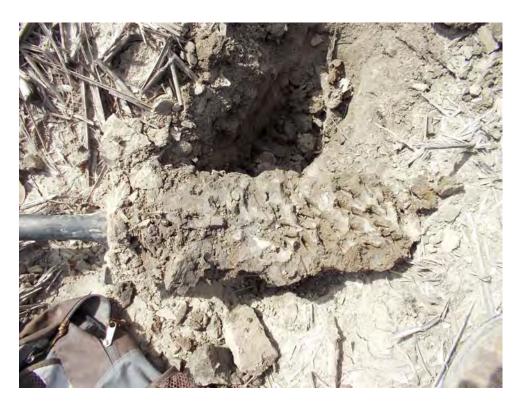
Photograph 5. Soil Profile Observed at Plot ${\bf 3}$

The soil series mapped by the NRCS at Plot 3 as Commerce silt clay loam; field investigations confirm this soil type. No wetland hydrology indicator was noted. It is GEC's opinion that this feature <u>does not meet</u> the criteria for a wetland based on lack of sufficient wetland vegetation and hydrology. Photographs 5 and 6 depict a soil profile and an overview of the plot location.

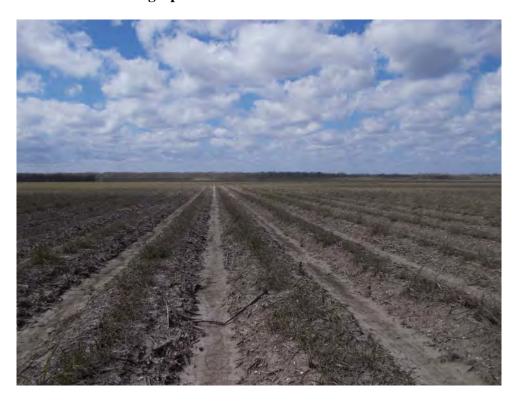
Photograph 6. Overview of Plot 3

The herbaceous stratum was dominated by sugarcane (*Saccharum officinarum*) and bermudagrass (*Cynodon dactylon*). The hydrophytic vegetation criteria was not met at this site.

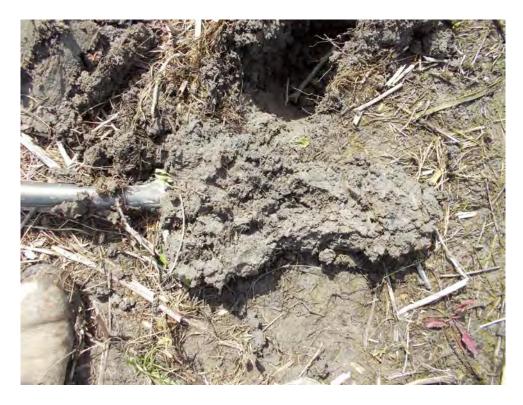
Photograph 7. Soil Profile Observed at Plot 4

The soil series mapped by the NRCS at Plot 4 as Sharkey clay; field investigations confirm this soil type. The primary wetland hydrology indicator was surface water and saturation. It is GEC's opinion that this feature <u>does meet</u> the criteria for a wetland based on all three parameters being met. Photographs 7 and 8 depict a soil profile and an overview of the plot location.

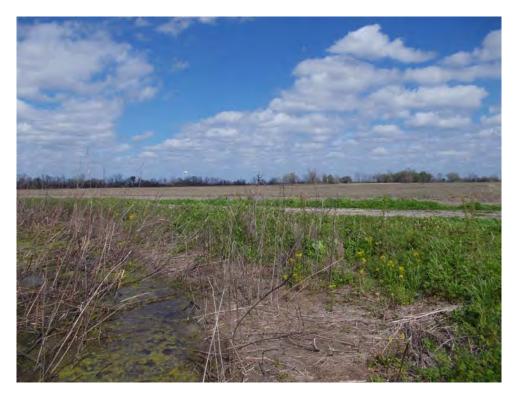
Photograph 8. Overview of Plot 4

The herbaceous stratum was dominated by bigpod sesbania (*Sesbania exaltata*) and black willow (*Salix nigra*). The hydrophytic vegetation criteria were met at this site.

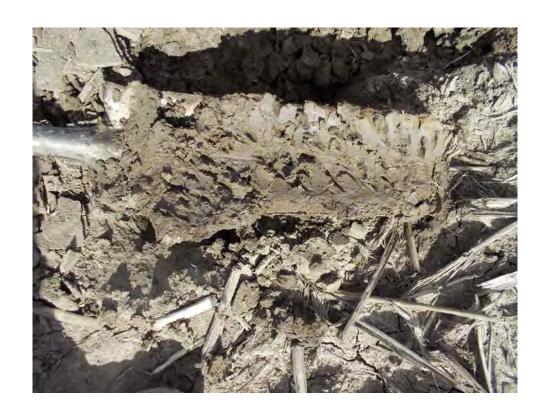
Photograph 9. Soil Profile Observed at Plot 5

The soil series mapped by the NRCS at Plot 5 as Sharkey clay; field investigations confirm this soil type. No wetland hydrology indictors were noted. It is GEC's opinion that this feature <u>does not meet</u> the criteria for a wetland based on lack of all three parameters being met. Photographs 9 and 10 depict a soil profile and an overview of the plot location.

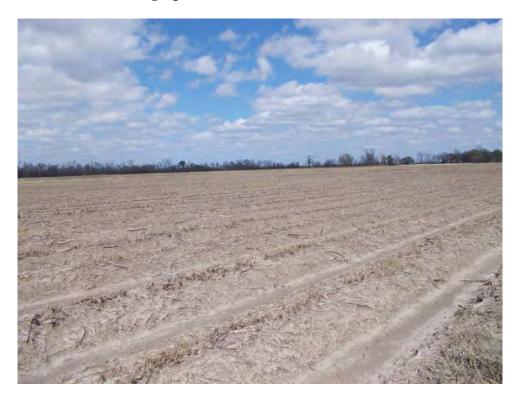
Photograph 10. Overview of Plot 5

The herbaceous stratum was dominated by sugarcane (*Saccharum officinarum*). The hydrophytic vegetation criteria were not met at this site.

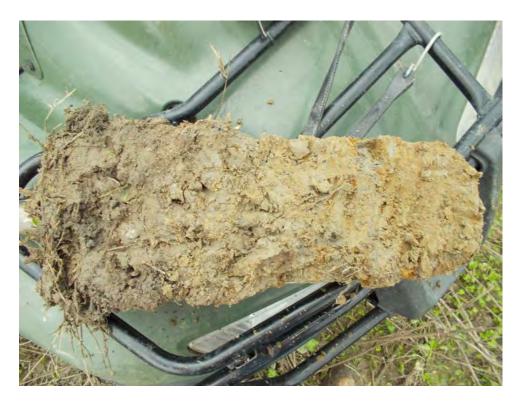
Photograph 11. Soil Profile Observed at Plot 6

The soil series mapped by the NRCS at Plot 6 as Sharkey clay; field investigations confirm this soil type. The primary wetland hydrology indictors were high water table and saturation. It is GEC's opinion that this feature does meet the criteria for a wetland based on all three parameters being met. Photographs 11 and 12 depict a soil profile and an overview of the plot location.

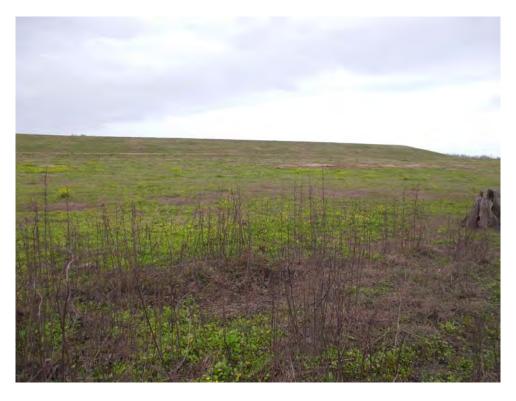
Photograph 12. Overview of Plot 6

The herbaceous stratum was dominated by Pennsylvania smartweed (*Polygonum pensylvanicum*) and spinyfruit buttercup (*Ranunculus muricatus*). The hydrophytic vegetation criteria were met at this site.
