Spanish Trail Industrial Park

Wetlands Delineation Report

RE: Wetland Delineation Report
Spanish Trail Industrial Park
St. Martin Parish, Louisiana

**WETLAND DELINEATION
SPANISH TRAIL INDUSTRIAL PARK
ST. MARTIN PARISH, LOUISIANA**

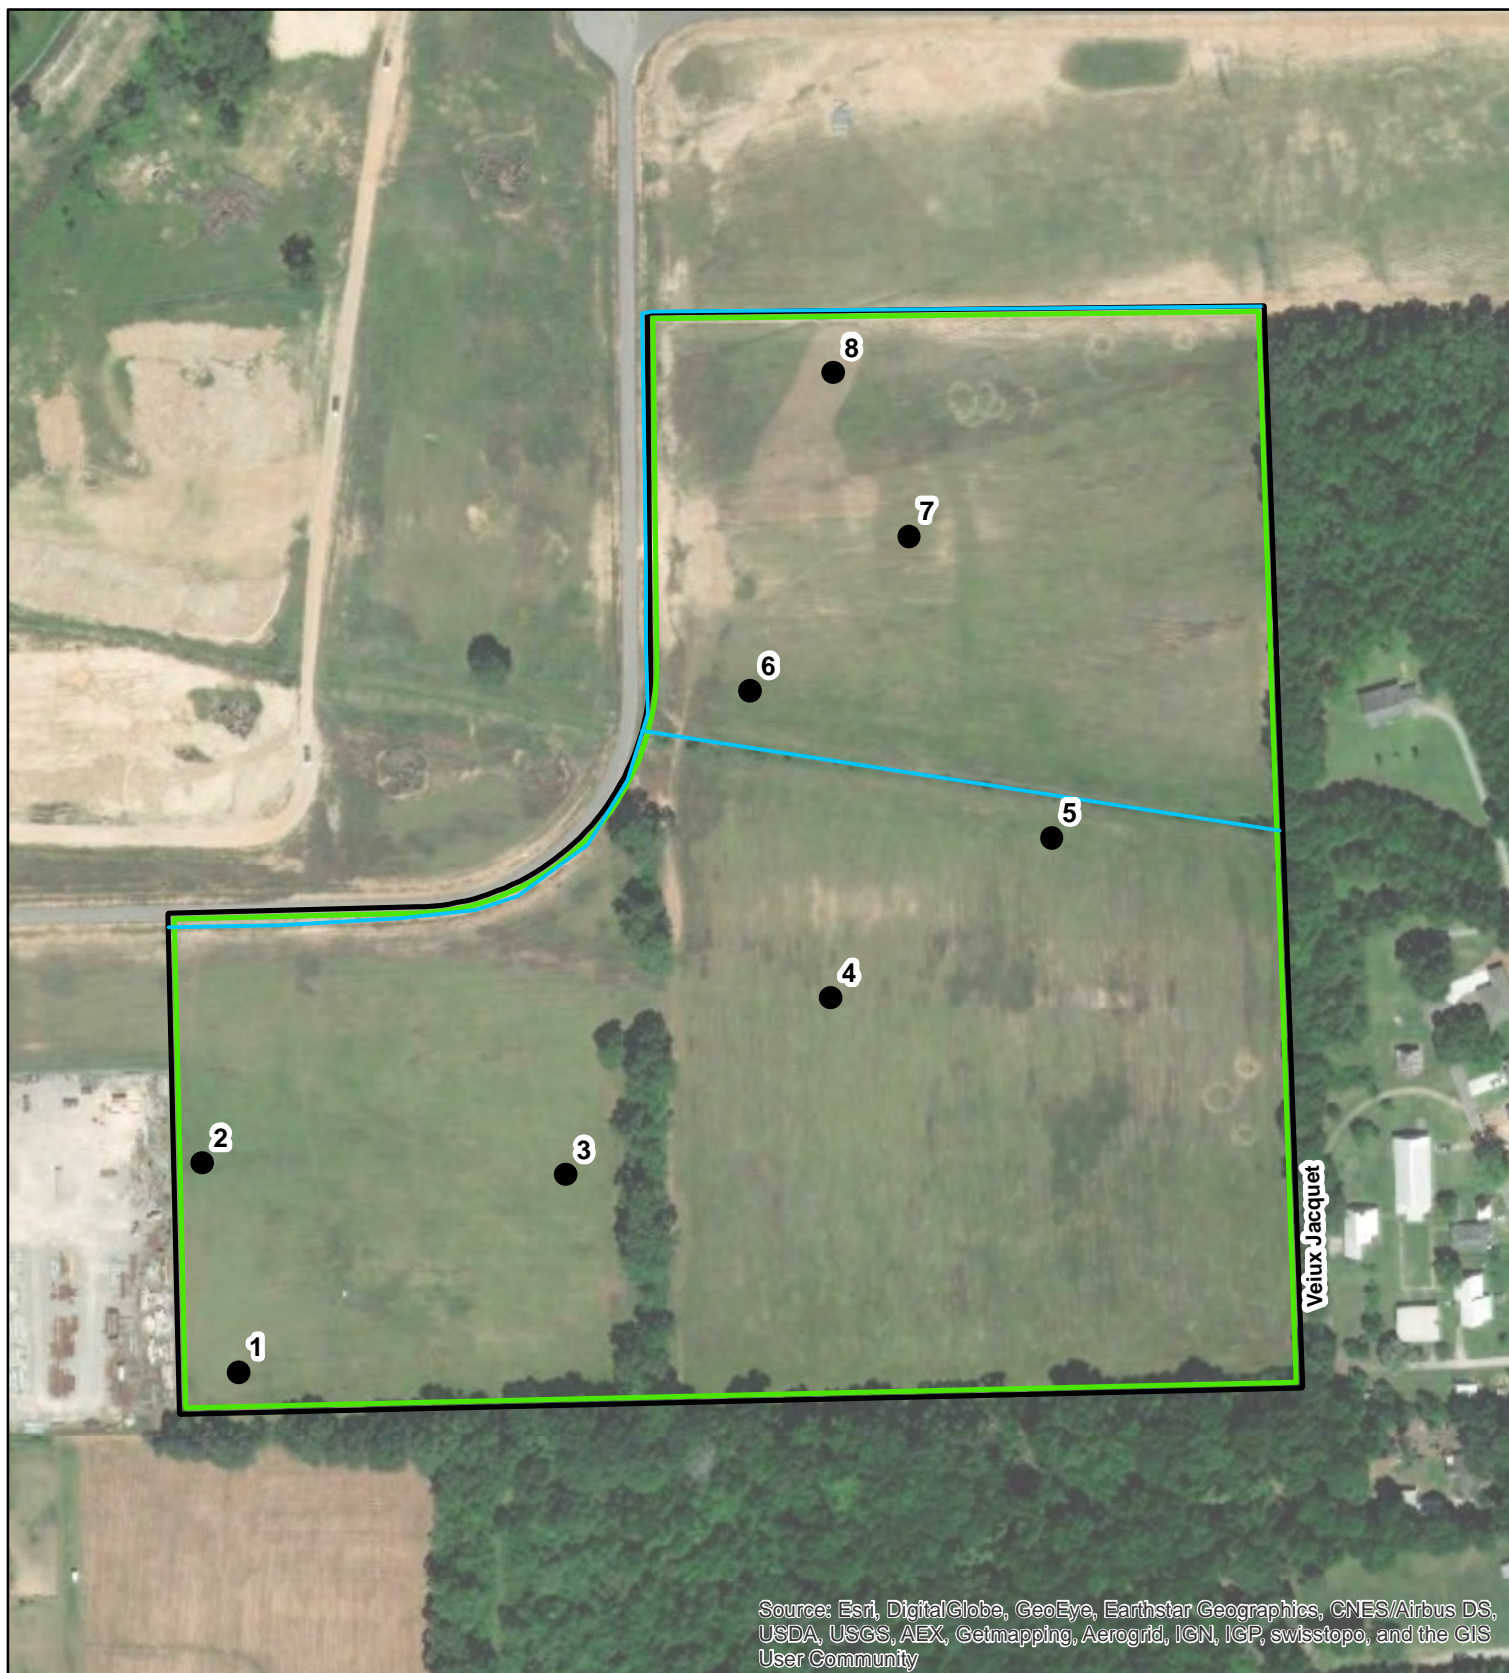
FIGURE 2

- REVIEW AREA (±50 AC)
- NON-WETLAND (±50 AC)
- NON-WETLAND WATERS (±3,440 LF)

**FIGURE 2
SITE DIAGRAM**

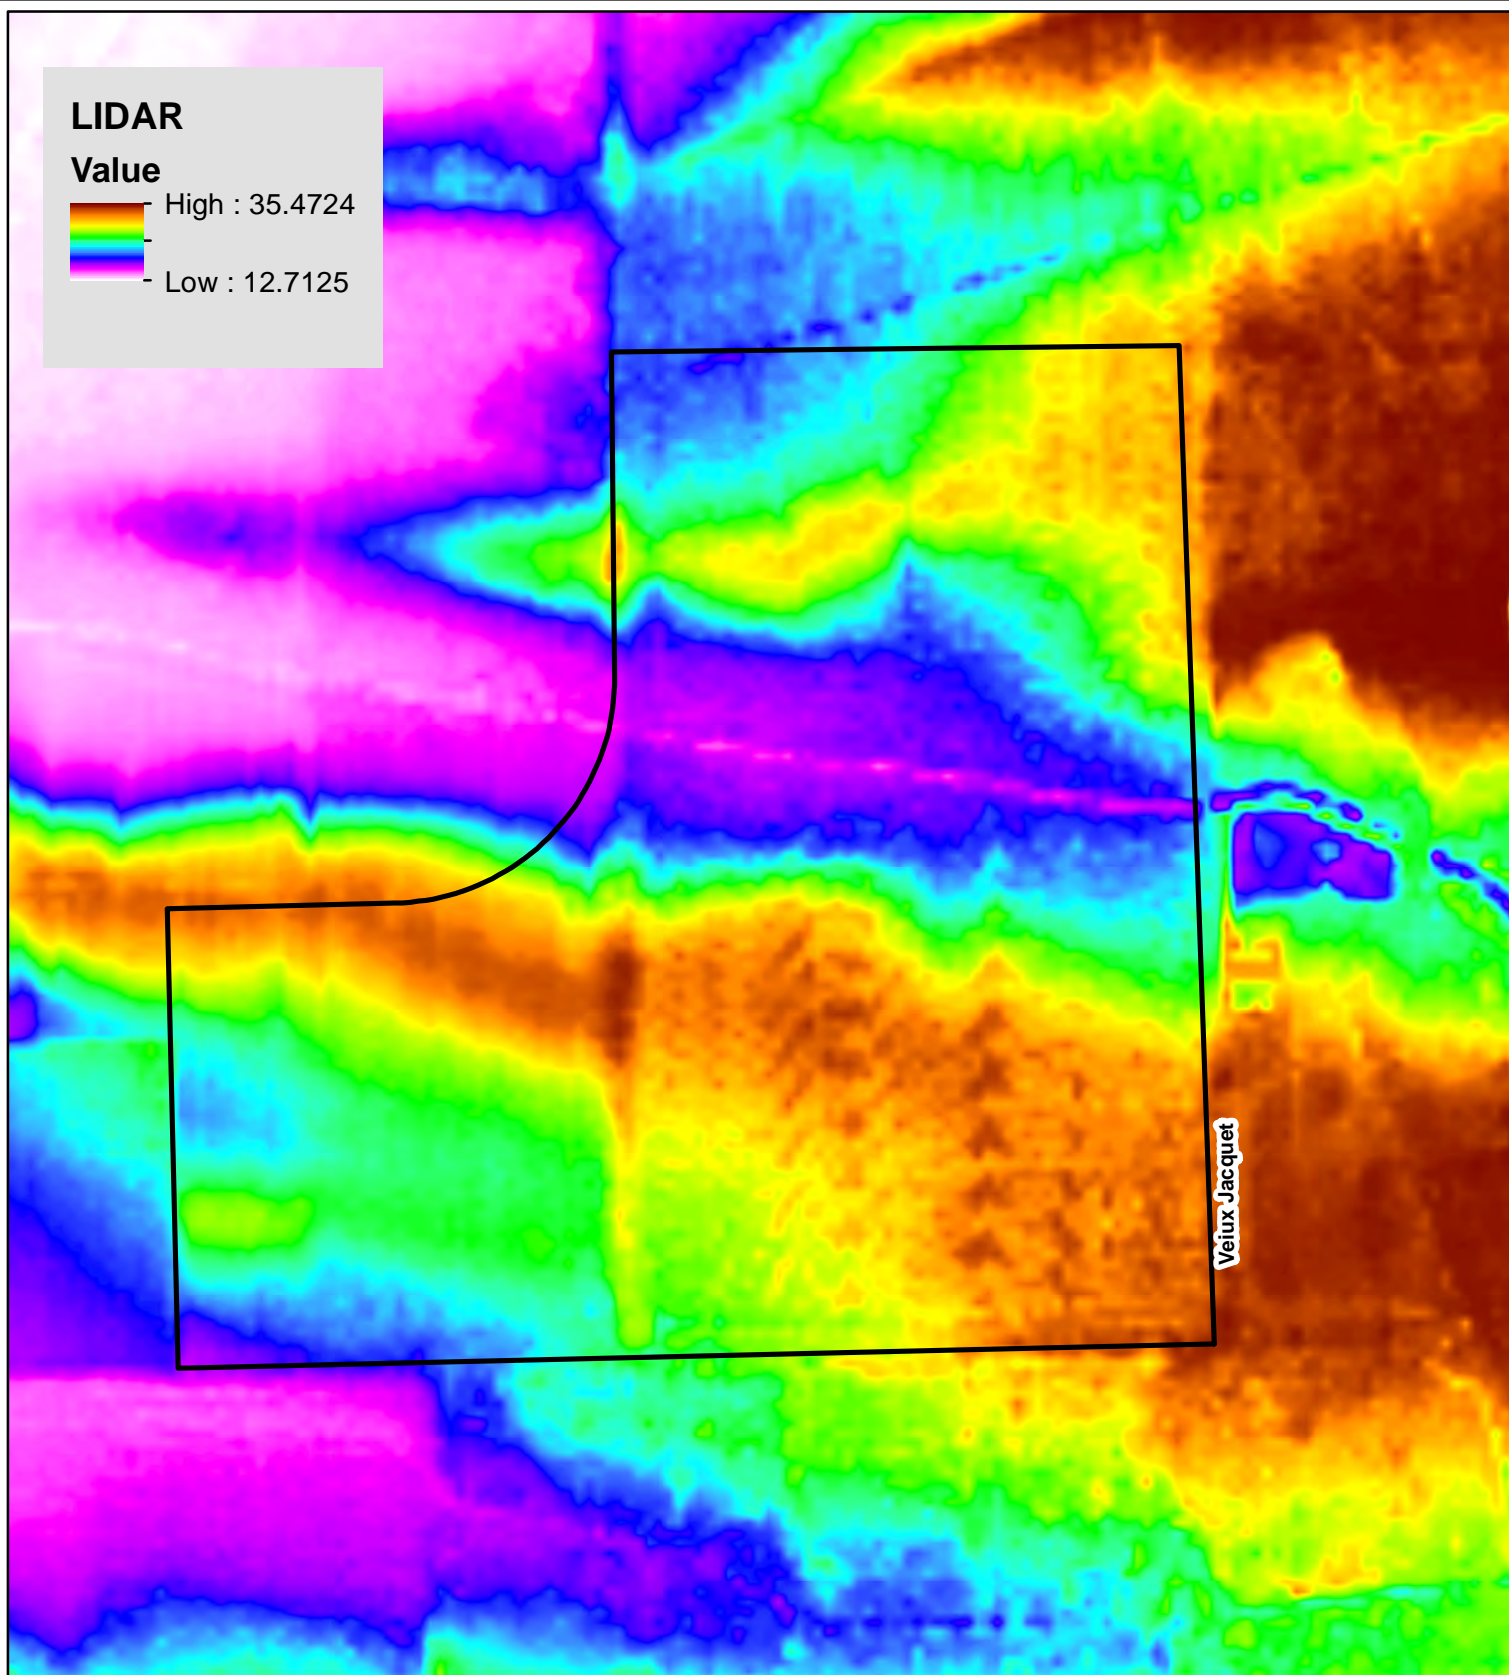
FIGURE 3

LIDAR

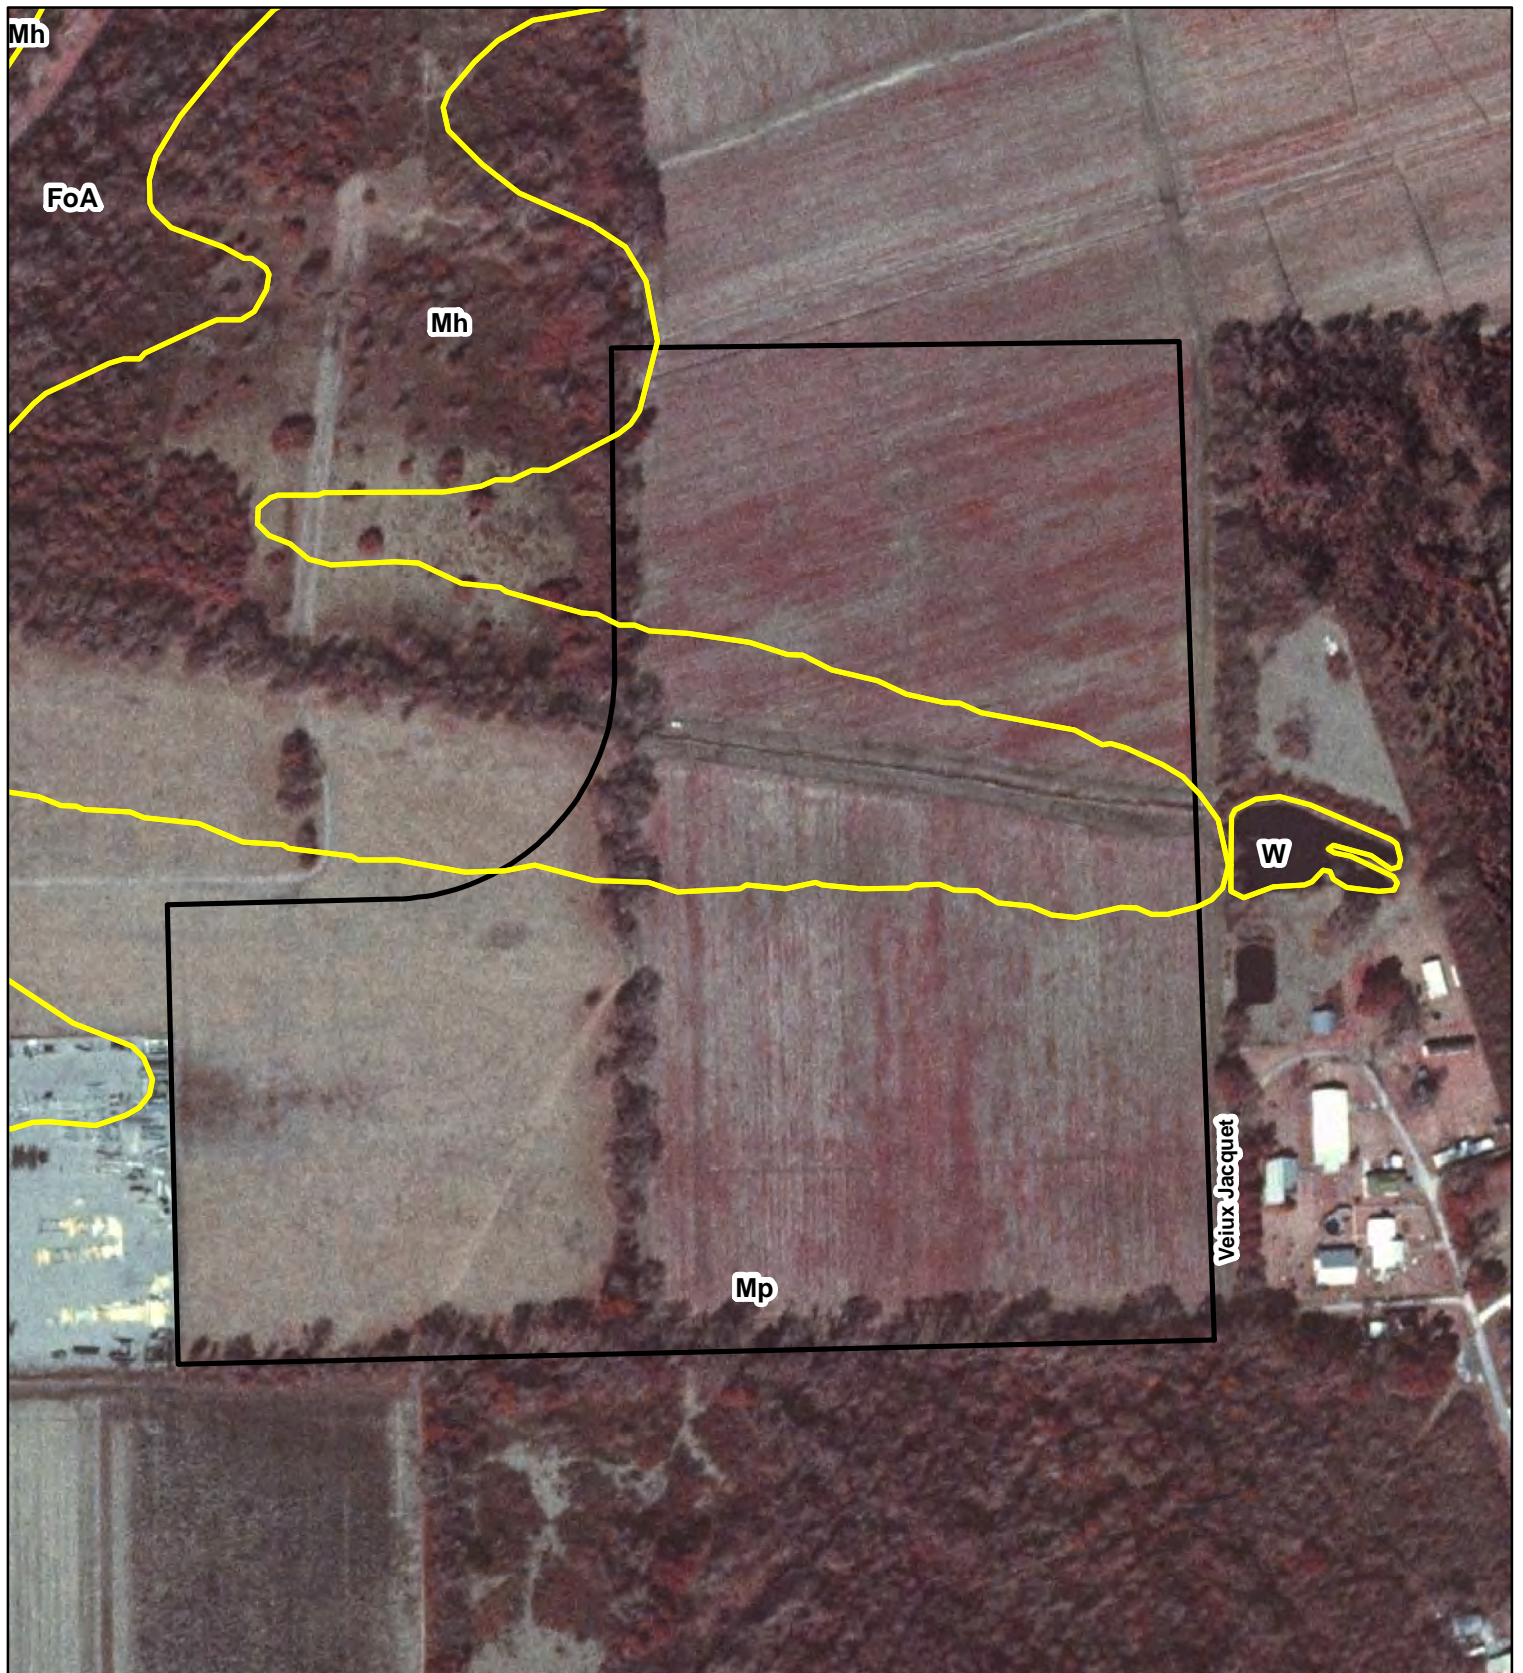
ATTACHMENT B

2004 INFRARED

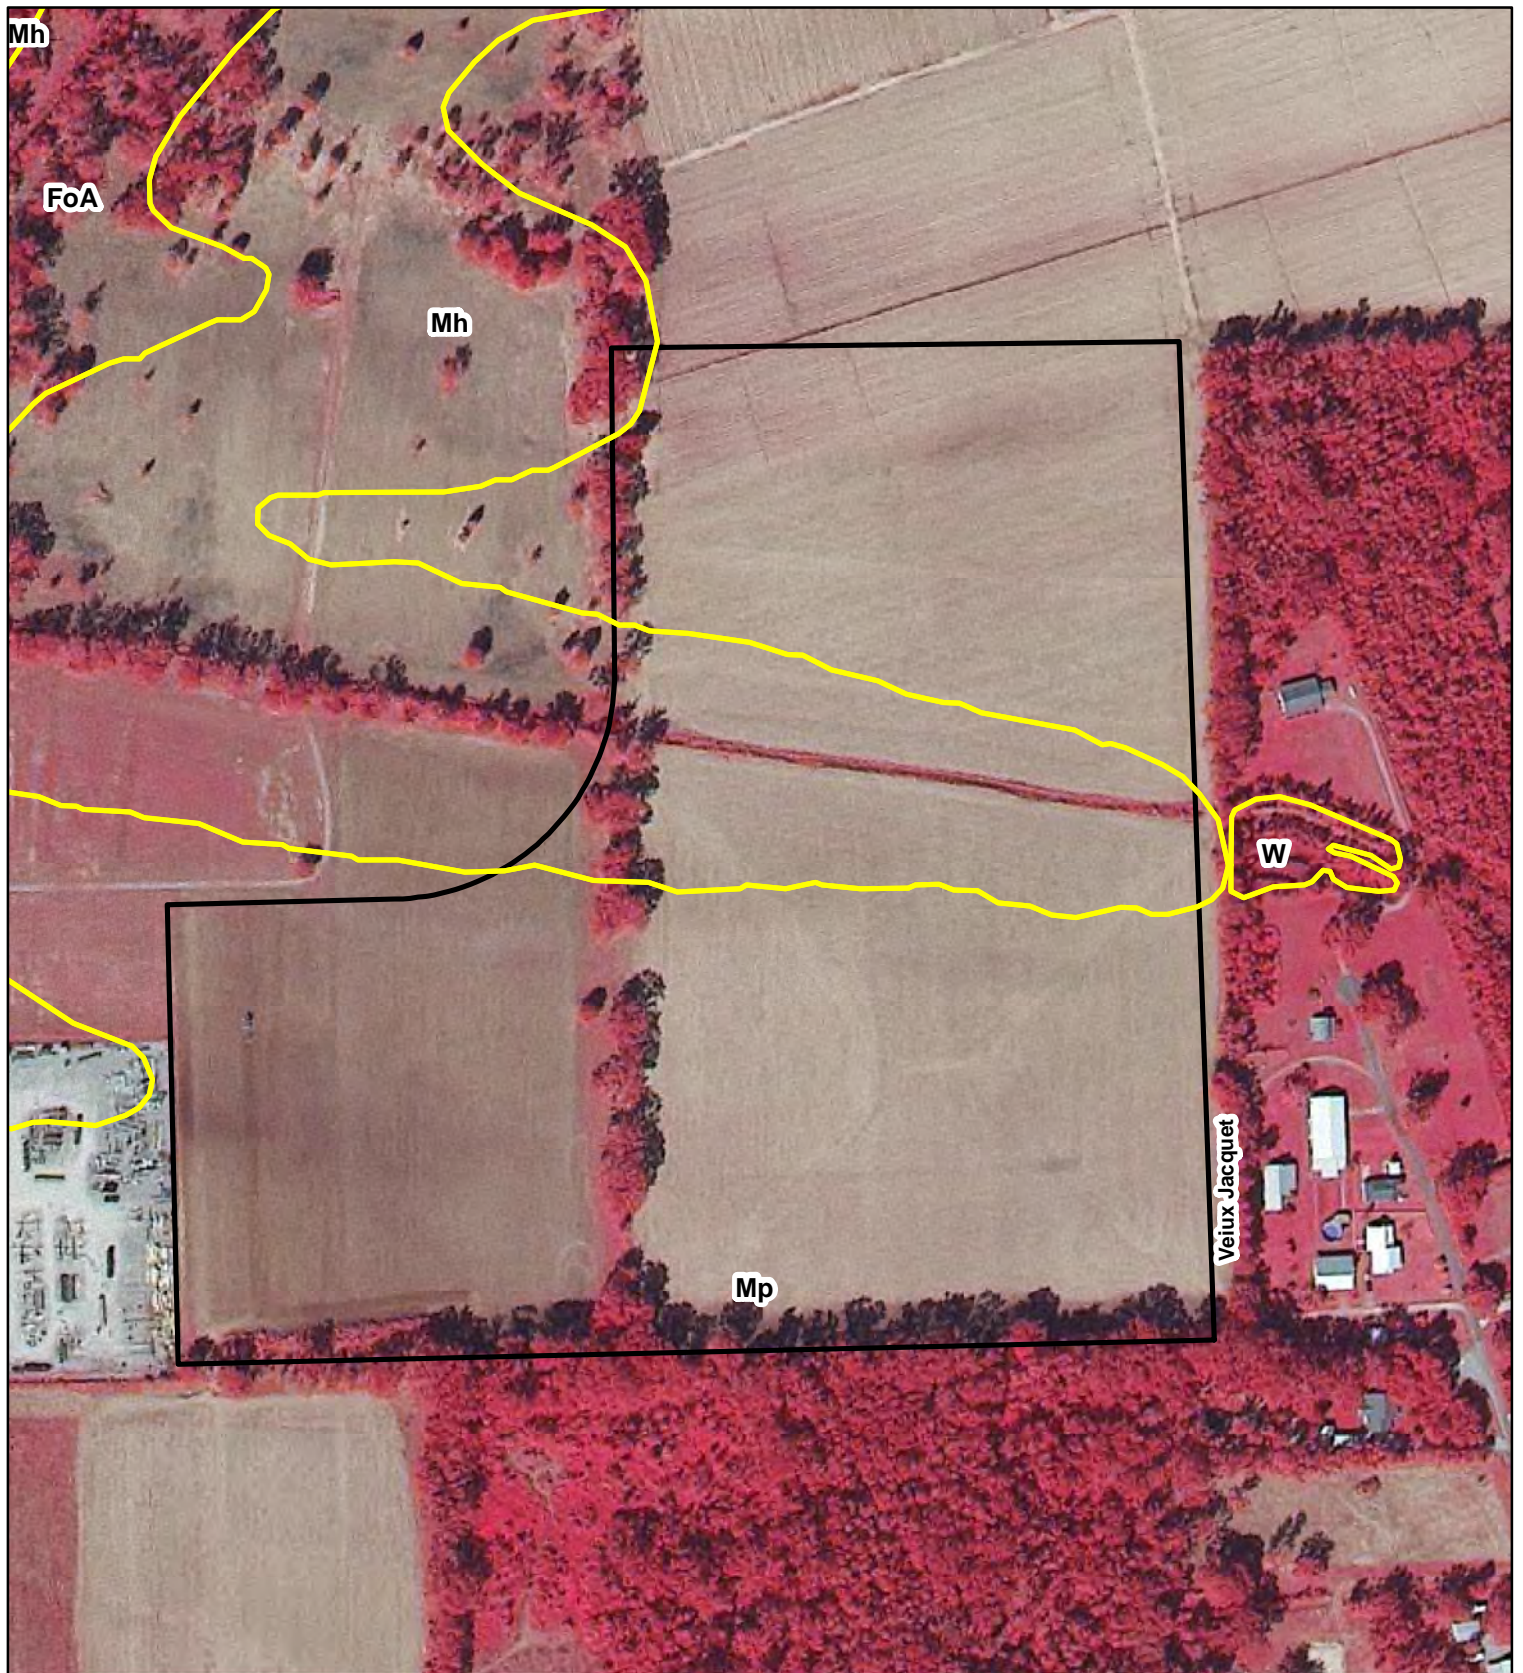
2008 INFRARED

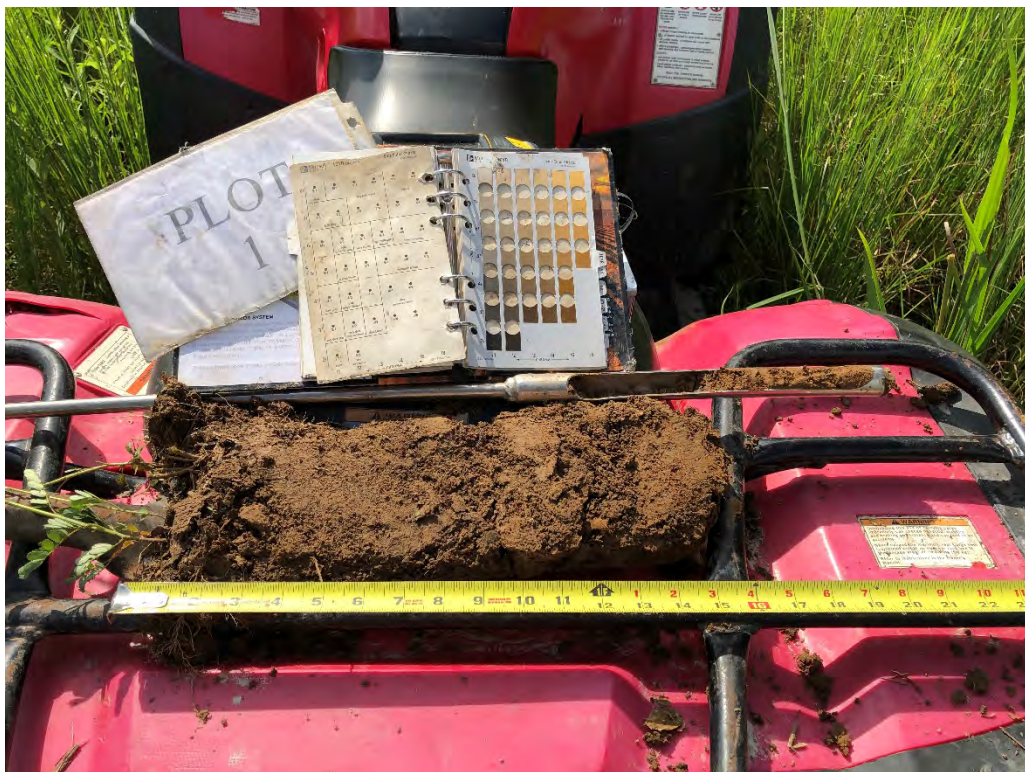
Field Observations: Surface Water Present? Yes _____ No <u>X</u> Depth (inches): _____ Water Table Present? Yes _____ No <u>X</u> Depth (inches): _____ Saturation Present? Yes _____ No <u>X</u> Depth (inches): _____ (includes capillary fringe)		Wetland Hydrology Present? Yes _____ No <u>X</u>
Describe Recorded Data (stream gauge, monitoring well, aerial photos, previous inspections), if available:		
Remarks: None observed, area well drained.

Depth (inches)	Matrix		Redox Features				Texture	Remarks
	Color (moist)	%	Color (moist)	%	Type ¹	Loc ²		
0-12	10YR 4/3	100					Silt Loam	
12-21	10YR 4/4	100					Silty Clay

Photograph 1
Sample Plot 1

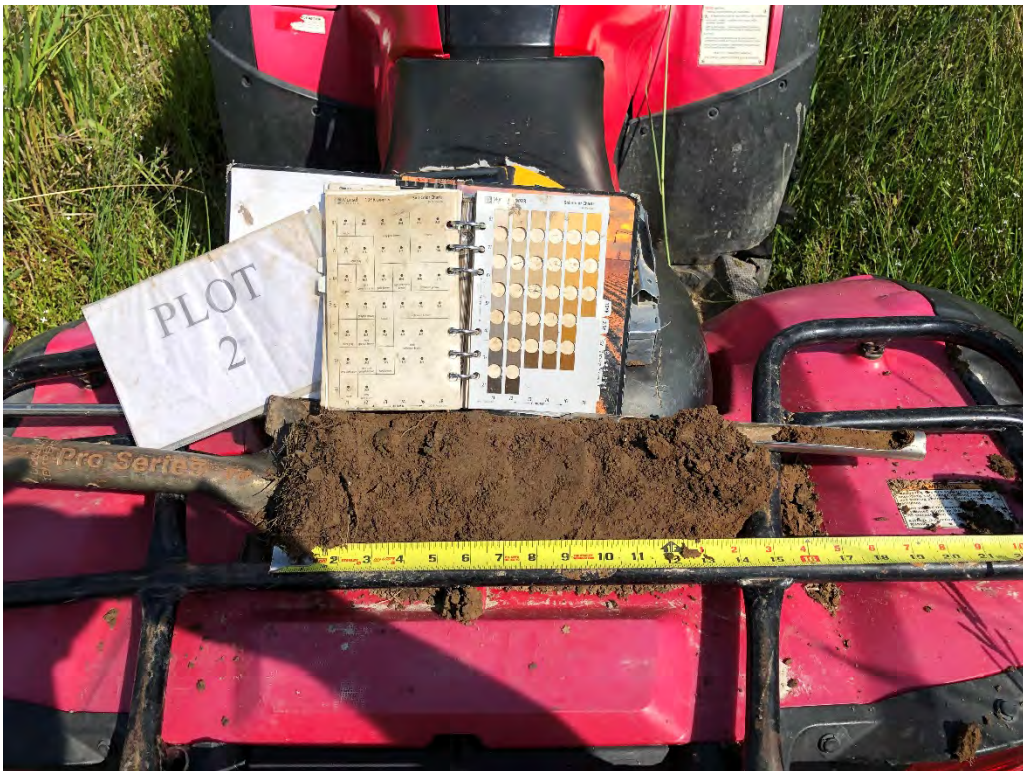
Field Observations: Surface Water Present? Yes _____ No <u>X</u> Depth (inches): _____ Water Table Present? Yes _____ No <u>X</u> Depth (inches): _____ Saturation Present? Yes _____ No <u>X</u> Depth (inches): _____ (includes capillary fringe)		Wetland Hydrology Present? Yes _____ No <u>X</u>
Describe Recorded Data (stream gauge, monitoring well, aerial photos, previous inspections), if available:		
Remarks: None observed, area well drained.

Depth (inches)	Matrix		Redox Features				Texture	Remarks
	Color (moist)	%	Color (moist)	%	Type ¹	Loc ²		
0-13	10YR 4/3	100					Silt Loam	
13-21	10YR 4/4	100					Silty Clay

Photograph 6
Sample Plot 2

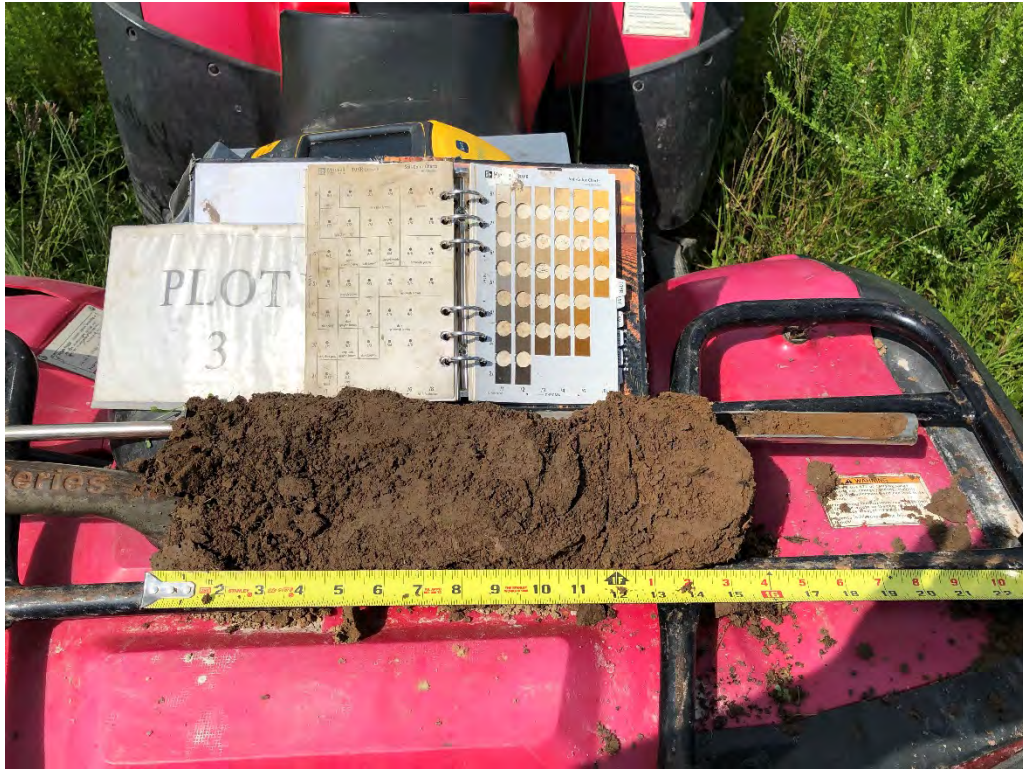
Field Observations: Surface Water Present? Yes _____ No <u>X</u> Depth (inches): _____ Water Table Present? Yes _____ No <u>X</u> Depth (inches): _____ Saturation Present? Yes _____ No <u>X</u> Depth (inches): _____ (includes capillary fringe)		Wetland Hydrology Present? Yes _____ No <u>X</u>
Describe Recorded Data (stream gauge, monitoring well, aerial photos, previous inspections), if available:		
Remarks: None observed, area well drained.

Depth (inches)	Matrix		Redox Features				Texture	Remarks
	Color (moist)	%	Color (moist)	%	Type ¹	Loc ²		
0-12	10YR 4/3	100					Silt Loam	
12-21	10YR 4/4	100					Silty Clay

Photograph 11
Sample Plot 3

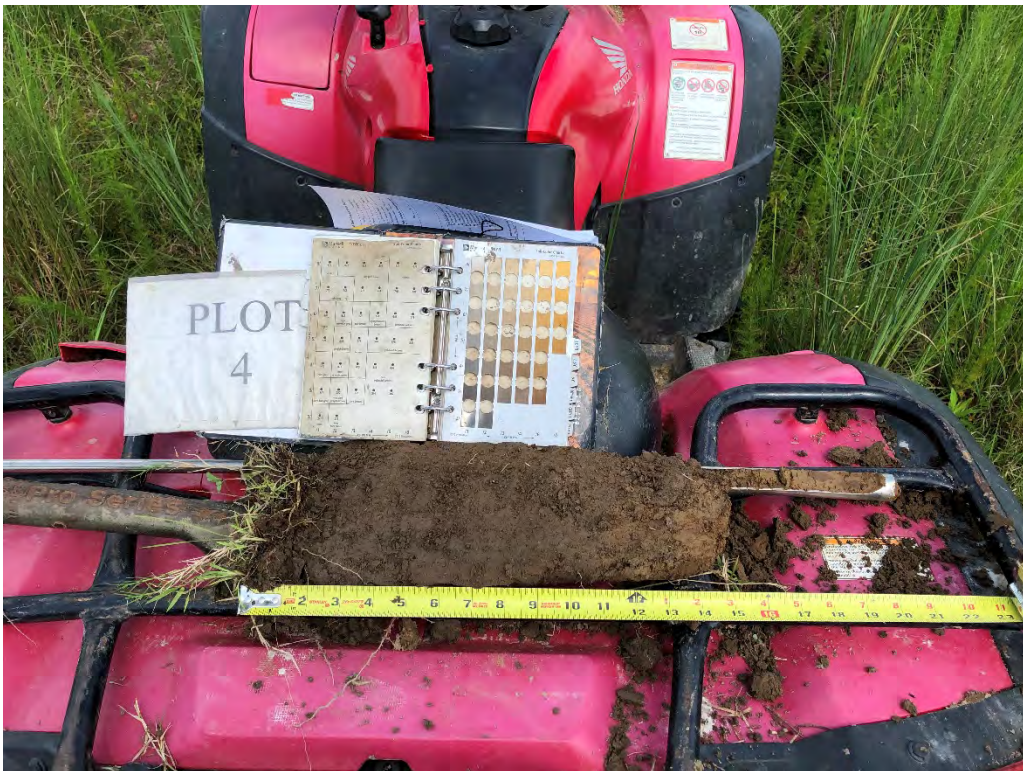
Field Observations: Surface Water Present? Yes _____ No <u>X</u> Depth (inches): _____ Water Table Present? Yes _____ No <u>X</u> Depth (inches): _____ Saturation Present? Yes _____ No <u>X</u> Depth (inches): _____ (includes capillary fringe)		Wetland Hydrology Present? Yes _____ No <u>X</u>
Describe Recorded Data (stream gauge, monitoring well, aerial photos, previous inspections), if available:		
Remarks: None observed, area well drained.

Depth (inches)	Matrix		Redox Features				Texture	Remarks
	Color (moist)	%	Color (moist)	%	Type ¹	Loc ²		
0-11	10YR 4/3	100					Silt Loam	
11-21	10YR 4/4	100					Silty Clay

Photograph 16
Sample Plot 4

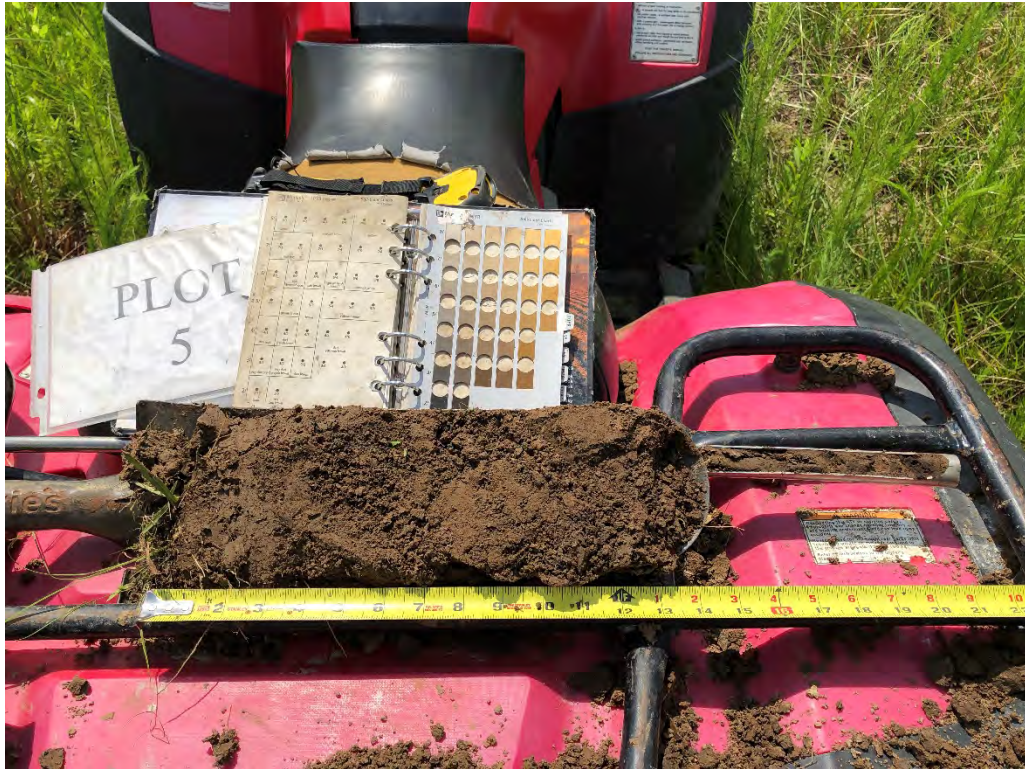
Field Observations: Surface Water Present? Yes _____ No <u>X</u> Depth (inches): _____ Water Table Present? Yes _____ No <u>X</u> Depth (inches): _____ Saturation Present? Yes _____ No <u>X</u> Depth (inches): _____ (includes capillary fringe)		Wetland Hydrology Present? Yes _____ No <u>X</u>
Describe Recorded Data (stream gauge, monitoring well, aerial photos, previous inspections), if available:		
Remarks: None observed, area well drained.

Depth (inches)	Matrix		Redox Features				Texture	Remarks
	Color (moist)	%	Color (moist)	%	Type ¹	Loc ²		
0-14	10YR 4/3	100					Silt Loam	
14-21	10YR 3/2	90	10YR 4/3	10	C	M	Silty Clay

Photograph 21
Sample Plot 5

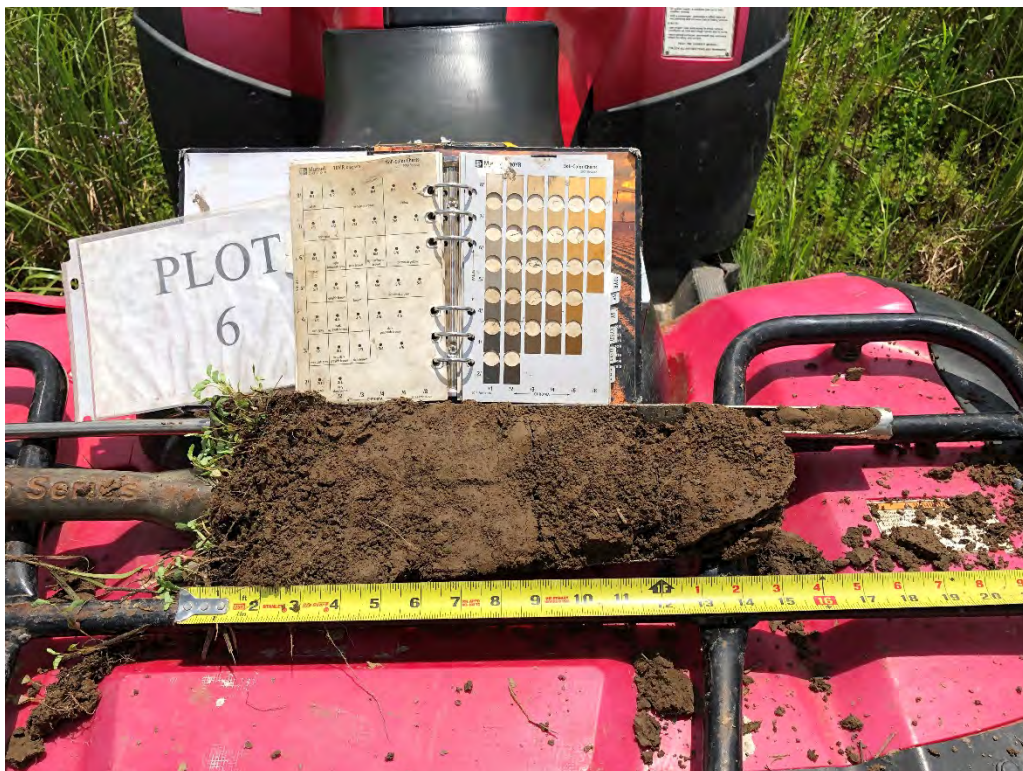
Field Observations: Surface Water Present? Yes _____ No <u>X</u> Depth (inches): _____ Water Table Present? Yes _____ No <u>X</u> Depth (inches): _____ Saturation Present? Yes _____ No <u>X</u> Depth (inches): _____ (includes capillary fringe)		Wetland Hydrology Present? Yes _____ No <u>X</u>
Describe Recorded Data (stream gauge, monitoring well, aerial photos, previous inspections), if available:		
Remarks: None observed, area well drained.

Depth (inches)	Matrix		Redox Features				Texture	Remarks
	Color (moist)	%	Color (moist)	%	Type ¹	Loc ²		
0-10	10YR 4/2	100					Silt Loam	
10-20	10YR 3/2	98	5YR 4/6	2	C	M	Silty Clay	Few/Faint

Photograph 26
Sample Plot 6

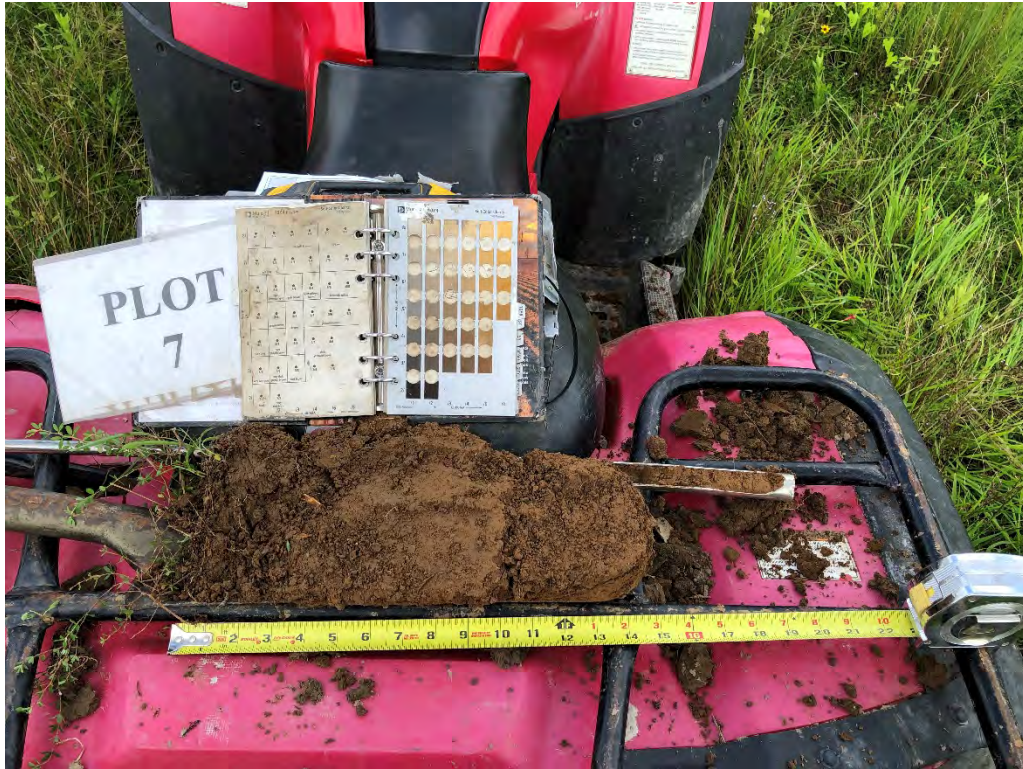
Field Observations: Surface Water Present? Yes _____ No <u>X</u> Depth (inches): _____ Water Table Present? Yes _____ No <u>X</u> Depth (inches): _____ Saturation Present? Yes _____ No <u>X</u> Depth (inches): _____ (includes capillary fringe)		Wetland Hydrology Present? Yes _____ No <u>X</u>
Describe Recorded Data (stream gauge, monitoring well, aerial photos, previous inspections), if available:		
Remarks: None observed, area well drained.

Depth (inches)	Matrix		Redox Features				Texture	Remarks
	Color (moist)	%	Color (moist)	%	Type ¹	Loc ²		
0-12	10YR 4/3	100					Silt Loam	
12-20	10YR 4/4	100					Silty Clay

Photograph 31
Sample Plot 7

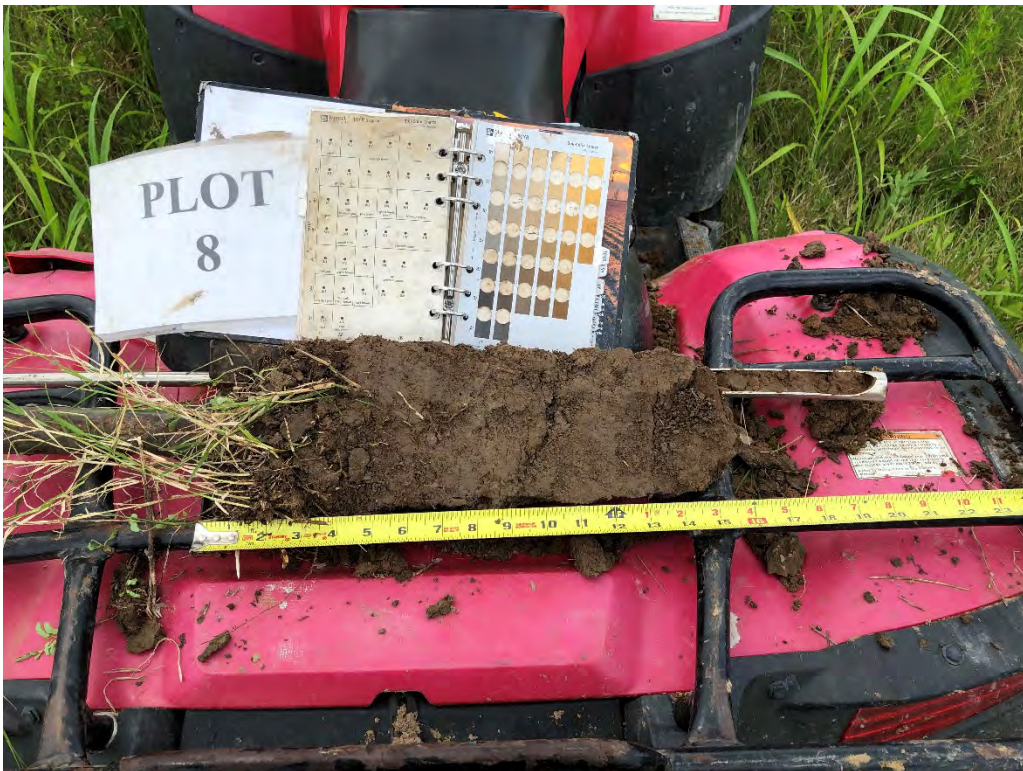
Field Observations:			
Surface Water Present? Yes _____ No <u>X</u>	Depth (inches): _____	Wetland Hydrology Present? Yes _____ No <u>X</u>	
Water Table Present? Yes _____ No <u>X</u>	Depth (inches): _____		
Saturation Present? (includes capillary fringe) Yes _____ No <u>X</u>	Depth (inches): _____		
Describe Recorded Data (stream gauge, monitoring well, aerial photos, previous inspections), if available:			
Remarks: None observed, area well drained.

Depth (inches)	Matrix		Redox Features				Texture	Remarks
	Color (moist)	%	Color (moist)	%	Type ¹	Loc ²		
0-11	10YR 4/2	100					Silt Loam	No redox noted
11-21	10YR 4/3	100					Silt Loam	No redox noted

Photograph 36
Sample Plot 8

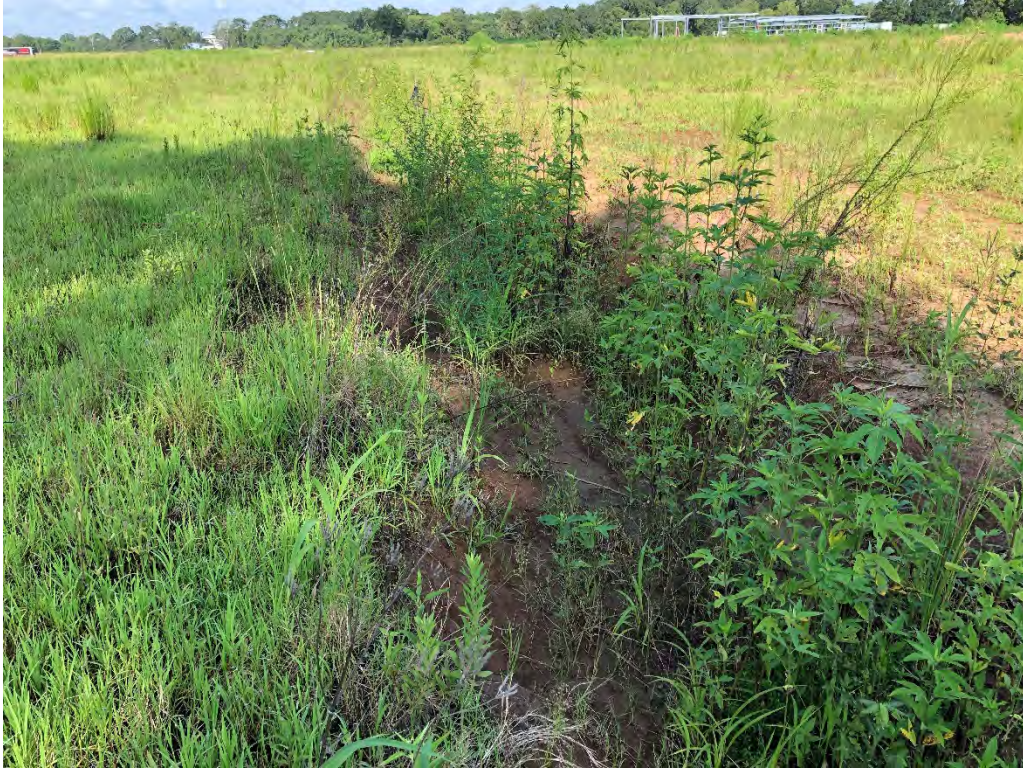
Based on the results of this delineation, no wetlands were identified within the property boundary. Drainage ditches are located on the investigated property. These drains comprise approximately 3,440 linear feet and will likely be considered non-wetland waters by the COE.

Photograph 41
View of Small Drain near North Property Boundary facing West

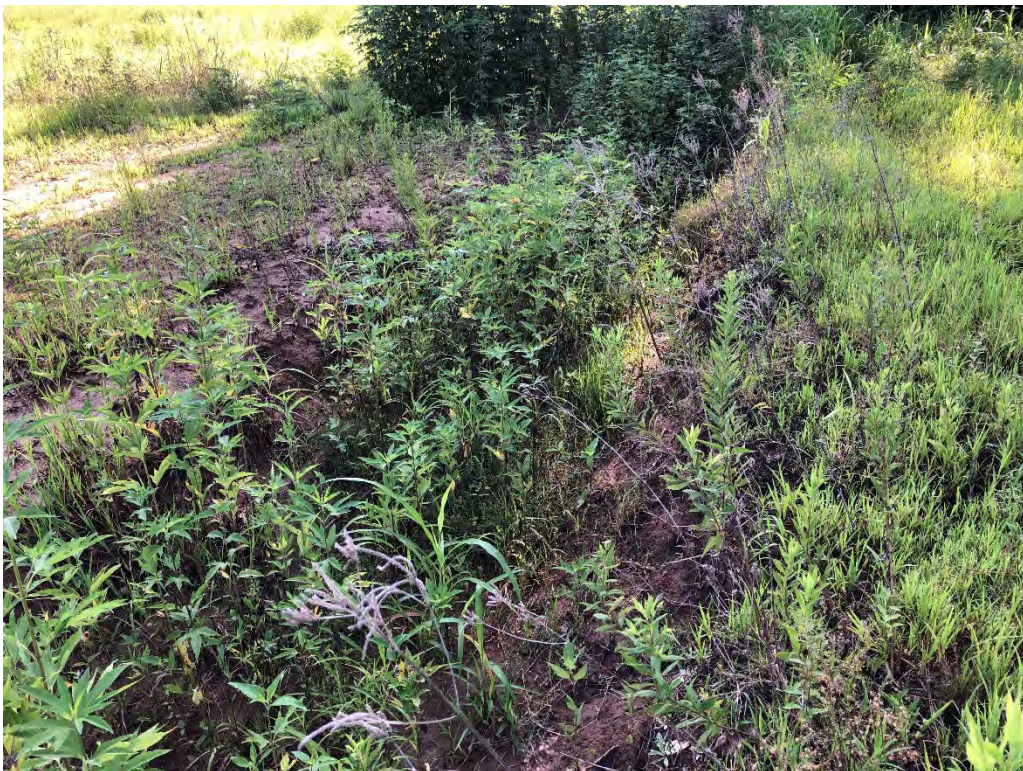
Photograph 42
View of Small Drain near North Property Boundary facing East

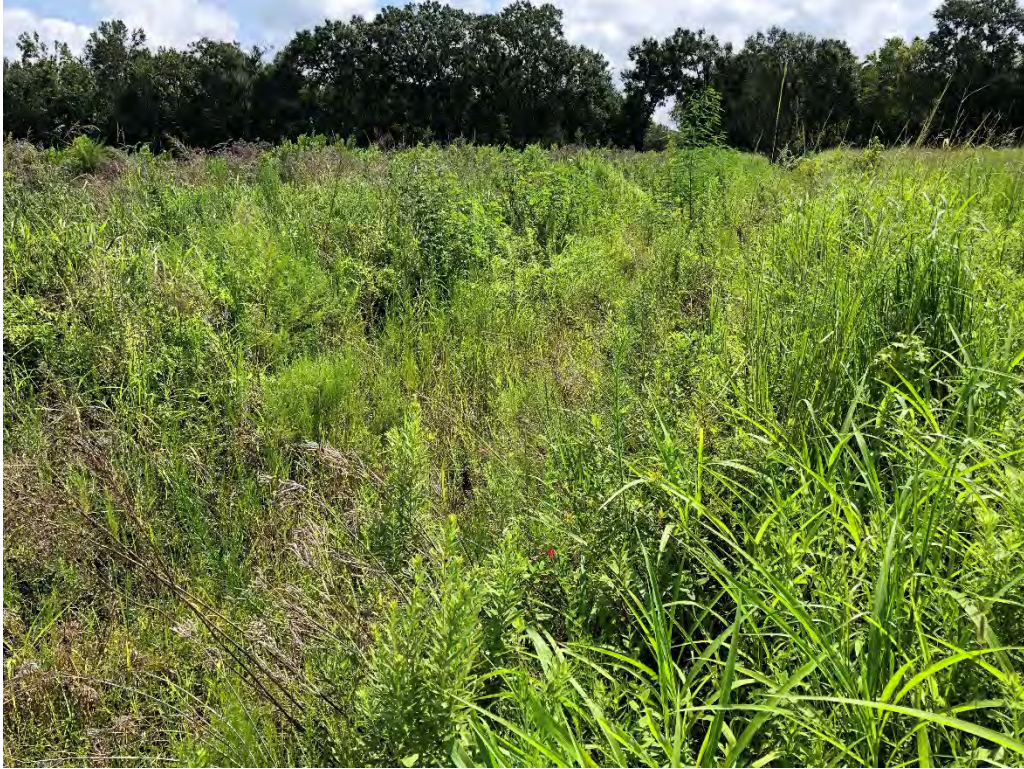
Photograph 43
View of Large Drain near Center of Tract, facing East

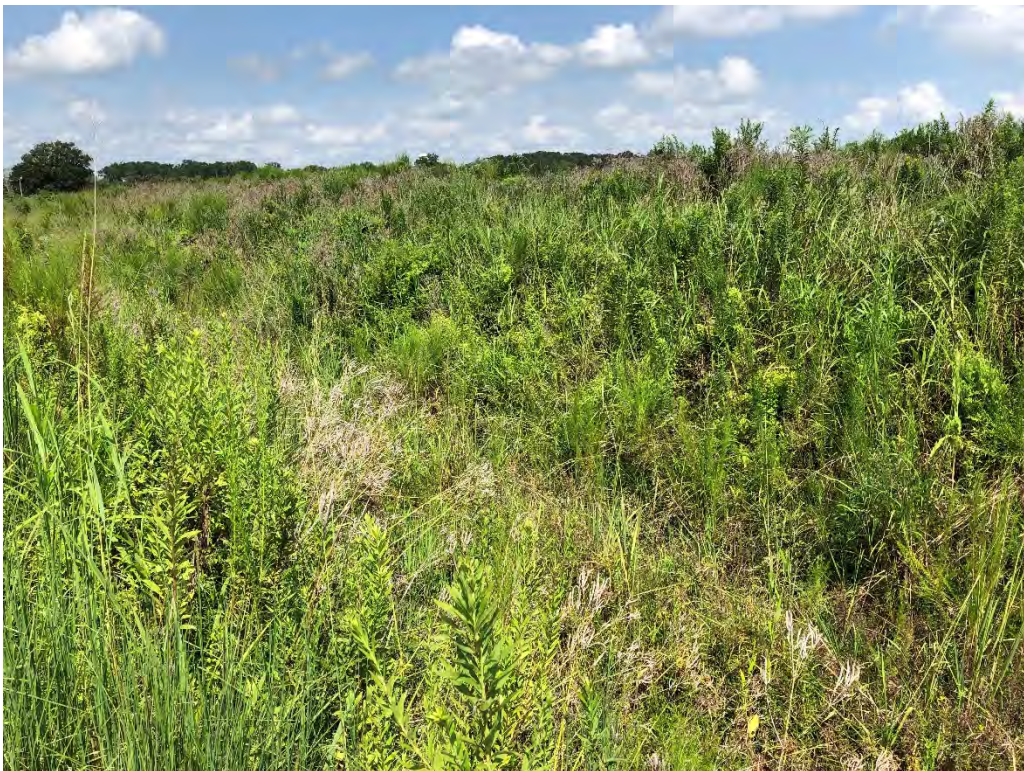
Photograph 44
View of Large Drain near Center of Tract, facing West
